« Study of High-Temperature Hydrogen Attack in carbon-steel equipment »

Volos, 2022

Fotaki Morfo

In the present thesis, there is also the investigation of the failed heat exchanger (M-9210), from the Aspropyrgos Refinery. The failure is attributed to the High Temperature Hydrogen Attack damage mechanism. Through the metallographic study and hardness measurement the thesis will add insight on the physical process that occur during the initiation and propagation of this particular case of failure. Finally, the gathered information and the results of the specimen examination will be discussed.

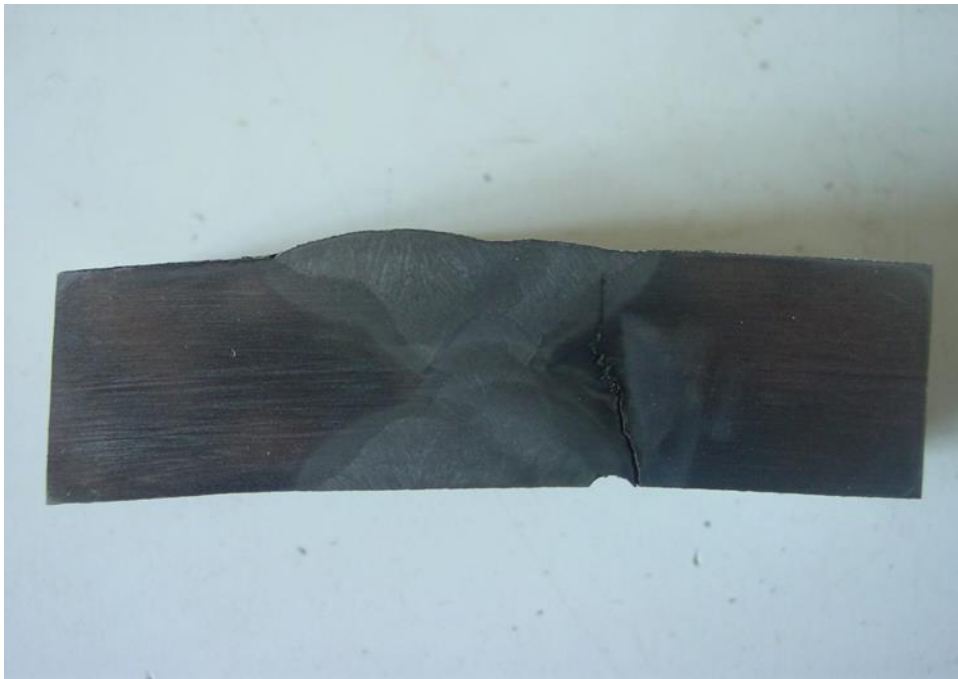
A segment cut from the exchanger outer tube was firstly examined with the Stereoscope to gain better insight on the crack propagation direction. The specimen taken for sampling was cut from the site of the weld L3, where the main crack is located. The specimen contained part of the main crack that demonstrated failure.

Figure 15. Piece of the external tube of the heat exchanger M-9210.

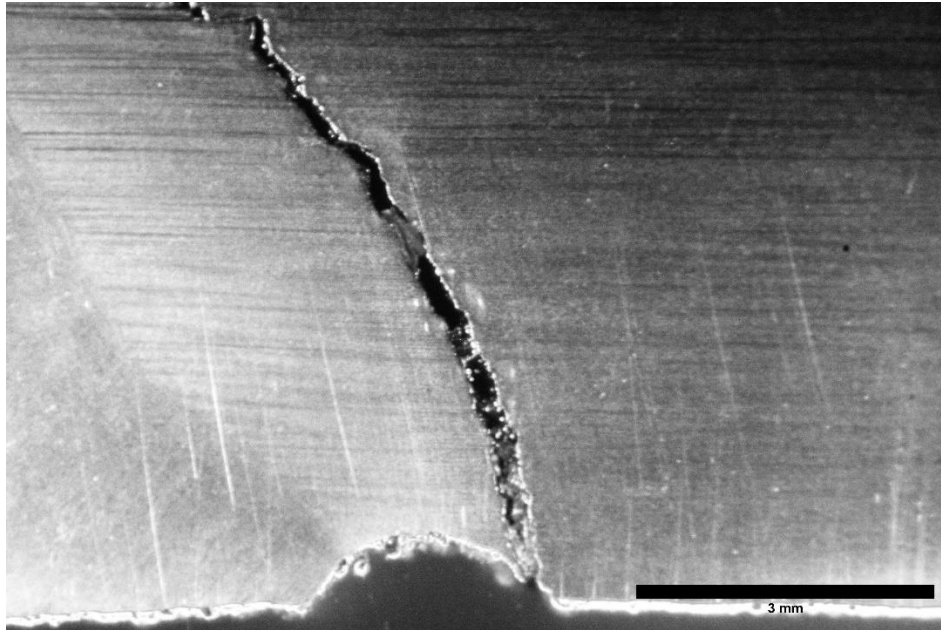
The main crack is shown up close, in the two pictures below (Figure 16), (Figure 17). The bottom half of the main crack corresponds to the first image, and the top half, corresponds to the second.

Figure 16. Bottom half of the main crack, using a stereoscope

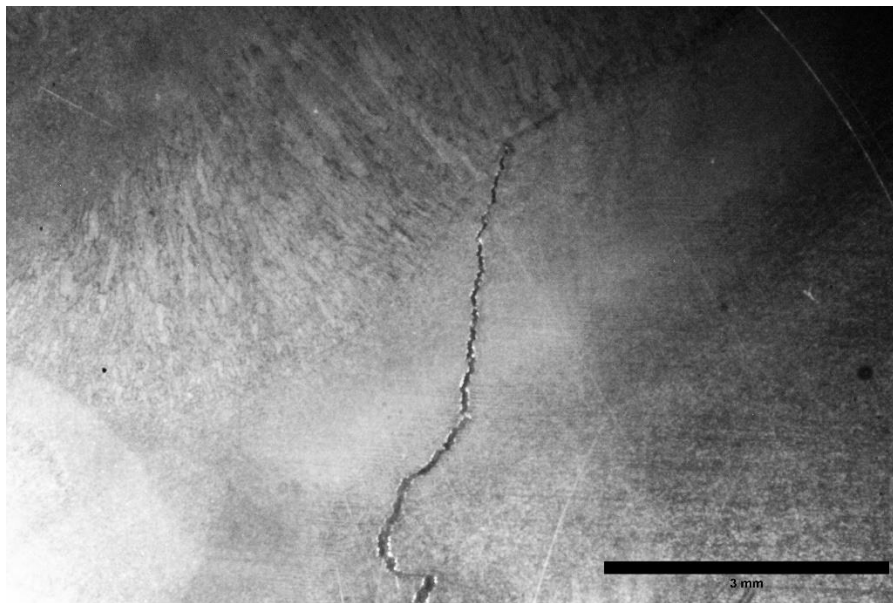
Figure 17. Top half of the crack, using a stereoscope

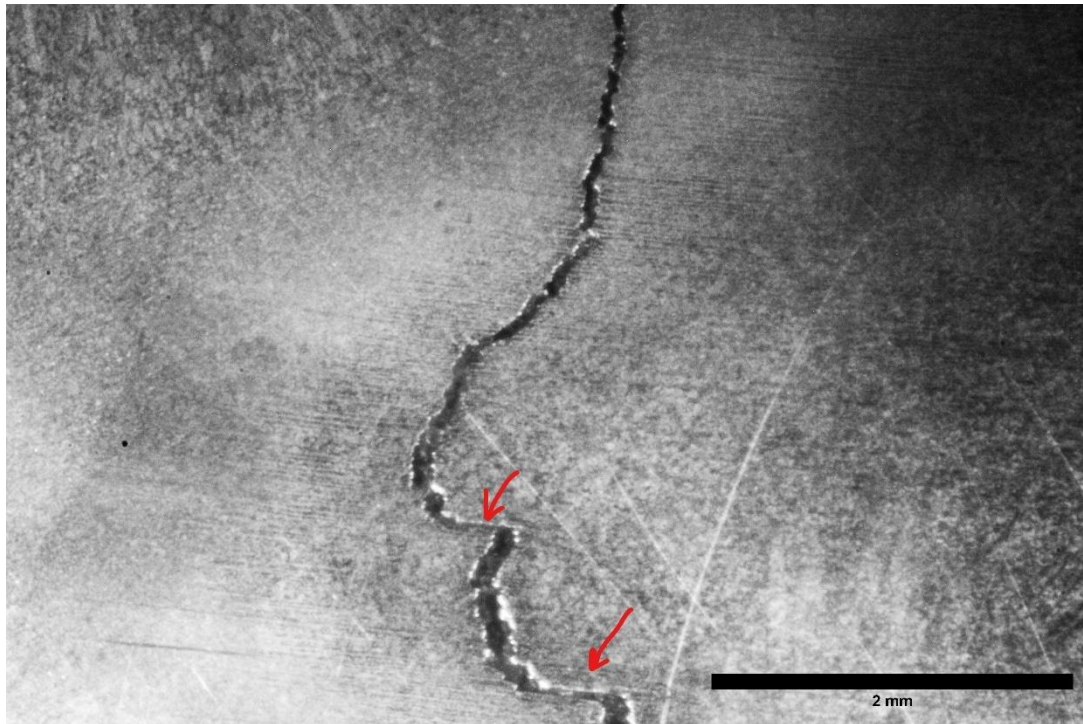
direction of the crack is parallel to the axis direction but shows abrupt change of direction, vertically to the axis direction, as indicated by the red arrows (Figure 18). The change in direction is limited to a small part of the crack, in the conjunction of the double V weld. The crack as it propagates, closing into the outer tube surface, enters the HAZ section of the weld and continues parallel propagation to the tube axis dimension.

Figure 18. Abrupt change of direction of the crack, vertical to the tube axis direction.

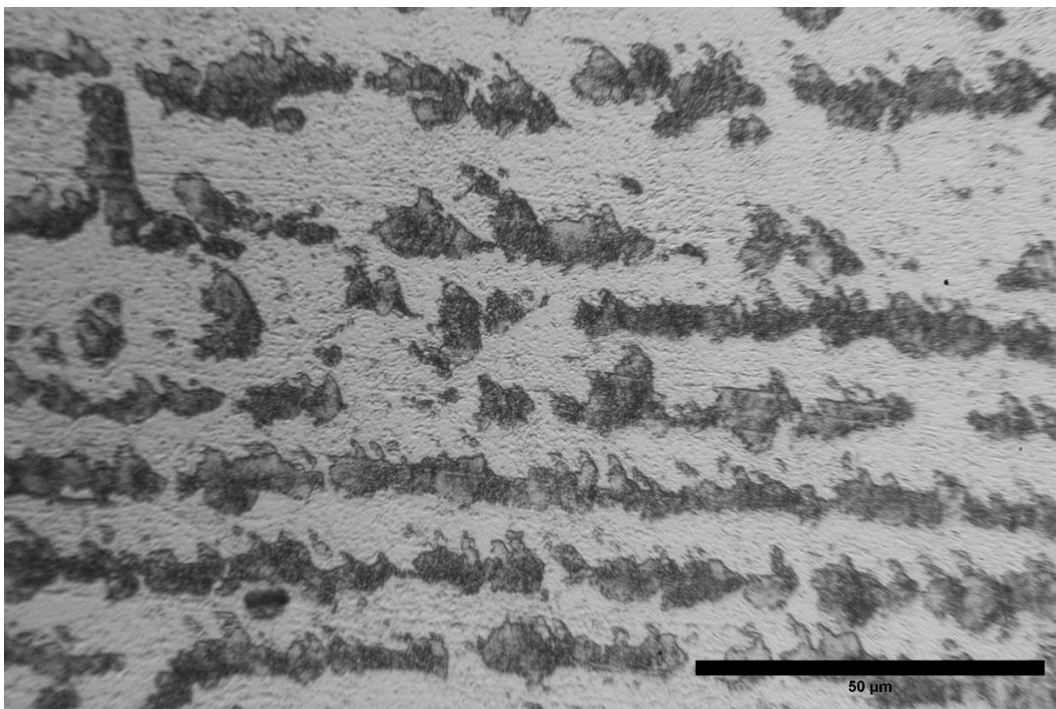
The examination of the specimen through the microscope reveals a ferritic and pearlitic matrix. The white portion is the ferrite, and the darker color is the pearlite (Figure 19).

Figure 19. Ferritic and pearlitic microstructure of the material in the base metal.

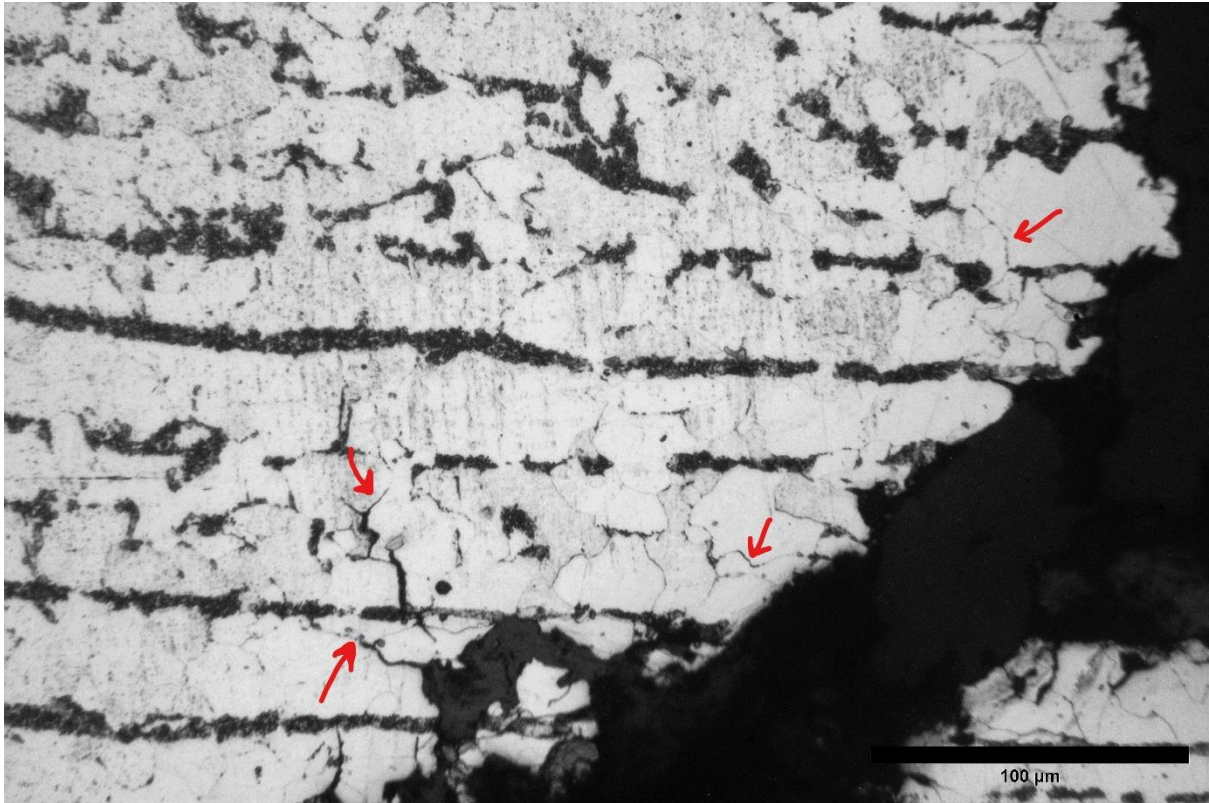
On the base, metal ferrite is the main phase we encounter. Pearlite content is lower than ferrite but significant non the less since pearlite has a higher carbon composition, due to the cementite carbides in the matrix. Banding, vertically to the main crack direction, is observed between the pearlitic and ferritic matrixes of the BM. Banding between the ferrite and the pearlite facilitates fissuring, providing an easy path for crack growth as a weak interface, and initiating micro-fissuring perpendicular to the main crack direction [30] . Banding is a result of cold work during the fabrication of the equipment. The specimen was slightly over etched for the different phases to be more accentuated (Figure 20Figure 20).

Figure 20. Intergranular cracking of the grain boundaries and banding in the base metal.

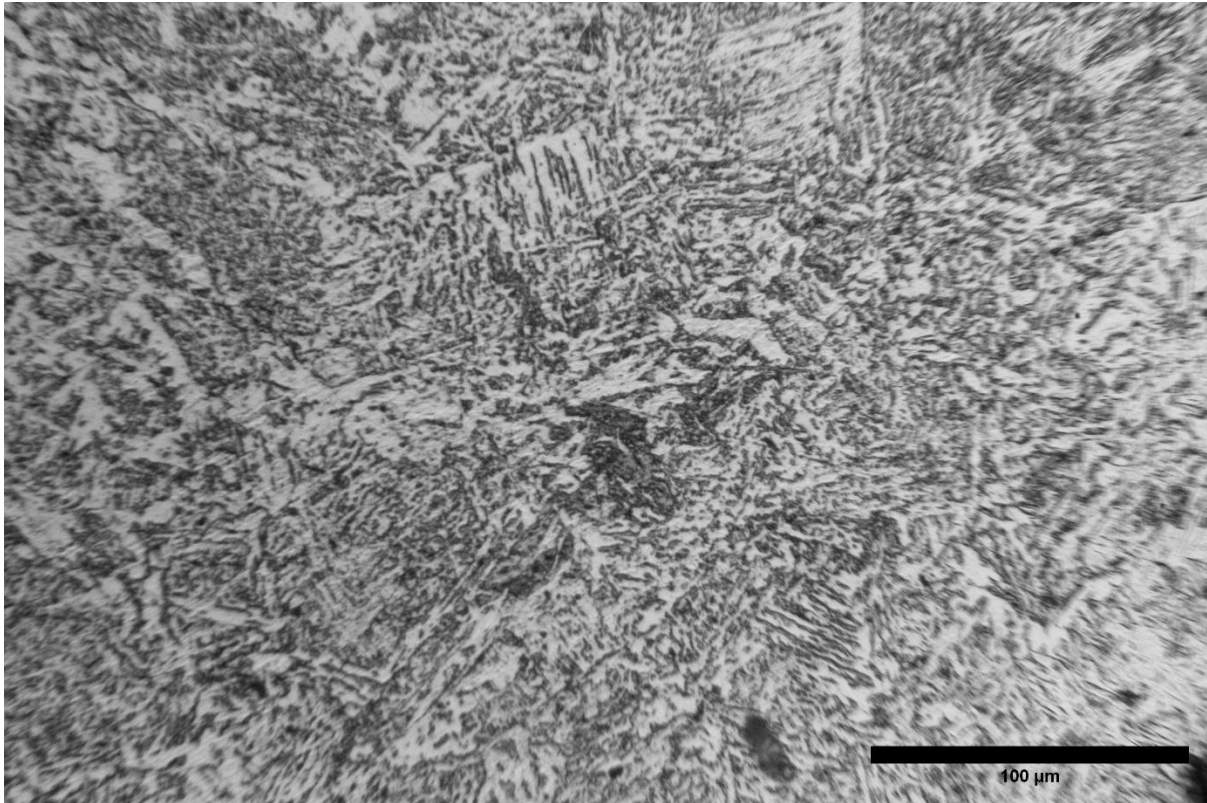
The crack tip advances in the HAZ of the weld. The microstructure of this region is different from the base metal. Spheroidization of the pearlite is observed, dissolution of the banding. Also, Widmanstätten ferrite is detected (Figure 21).

Figure 21. HAZ side microstructure. Pearlite spheroidization and Widmanstätten ferrite.

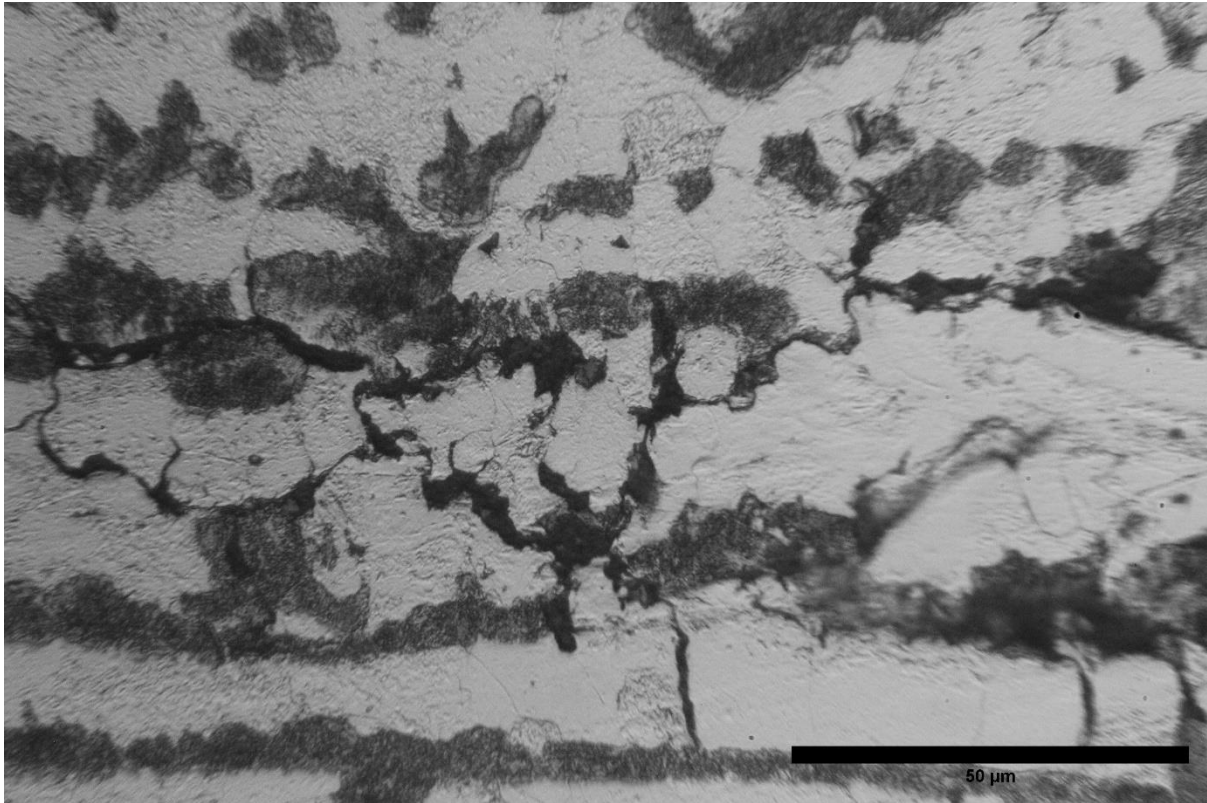
The length of the main crack reaches 0.5m. The main crack was observed on the boundaries of the HAZ and the BM zones of the welded metal. It follows a path close to the weld and advances within the thickness. It initiates on the base metal at the internal surface. The top half of the crack advances into the weld's HAZ side. Hydrogen gains access through the crack to the metal's interior. The advance of the main crack is facilitated due to further surface and internal decarburization. The main crack is intergranular and seems to propagate by the coalescence of elongated voids and fissures. Numerous intergranular micro-cracks are observed on grain boundaries (Figure 22). The damage is severe. In some areas the optical microscopy examination reveals elongated voids, which consume almost entire pearlite grains. In some areas there is significant branching of fissures, especially near the main crack. On the banks of the main crack there is evidence of brittle grain detachment.

Figure 22. Intergranular propagation of fissures and pearlite grain consumption.

The main crack abruptly changes direction in the middle portion. The cause may be the intense stress created by the weld. The change of direction appears almost at the conjecture of the double V weld. In the sections where the main crack changes direction intense cracking appears, perpendicular to the crack propagation direction.

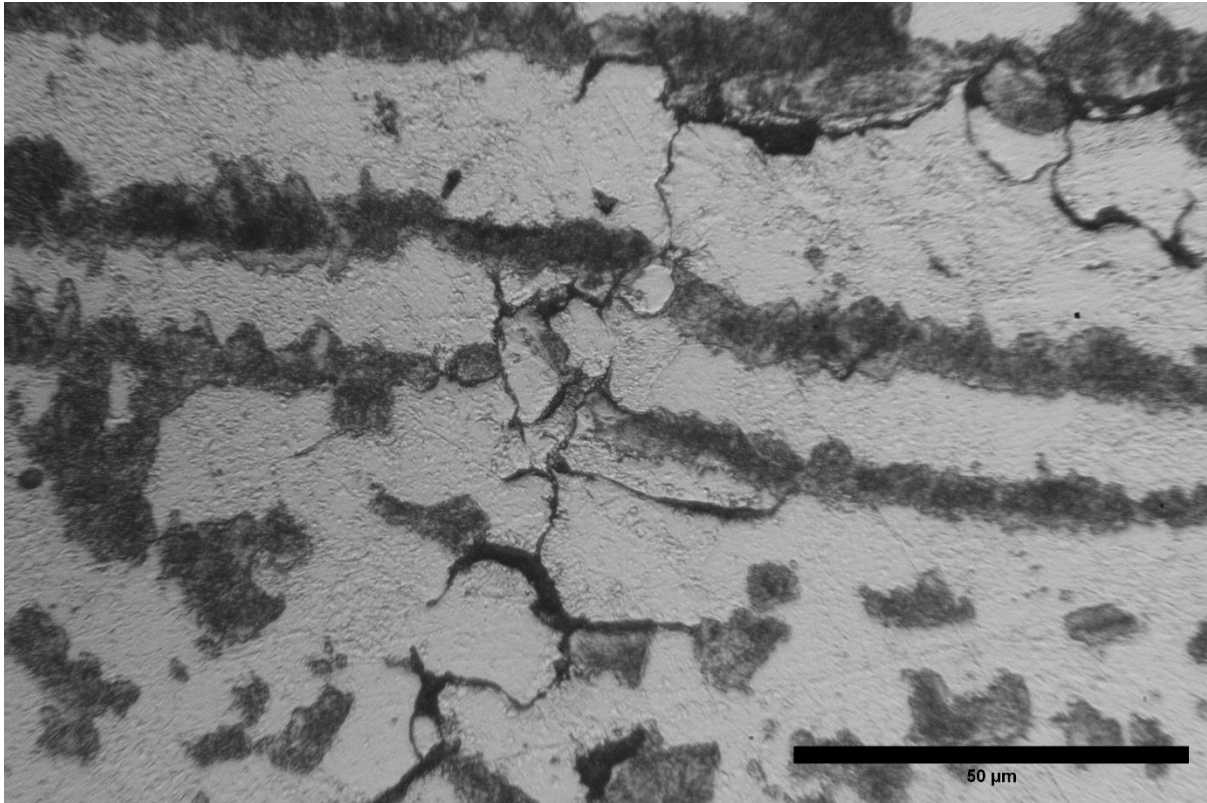
Banding facilitates the propagation of fissures. The fissures travel along the grain boundaries of the pearlite colonies and occasionally cross vertically, through the ferrite matrix. These paths seem to be created for the fissures to propagate to the neighboring pearlite colonies, probably in search of a carbon source (Figure 23).

Figure 23. Intergranular fissure propagation perpendicular to the direction of pearlite banding.

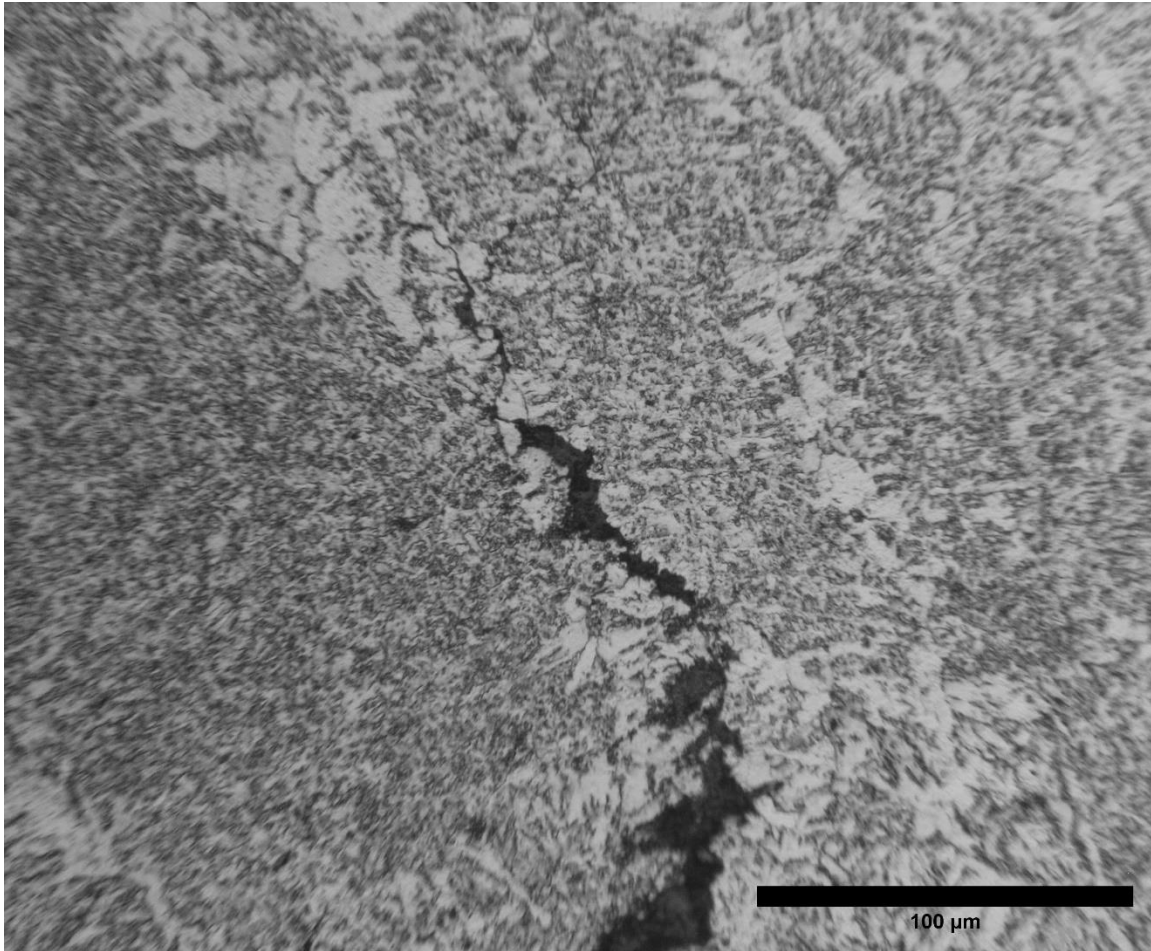
Decarburization in the vicinity of the main crack is enhanced. With the crack formation additional surfaces for surface decarburization are created. In some regions, veins appear, apparently due to the influence of residual stresses, possibly due to welding (Figure 24).

Figure 24. Decarburization of the banks of the main crack.

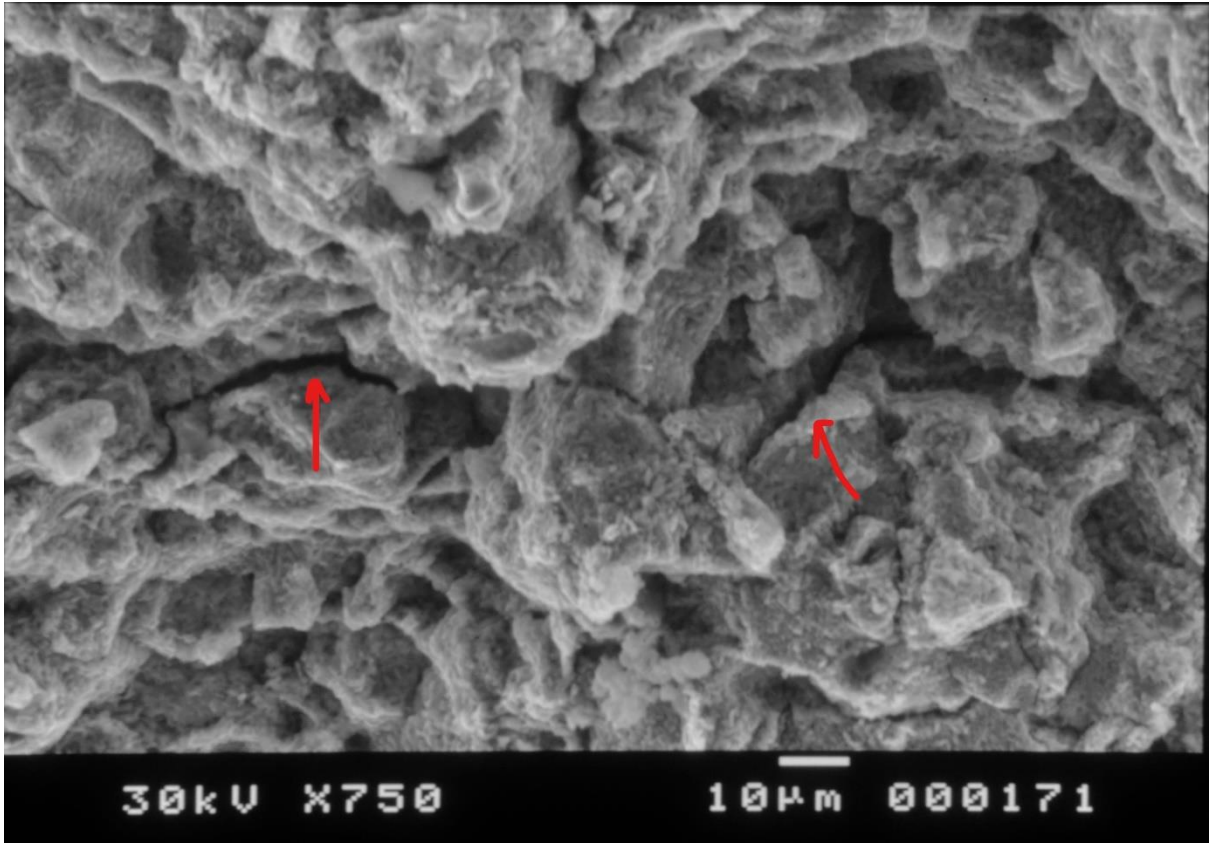
The main crack was cracked open revealing the crack surface. SEM examination of the crack surface indicated severe HTHA damage. Cracks are evident on the grain boundaries, in the form of intergranular micro-fissuring, as the red arrows indicate. Micro fissuring was previously observed through the optical microscopy examination of the specimen.

Figure 25. Intergranular fissuring evidence.

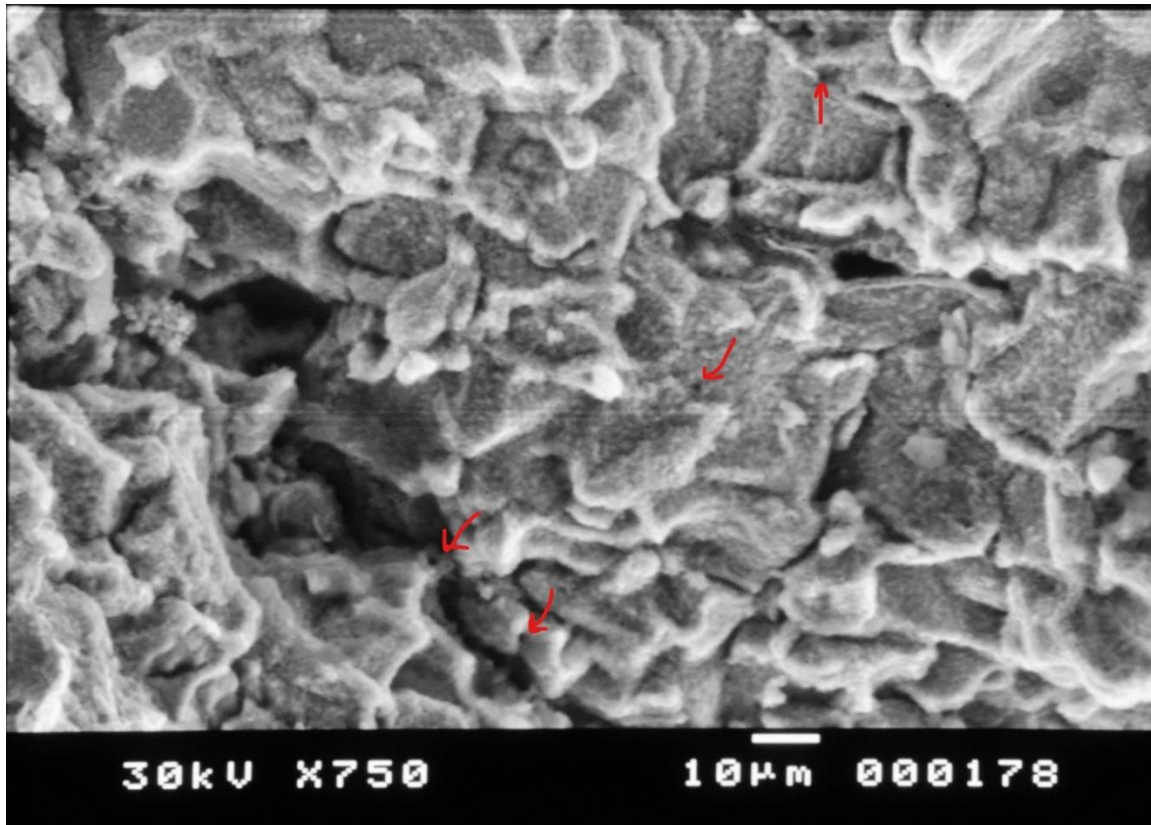
Also, voids can be detected on the grain facets, as the red arrows in [\(Error! Reference source not found.\)](#) indicate.

Figure 26. Voids on the grain boundary facets.

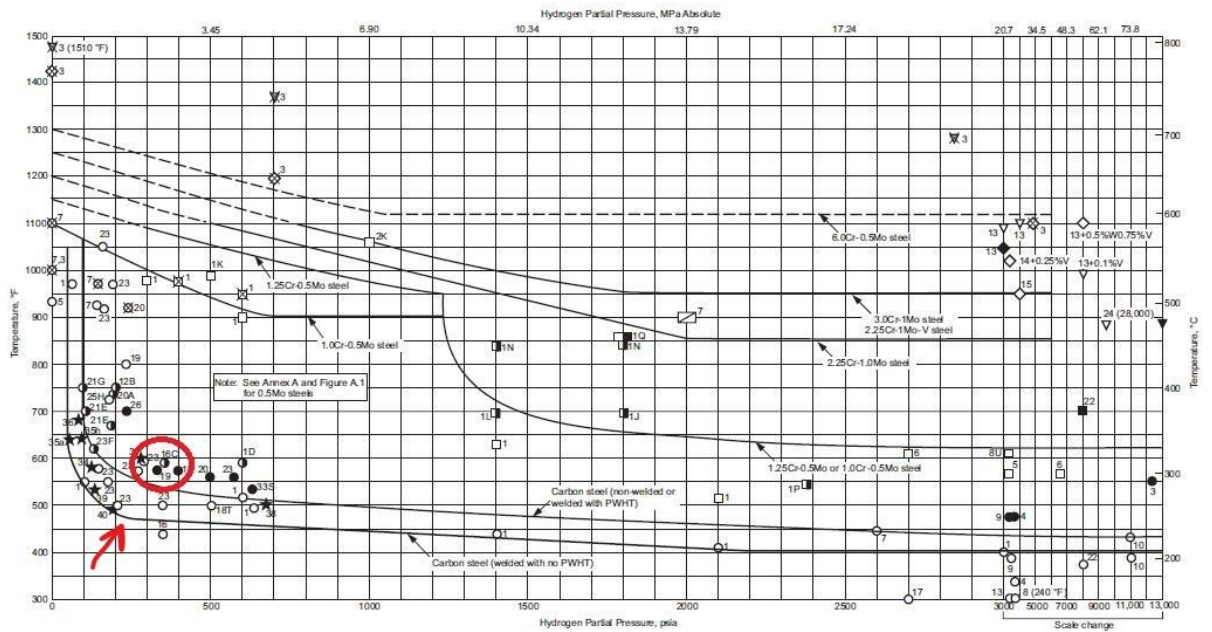
- A crack, of 0.5m, covers a section of the carbon steel heat exchanger M-9210 and spreads from the internal surface along the thickness of the material.
- According to the operational information the heat exchanger was operating far above the limits set by the Nelson Curves for non-Post Weld Heat Treated carbon steel, and the Post Weld Heat Treated. Surpassing the limit set by the Nelson Curves, makes it highly possible for HTHA to appear. Carbon steel is also the most susceptible material for this type of attack. The operating limits, for non-PWHT carbon steel, are indicated by the lowest curve, as shows the red arrow.

Figure 27. Area of operating conditions for exchanger M-9210

- The metallographic examination of a specimen, coming from the heat exchanger M-9210, revealed that the responsible failure mechanism is High Temperature Hydrogen Attack. The main propagated from the hydrogen rich internal surface of the exchanger tube and thinned as it propagated within the tube's thickness. Indications of intense decarburization, on the internal surface and the banks of the main crack, and intergranular grain boundary separation and intergranular fissuring led to this assumption.
