## **Failures in Marine Structures**

Diploma Thesis

Tilemachos I. Solinis

Volos, 2023

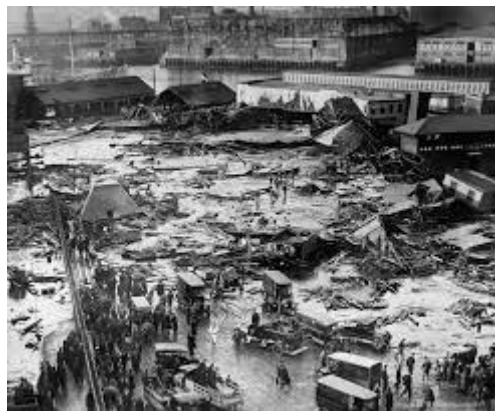
The tank's design was flawed, as the steel used was not thick enough to handle the increasing pressure. The internal pressure rose due to fermentation inside the tank, which increased the levels of carbon dioxide. Additionally, thermal shock, which is defined as fluctuations in temperature, could cause stress in materials, particularly brittle ones. On the day prior to the accident, the temperature had risen from  $-17^{\circ}\text{C}$  to  $5^{\circ}\text{C}$ , putting further strain on the already weakened tank. A 2014 analysis revealed the metallurgical reasons for the failure. The steel lacked carbon and manganese, making it brittle when cooled below  $13^{\circ}\text{C}$ . The operating conditions at the time of the failure were  $4^{\circ}\text{C}$ , which was significantly lower than the transition temperature. Another cause of the failure was the presence of fatigue cracks that had developed around a critical point. The tank had been filled multiple times, which subjected the panels to intermittent cyclic loads. These factors, along with the lack of structural assessments (such as inspections and ignoring warning signs like groaning noises), led to the catastrophe [3].

*Figure 2: The aftermath of molasses flood.*

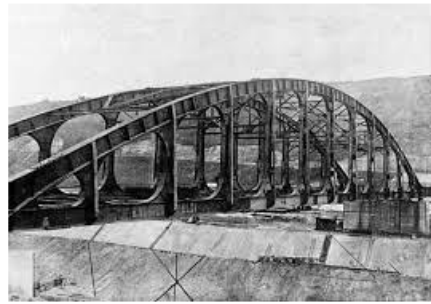
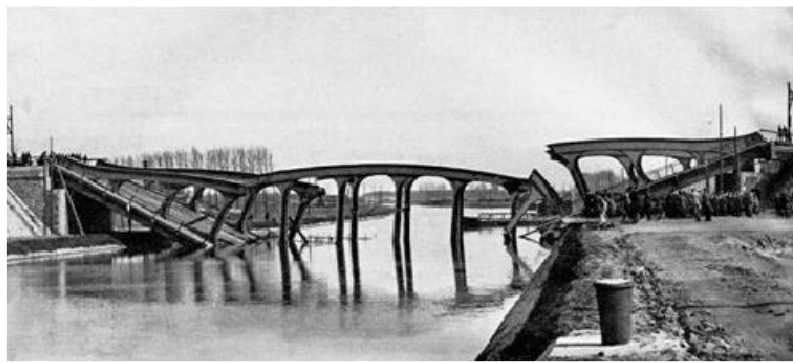
*Figure 3: (a) The Hasselt Bridge, (b) The bridge after the failure*

Despite the fact that the bridge had an adequate resistance to tension the chemical composition of the steel made the structure susceptible to brittle fracture. It had been found that the steel had plenty of sulphur and phosphorus, a fact that indicated the reduced magnitude of toughness which consequently resulted in inappropriate transition temperature. The temperature was  $-20^{\circ}\text{C}$  at the moment of the incident.

Besides that, the welding quality at the failed segment of the bridge was poor. The welding that functioned as a linkage between the flanges of vertical girders and the lower chord's ones was deficient, meanwhile the residual stresses at this point were extremely high. Hence, the low toughness in conjunction with extremely low temperatures, the inferior welding in combination with the high stress concentration as well as the existence of imperfections caused this disastrous collapse [4].

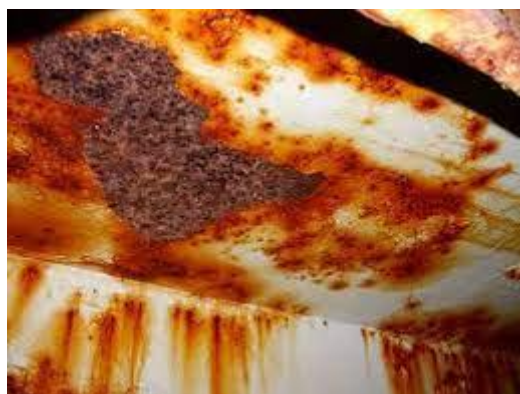
*Figure 34: The ship's hull affected by uniform corrosion.*

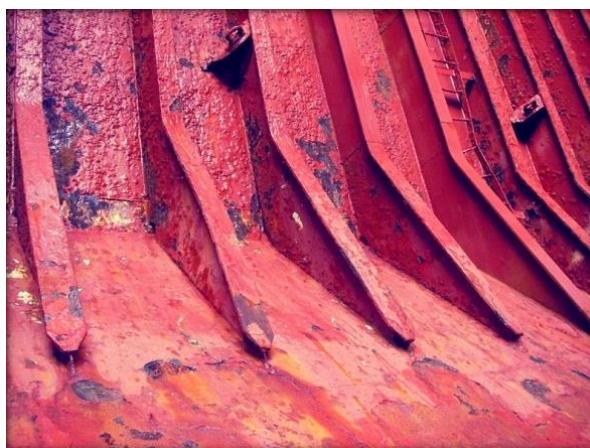
*Figure 35: Pitting corrosion at the ship's hopper tanks.*

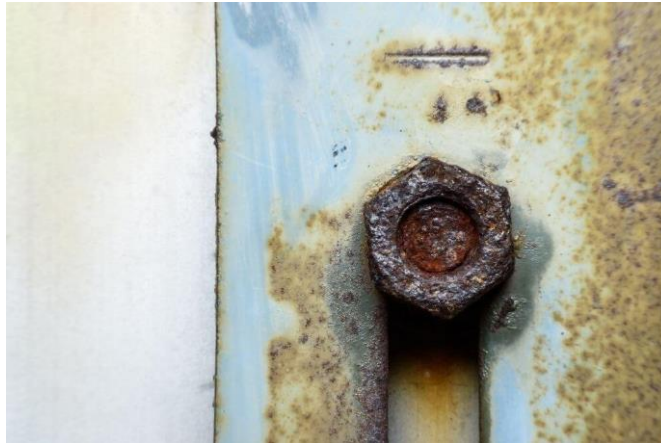
*Figure 36: Crevice corrosion thrives at areas around nuts.*

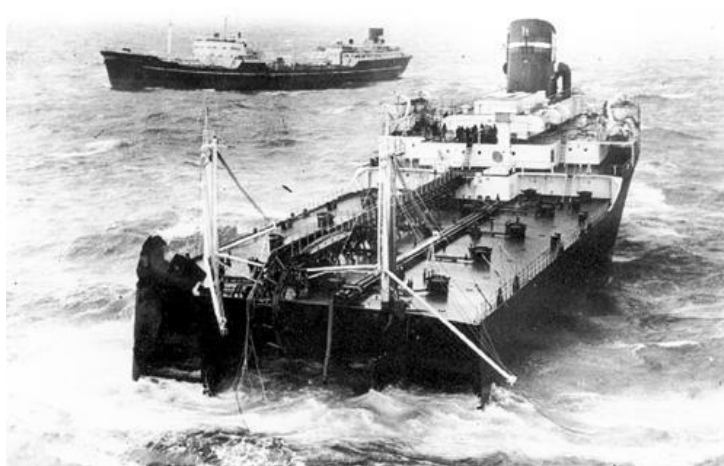
*Figure 54: The World Concord split in half.*

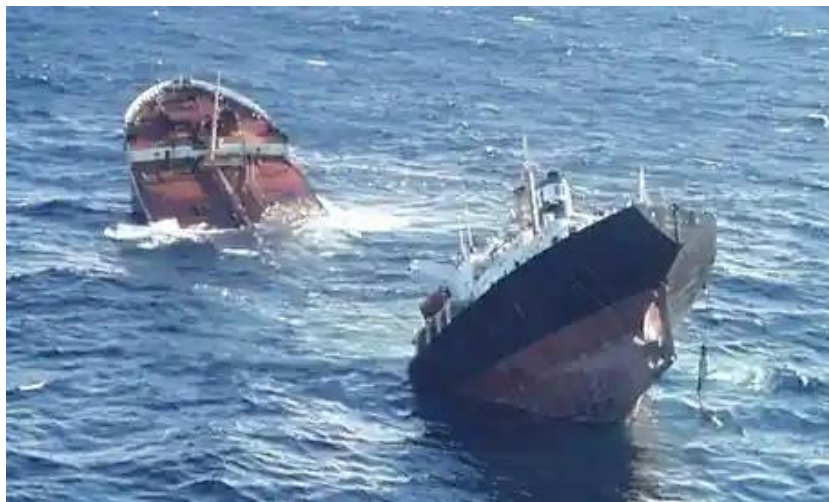
*Figure 56: M/T Prestige off the coast of Spain after break off in two.*

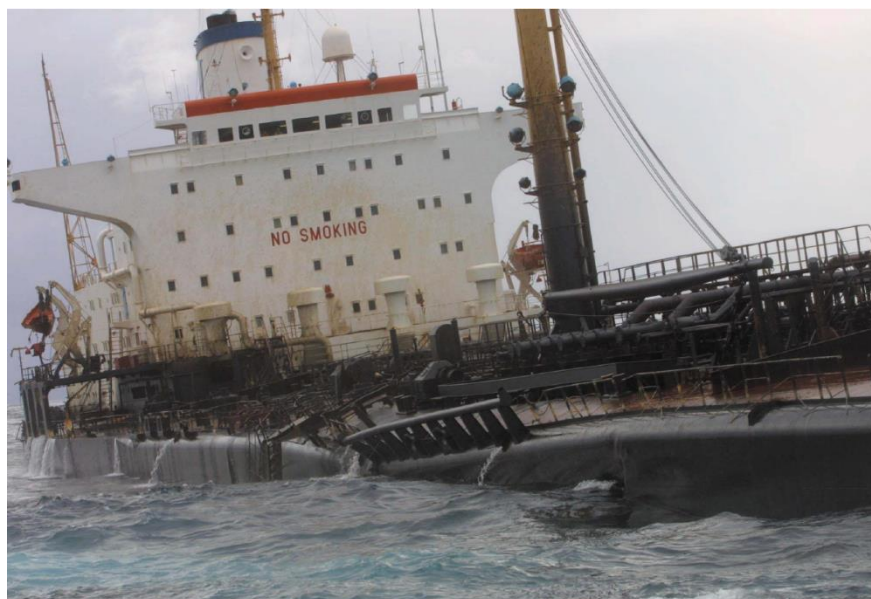
*Figure 58: The damage of the starboard side and the preexisting permanent deformations from STS operations at the side shell plating.*

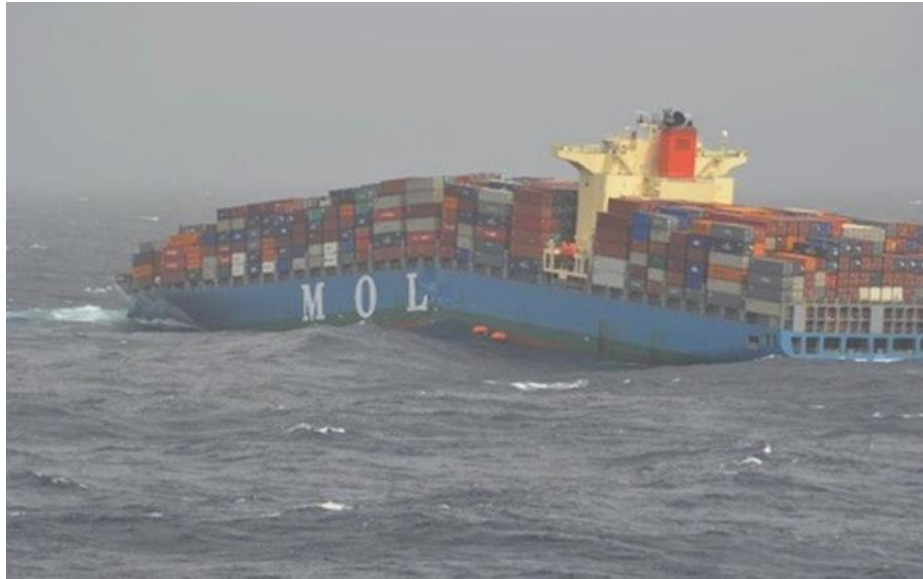
*Figure 60: MOL Comfort after the failure of her hull.*

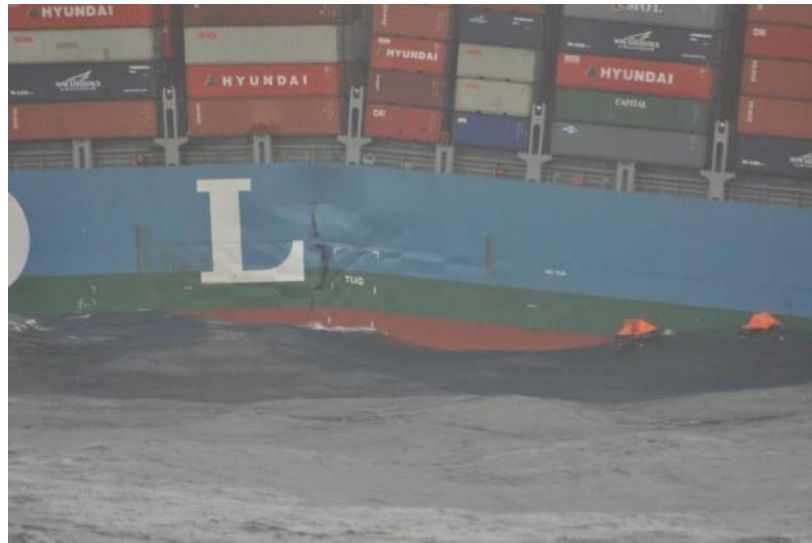
Figure 64: The fractured hull of the ship.

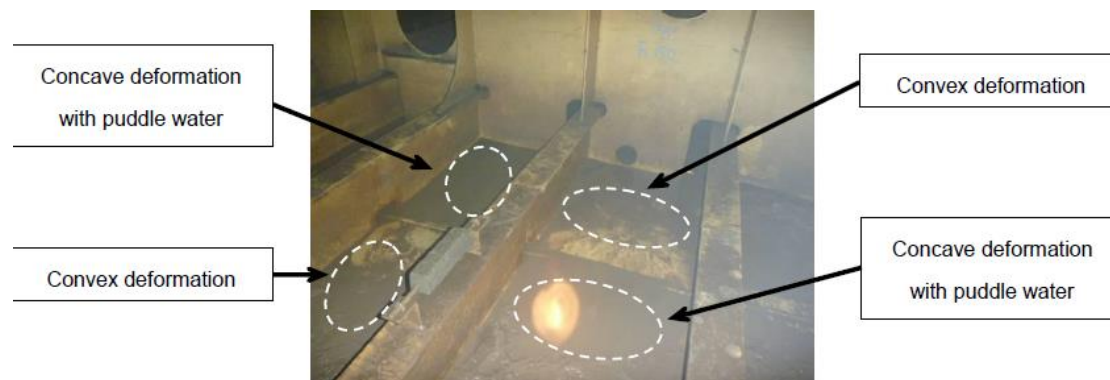
Figure 65: Buckling deformation in the bottom shell plates of the sister ships.

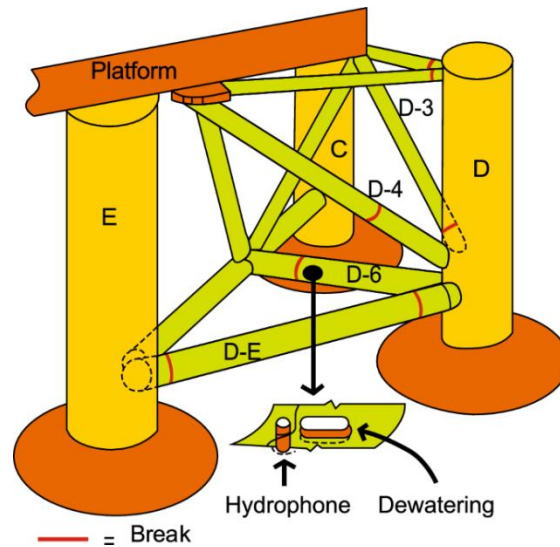
Figure 71: Position of fatigue fracture on D6 brace.
