# **ANALYSIS ON THE FAILURE OF TWIST EXIT ROLLER GUIDES IN STEEL HOT ROLLING**

by  
**CHRIS VASILEIOU**

Submitted in partial fulfillment of the requirements for the degree of Diploma  
in Mechanical Engineering at the University of Thessaly

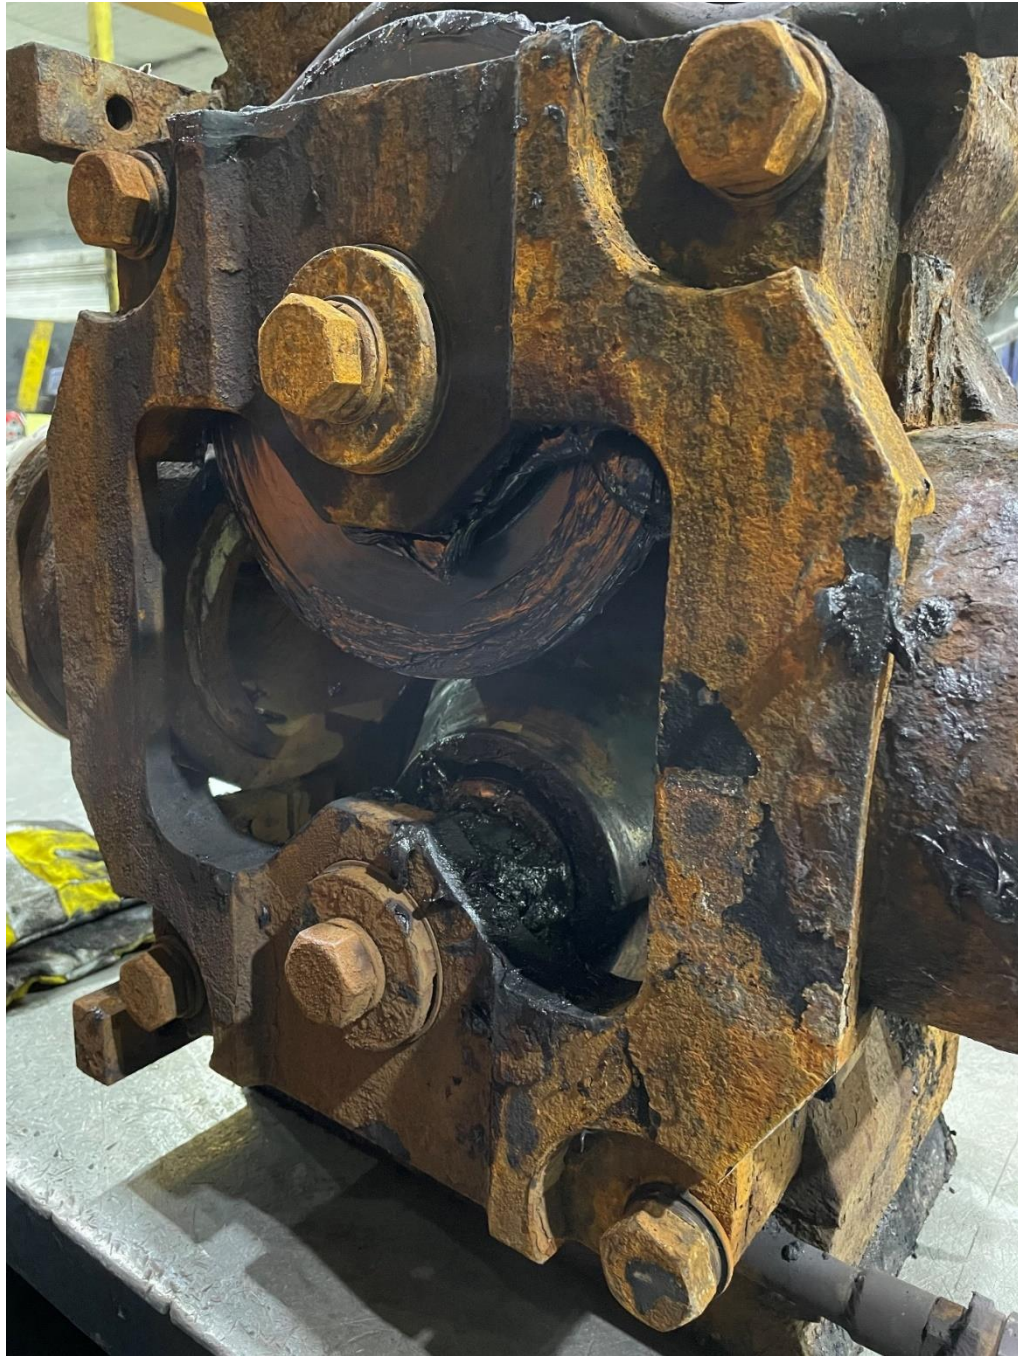
**Figure 2.1:** Side view of a twist exit roller guide after a production cycle.

the sustained reliability and performance of the equipment. **Figures 2.1, 2.2, 2.4, 2.6 and 2.7** present detailed views of the twist roller exit guides and **Figures 2.3 and 2.5** from [7] their supporting components, intended to provide the reader with a clearer understanding of the equipment in question.

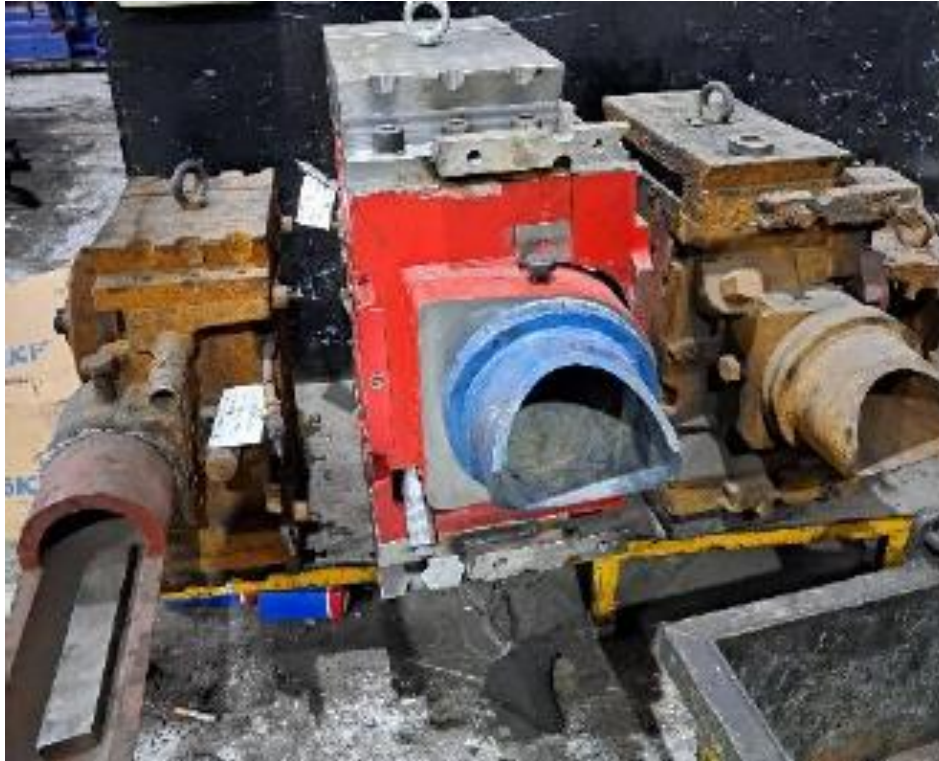
**Figure 2.2:** Front view of various twist exit roller guides from the maintenance workshop.

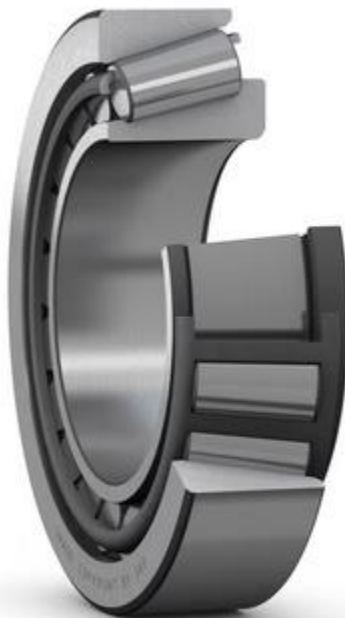
**Figure 2.3:** Single row tapered ball SKF bearing used on the twist exit roller guides.

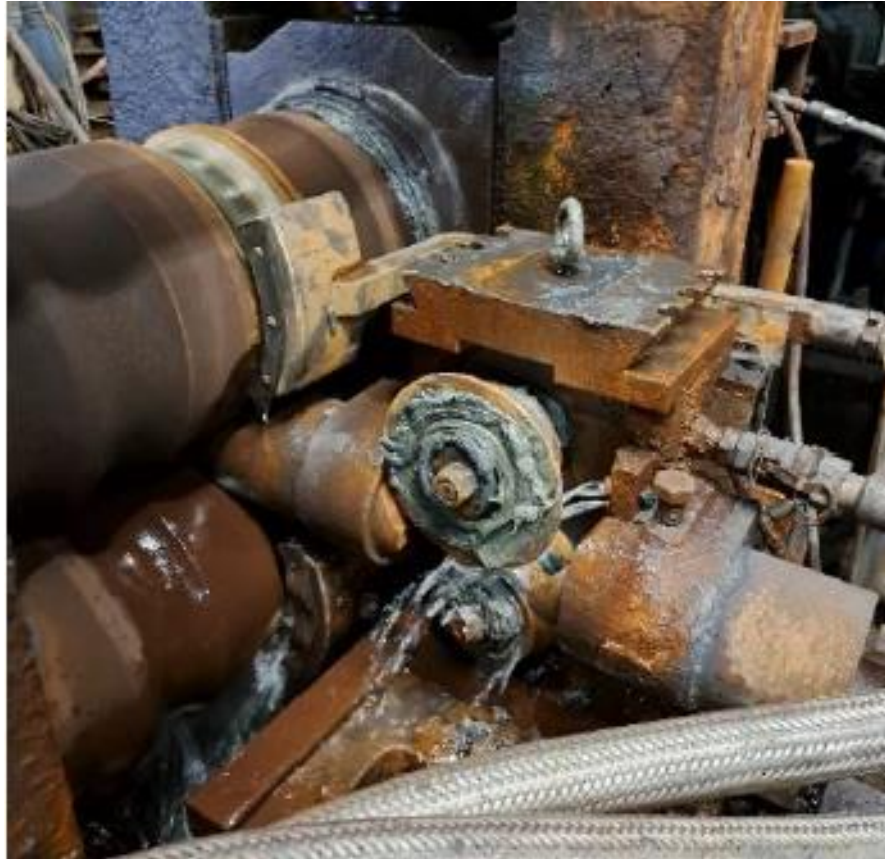
**Figure 2.4:** Twist exit roller guide assembled on the rolling cylinders just before a production cycle starts.

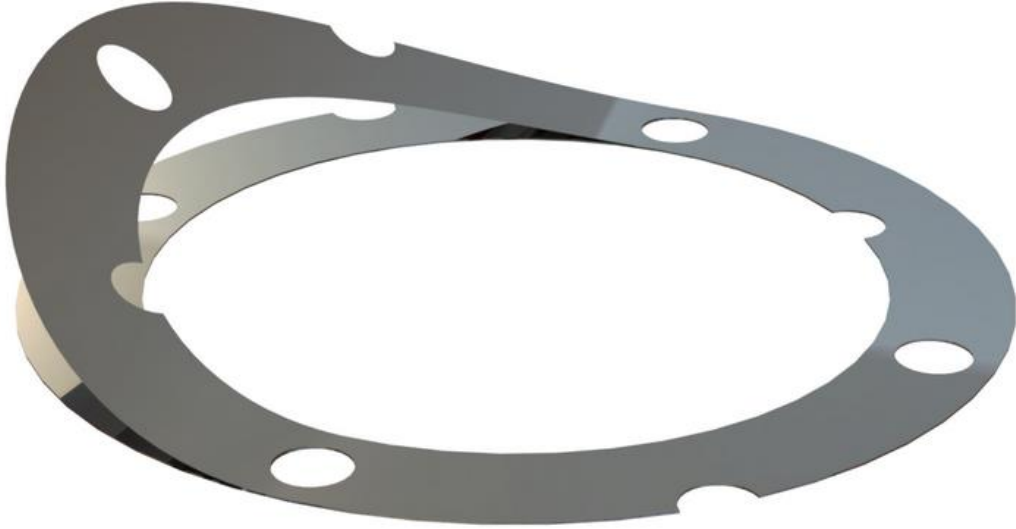
**Figure 2.5:** Shims used for eliminating the tolerances during assembly process.

Regarding the measurement of the correct number of shims, a procedure recommended by Danieli technicians involves initial assembly without shims, followed by measurement of axial clearance. Shims are then added as necessary to achieve the desired rotational stiffness of the roller.

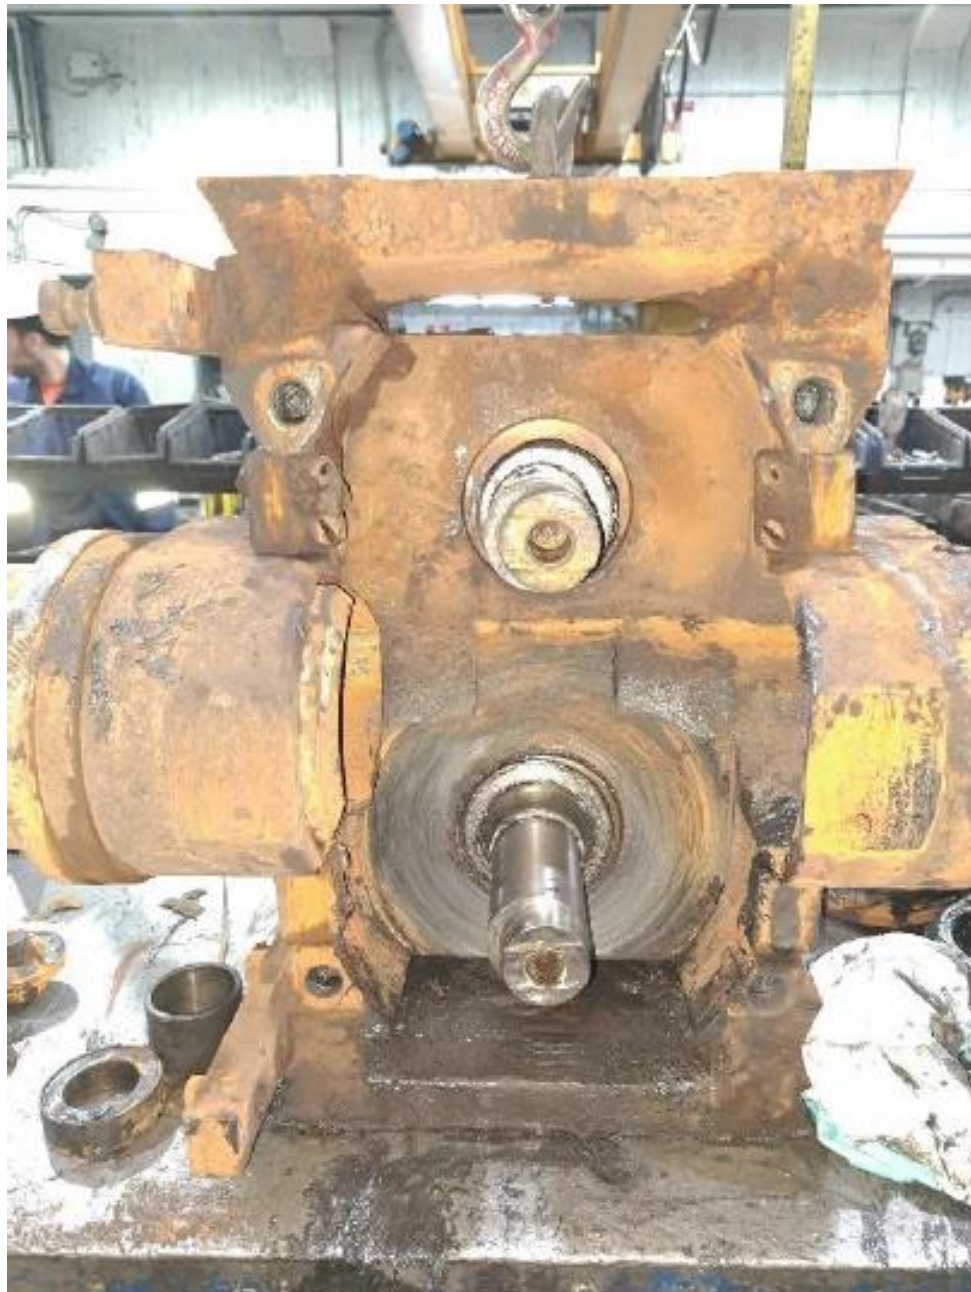
Additionally, excessive accumulation of grease and chips at the base of the guide following daily operations was identified, exacerbating roller rotation difficulties, and contributing to accelerated wear on the guide body. Efforts to address these concerns are integral to ensuring

**Figure 2.6:** The wear observed on the body surface, resulting from contact with the lower roller, can be attributed to the substantial accumulation of grease and chips on the base surface.

From an assembly process standpoint, addressing the effective removal of excess grease and debris during operation is crucial, as these factors impede the roller's rotation and consequently impact the structural integrity of the guide's body. Additionally, a more precise method for the placement of shims is warranted. The appropriate number of shims must be determined to achieve the desired rotational stiffness of the roller, striking a balance between too loose and too stiff.

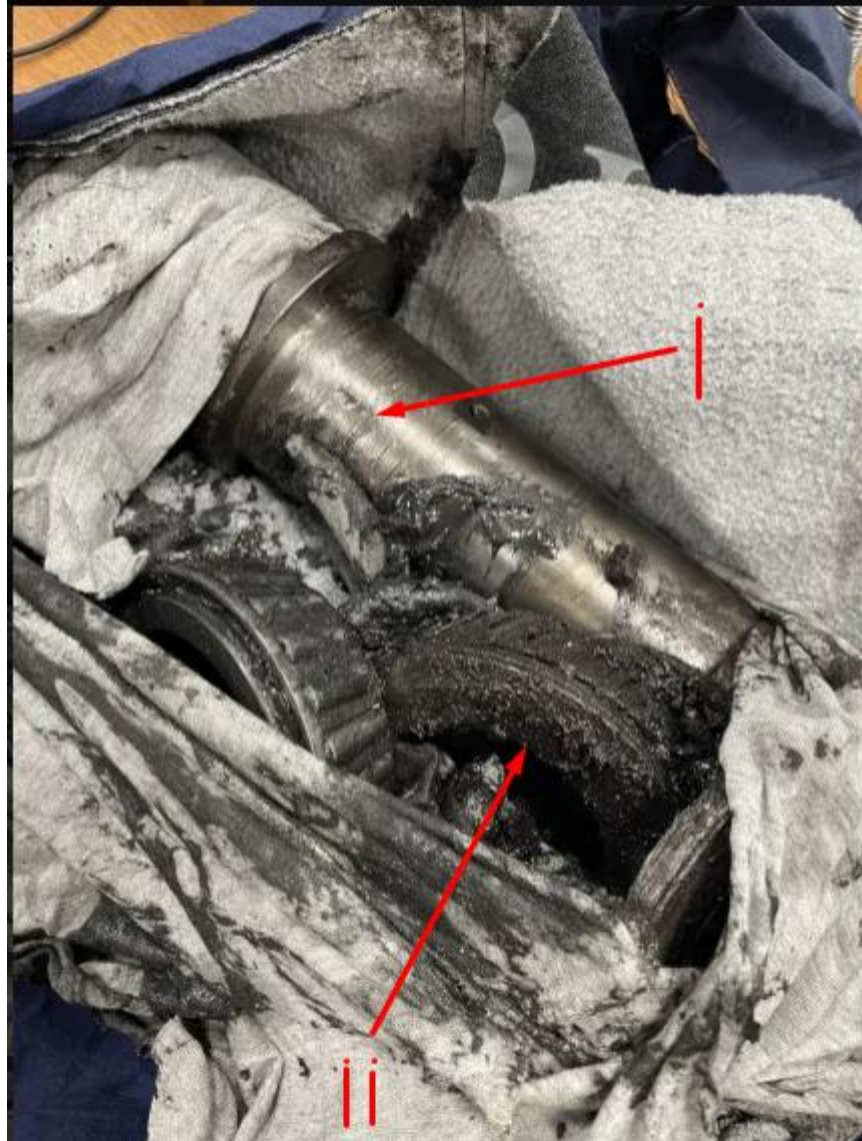
The failure of the equipment primarily stems from bearing failures, with the larger of the two bearings inside the rollers being the primary point of concern, accounting for approximately 95% of failures. Thus, the investigation focused on this specific type of bearing, supplied by an external partner, SKF, capable of withstanding both radial and axial loads. The bearings are different in size and are not facing each other. Ongoing examinations revealed instances of pitting and brinelling on the inner ring surface, cracks on the outer ring surface, and scratches on the cylindrical roller bearings. While cracks on the outer ring surface were most frequently recorded, various parameters were meticulously examined, including lubrication levels, the condition of associated parts such as spacers and nuts, and potential assembly errors.

**Figure 2.7:** i) Cracks on the surface of a failed used shaft and ii) cracks which led to the total catastrophic failure of the big sized ball bearing.

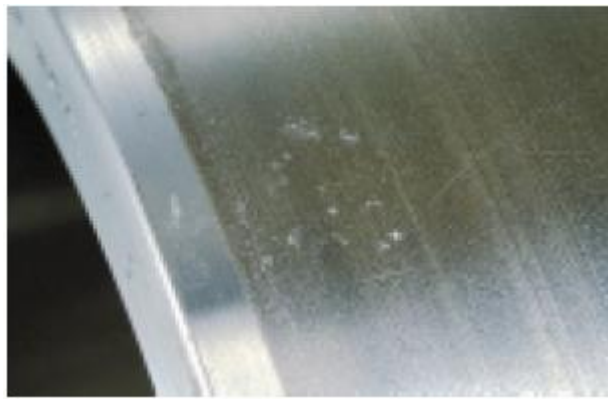
Pitting is a phenomenon characterized by the formation of small holes, typically 0.1 mm in depth, on the raceway surface due to rolling fatigue. Common causes include potential reductions in internal clearances during operation, flaws resulting from errors during the mounting process, or inaccuracies in the shapes of shafts or housings. Effective countermeasures often involve upgrading the type of lubricant used and either reducing external loads or switching to a different type of ball bearing. **Figure 3.1 ([8])** illustrates this type of failure on the surface of the bearing's inner ring.

**Figure 3.1:** Pitting on the inner ring of the bearing.

Unfortunately, improving protection against external material ingress into the bearings proves challenging, necessitating frequent replacement every two to three days to prevent pitting phenomena. This solution, albeit effective, contradicts company policy due to increased workload.

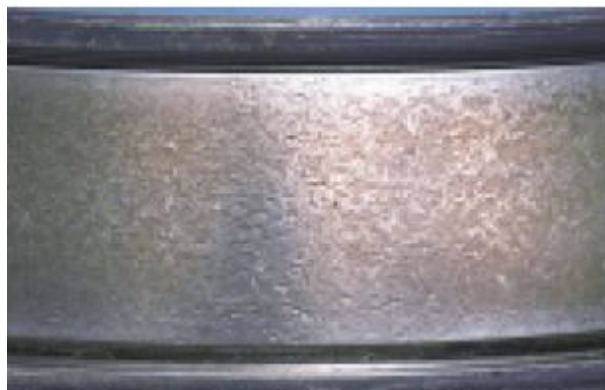
Brinelling refers to depressions formed on the portion of the raceway surface that encounters the rolling element, resulting from plastic deformation. This phenomenon is typically caused by solid external particles or excessively high radial and axial loads. Addressing this type of failure requires a comprehensive investigation to identify the sources of these heavy loads, along with meticulous cleaning during the mounting process. **Figure 3.2 ([8])** depicts this form of failure on the inner ring raceway surface of the bearing.

**Figure 3.2:** Brinelling observed on the inner ring raceway surface of the bearing.

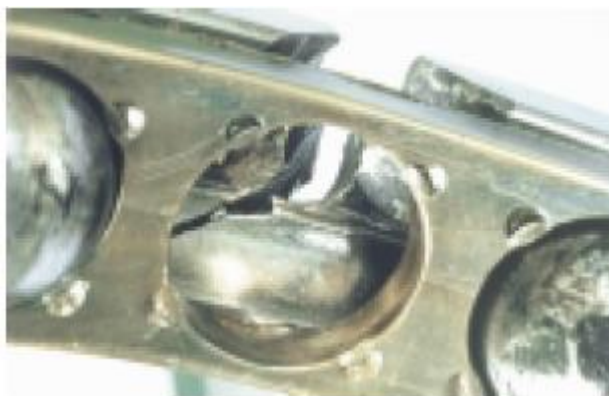
Slight cracks, splitting, and fractures often manifest on the surface of the outer ring. Primary causes typically include overloading, abnormal heat generation, or incorrect installation of the ball bearing. In addition to the countermeasures outlined in [Chapter 3.3](#), solutions aimed at mitigating thermal impacts could also prove effective. **Figure 3.3 ([8])** illustrates this type of failure on the outer ring of the bearing.

**Figure 3.3:** Crack detected on the outer ring of the bearing.

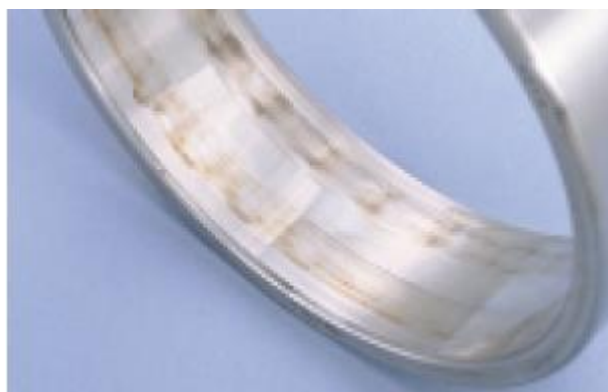
Scratches are a form of failure resulting from sliding contact, often leading to flaws in the axial direction or cycloidal flaws on the roller end or rib face of the bearing ring that guides rollers. Once more, inadequate lubrication, improper rotation of rolling elements, intrusion of external particles, and overloading are primary causes. Similar countermeasures outlined in [Chapters 3.1](#), [3.2](#), and [3.3](#) could effectively address this type of failure. **Figure 3.4 ([8])** depicts this form of failure on the outer ring raceway surface of the bearing.

**Figure 3.4:** Scratch identified on the outer ring raceway surface of the bearing.

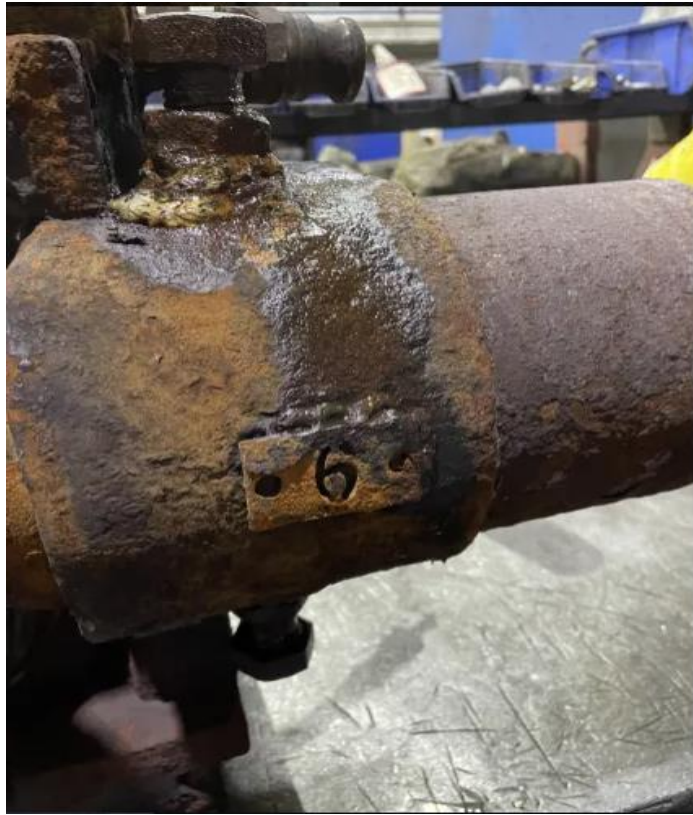
During the final three days of this two-week period, an expert technician from the external partner visited the company's workshops to oversee the assembly process. Their feedback was overwhelmingly positive, with only one suggestion regarding the accumulation of grease and waste material on the base surface of the exit roller guide. It was recommended to machine an inclined surface on the equipment's base and install an additional water flow nozzle to facilitate material removal. However, it was noted that this accumulation was not deemed a logical cause for the encountered failures. **Figure 4.1** illustrates the type of wear observed on the outer surface of the twist exit roller guides.

**Figure 4.1:** Wear observed on the outer surface of the twist exit roller guides.

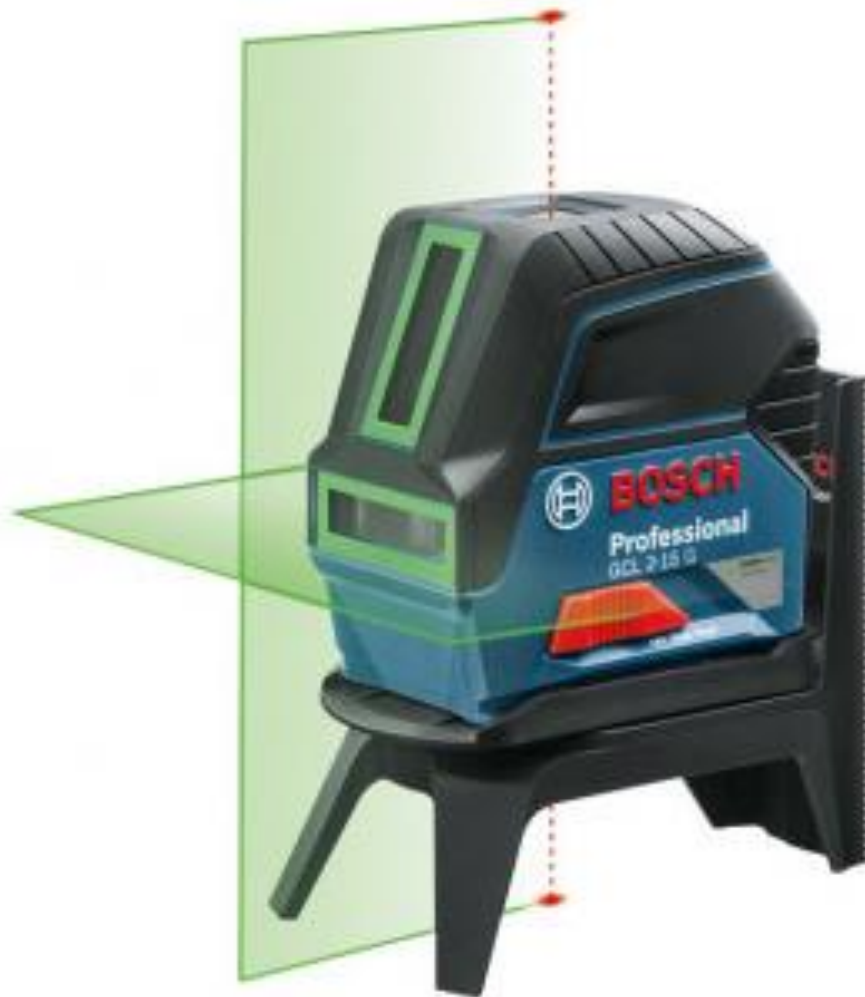
**Figure 10.11:** Alignment Laser.
