UNIVERSITY OF THESSALY

Ph.D. Dissertation

**STRUCTURAL INTEGRITY OF STEEL HYDROCARBON
PIPELINES WITH LOCAL WALL DISTORTIONS**

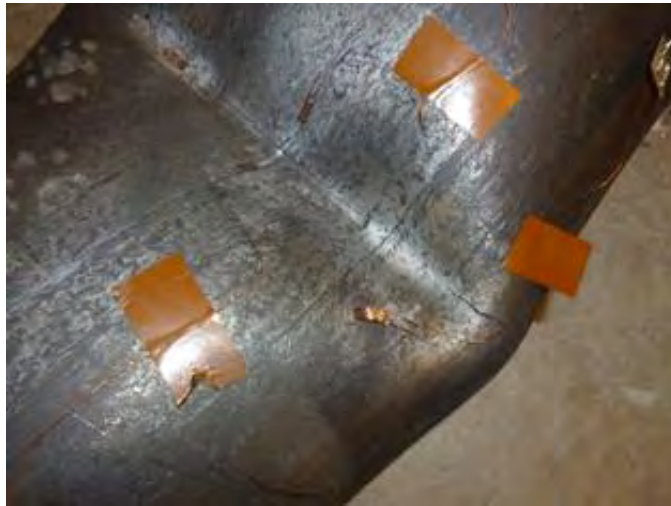
Figure 3-38: Pipe wall rupture of specimen SP5d due to cyclic bending loading at the dent "ridge".

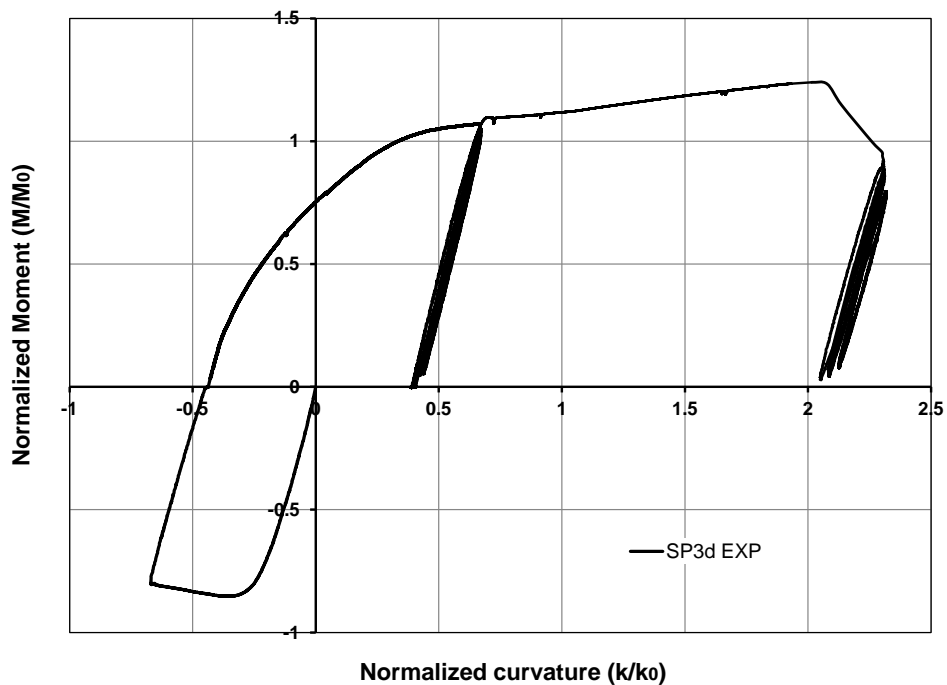
Figure 3-40 Normalized moment-curvature curve for SP3d specimen during monotonic and cyclic bending

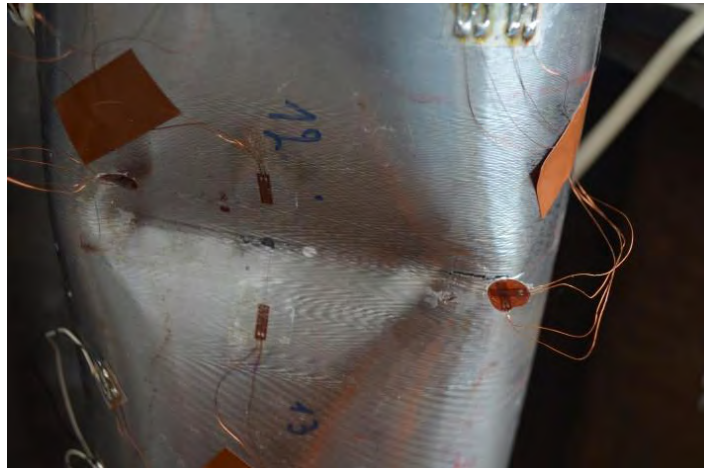
Figure 3-45: Pipe wall rupture of specimen SP9d-4pb due to cyclic bending loading at the dent “ridge”.

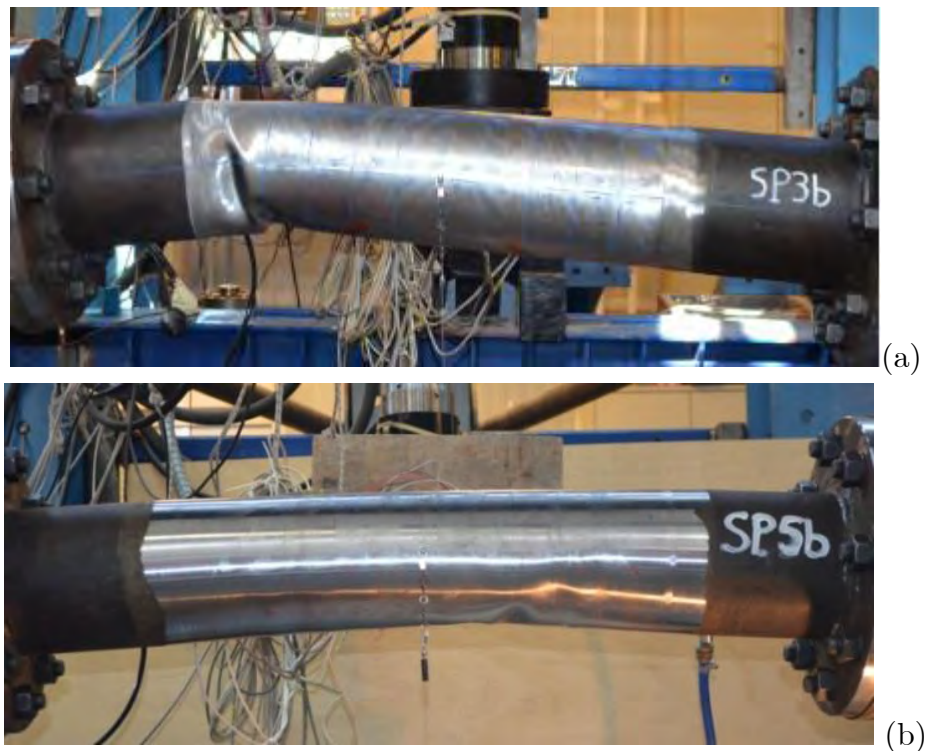
Figure 3-51: Side views of buckled specimens (a) SP3b, (b) SP5b, (c) SP6b and (d) SP7b buckled specimens.

The final buckled shapes of the specimens before the application of cyclic bending are shown in Figure 3-51. In particular, Figure 3-51c, shows that specimen SP6b buckled almost exactly at the midspan. For the most cases of pipe specimens the buckling pattern consisted of a diamond-type shape with one major and two minor buckles on each side of the bending plane, as shown clearly in Figure 3-52b. On the other hand, the buckled mode of specimens SP5b and SP8b, consisted of two main buckles perpendicular to the pipe main axis on each side of the bending plane (Figure 3-52c).

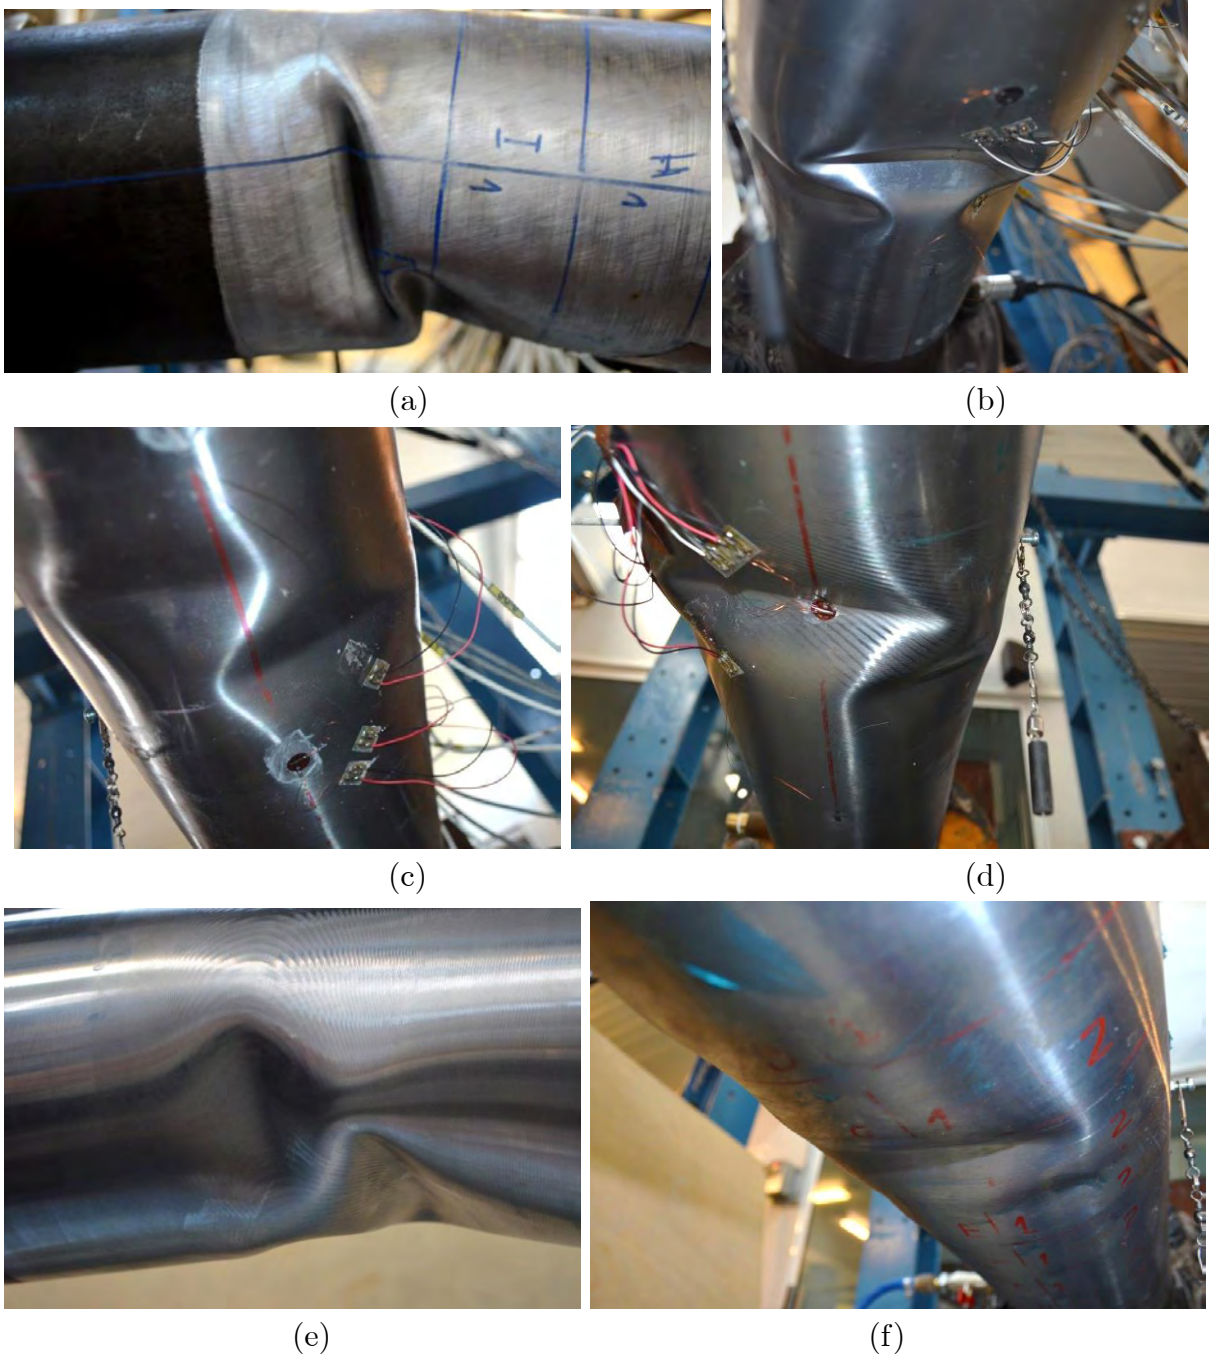
Figure 3-52: Detail of the non-symmetric buckle for (a) SP3b, (b) SP4b and (c) SP5b (d) SP6b (e) SP7b and (f) SP8b specimens.

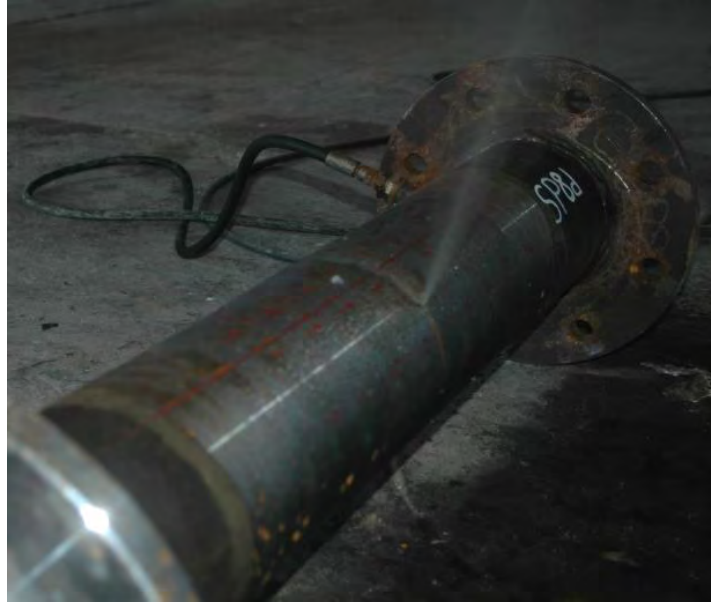
Figure 3-57: Rupture $\text{Ø}165/3$ pipe specimen SP8d due to cyclic internal pressure; wall rupture location at the "ridge" of the dent location.

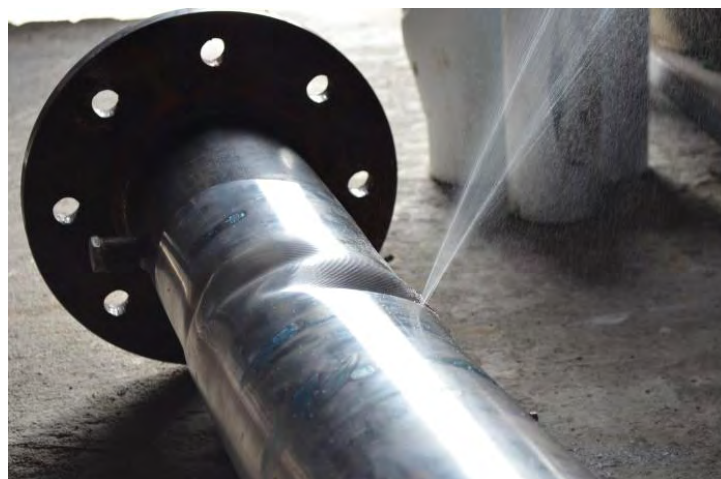
Figure 3-59: Ruptured $\varnothing 165/3$ pipe specimen (SP7b) due to cyclic internal pressure; wall rupture location at the buckle location

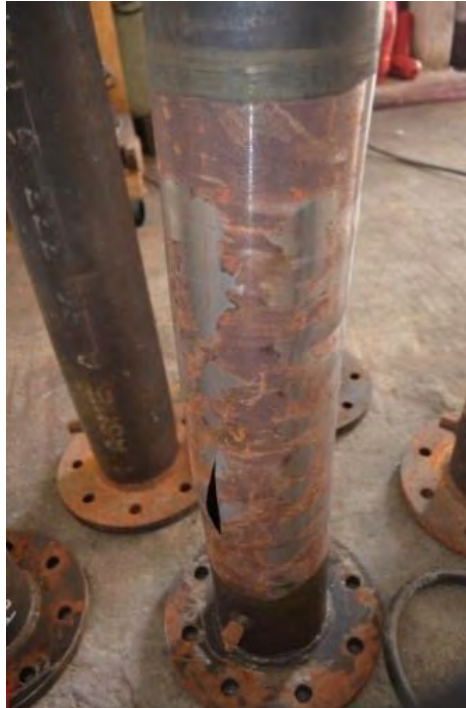
Figure 3-60: Rupture of SP8b specimen, away from the buckled area

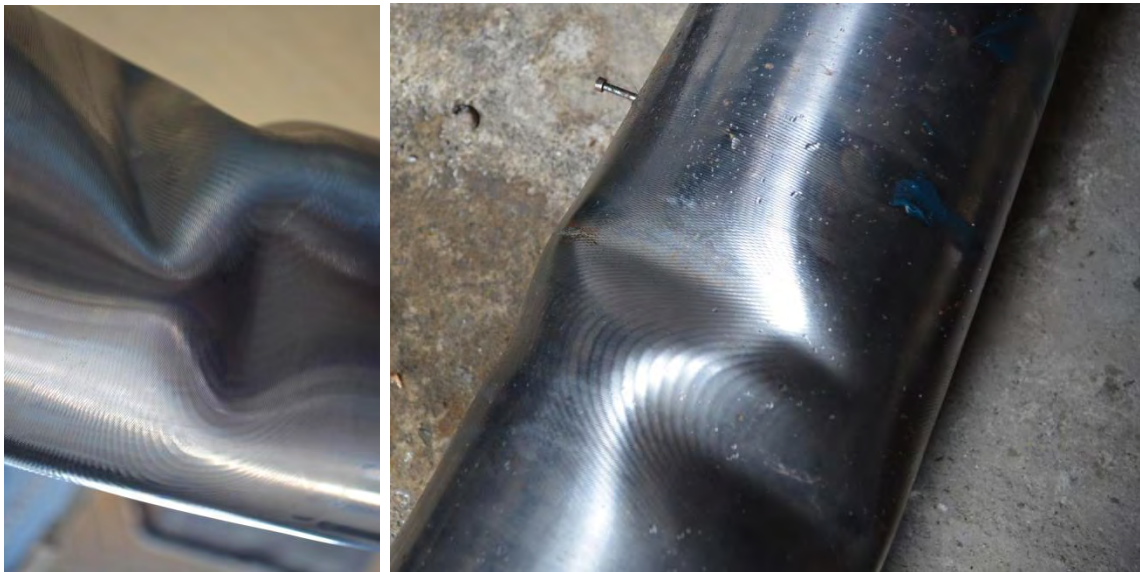
Figure 3-61: Buckled specimen SP7b: (a) buckle region prior to pressure application and (b) after cyclic internal pressure

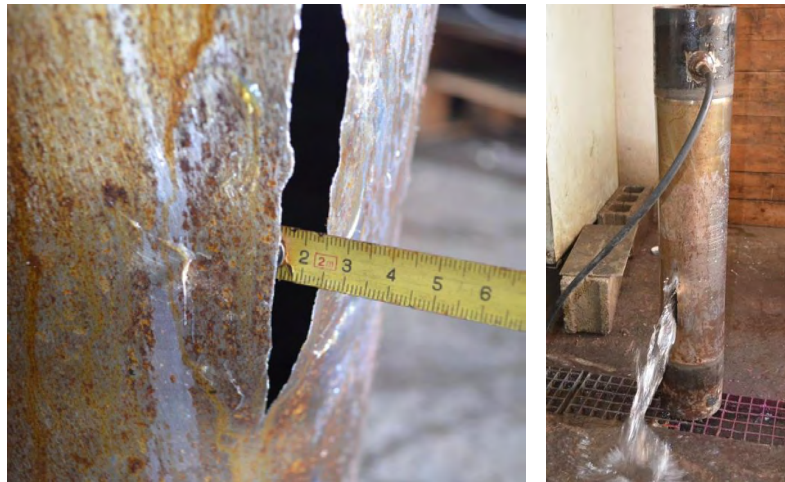
Figure 3-62: Rupture of perfect $\text{Ø}165/3$ pipe specimens; (a) thickness wall reduction at the critical region and (b) the location of the rupture.

specimen were capped with steel caps. The perfect $\text{Ø}165/3$ tube failed at a level of 50 bar (5MPa) which is about the 1/4 of the theoretical value of burst pressure. As shown in Figure 3-62, the rupture occurred at the one side of the pipe machined central part, close to the transition thickness zone. This “early” failure can be attributed to the fact that, with the application of internal pressure, the thickness value at the rupture region was decreased to 1mm. On the other hand the $\text{Ø} 168.3/4.78$ specimen failed at a burst pressure 35MPa, which is somewhat larger than the theoretical burst value. The rupture was located at the center of the specimen.

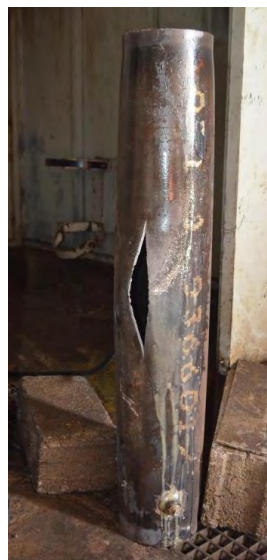
Figure 3-63: Rupture of perfect $\text{Ø} 168.3/4.78$ specimen

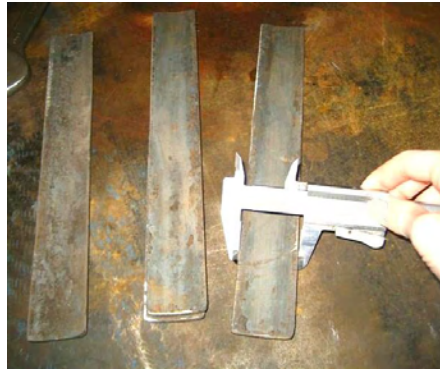
Figure 3-64: Geometry of Strip specimens

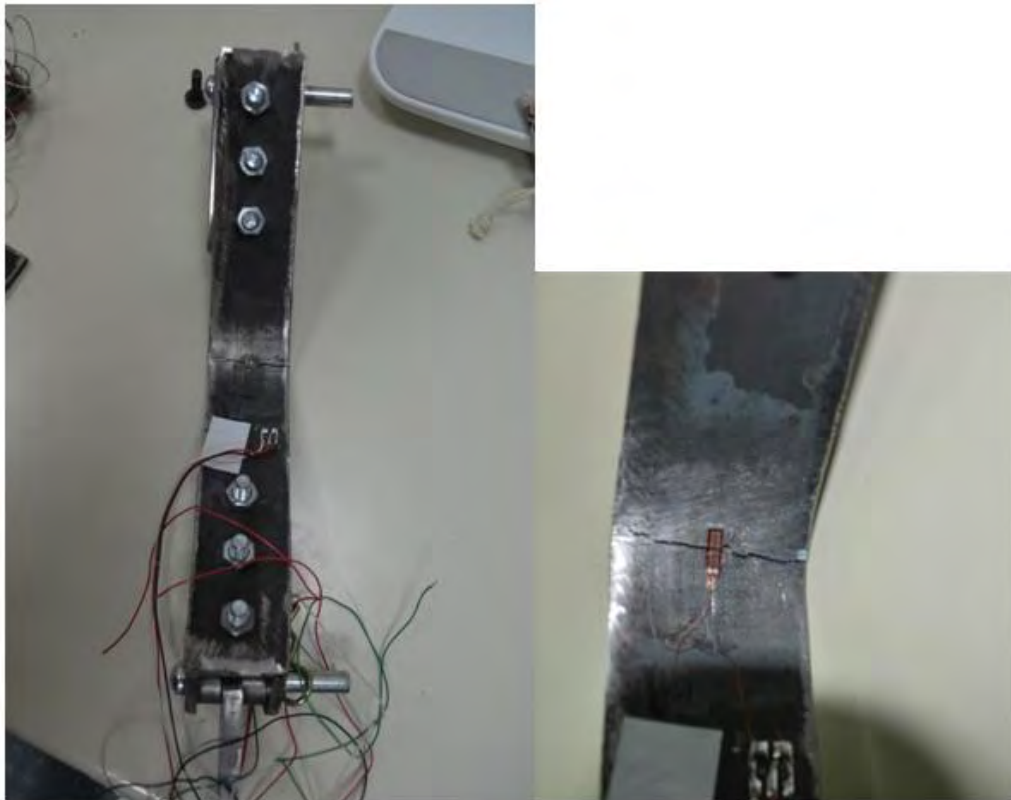
Figure 3-81: Crack development of specimen S21-View from the inner face of the strip. The crack propagated along the transverse direction.

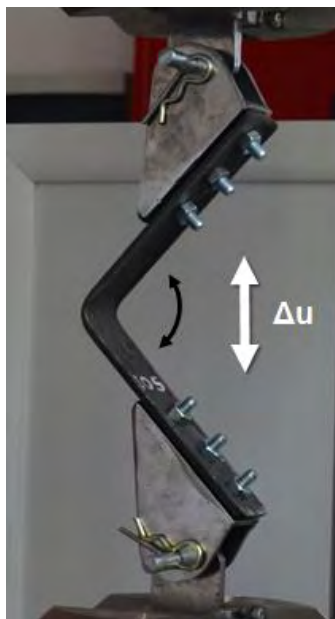
Figure 5-3: Loading and test configuration of strip specimens
