# Effect of Aging time on Corrosion-induced Hydrogen Trapping in High-Strength Al-Alloy 2024

THESIS

Submitted in partial fulfillment of the requirements for the degree of bachelor in mechanical Engineering

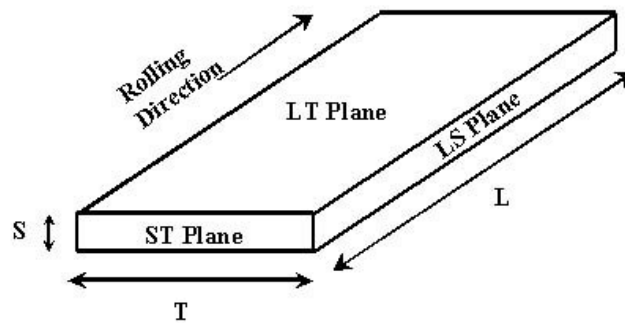
Fig. 3. 1: Labelling scheme used for directions and planes.

The labeling scheme used to identify the orientations and planes of the alloys is shown in Fig. 3. 1.

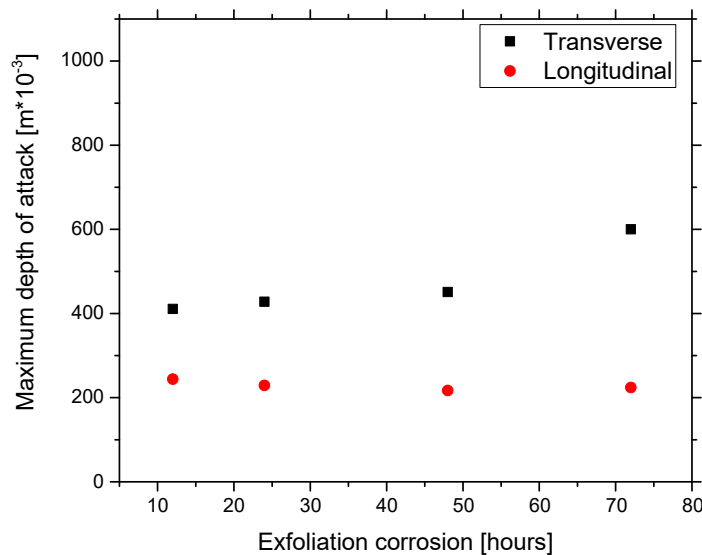
Fig. 4.8. Maximum depth of attack, of not heat treated aluminum alloy 2024-T351 specimens after exposure to EXCO solution.

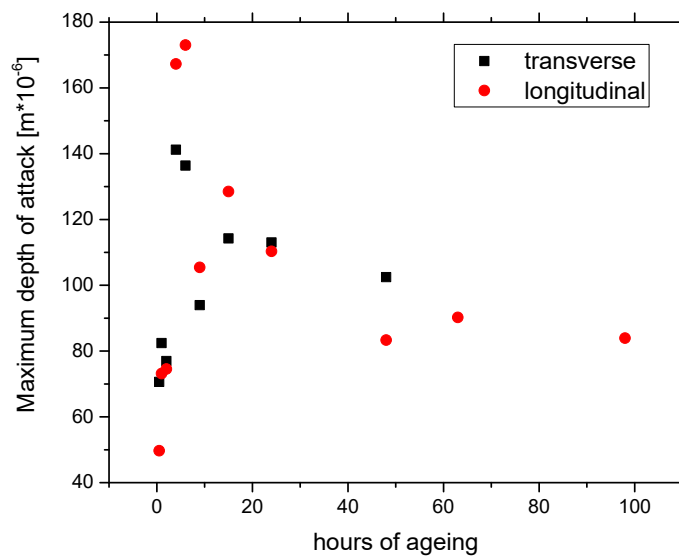
Fig. 4.20. Maximum depth of attack for the different times of aging for the ST and LS plane after 2 hours of EXCO exposure.

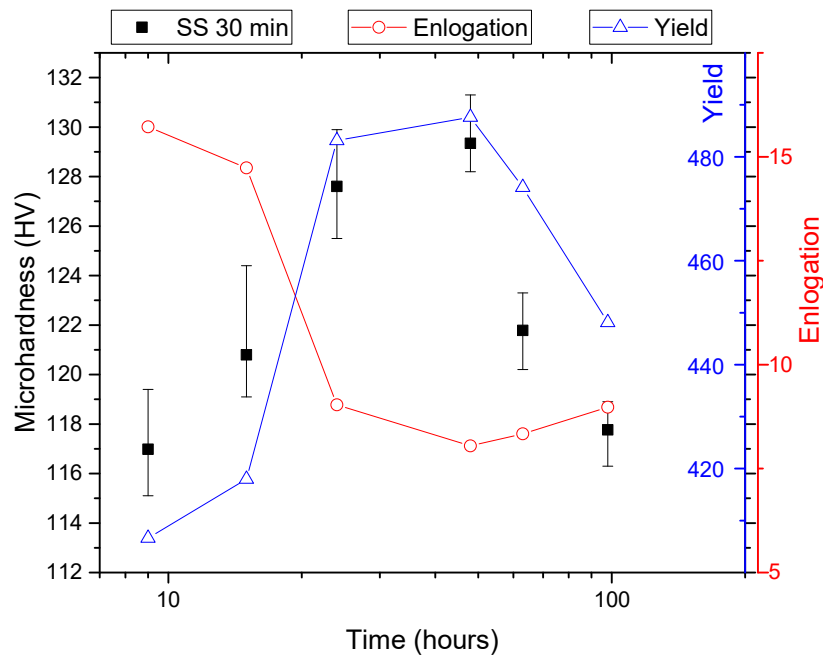
Fig. 4.51: Microhardness profile of 2024-T351 versus time of aging. The aging was performed at  $T=170^{\circ}\text{C}$  for duration of 30 min, 1 h, 2 h, 4 h, 6 h, 9 h, 15 h, 24 h, 48 h, 63 h and 98 h respectively.

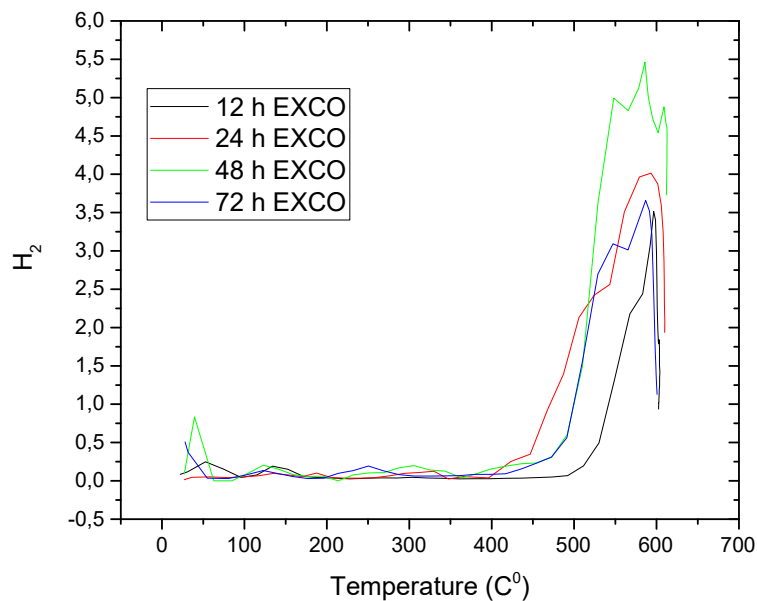
Fig. 52 : Spectrum of hydrogen evolved from the specimens in the T351 condition after (a) 12 h (b)24 h, (c) 48 h and (d) 72 h exposure to the EXCO solution.
