UNIVERSITY OF THESSALY  
POLYTECHNIC SCHOOL  
DEPARTMENT OF MECHANICAL ENGINEERING  
LABORATORY OF MATERIALS

Diploma Thesis

**Investigation of Stress-Oriented Hydrogen-Induced  
Cracking (SOHIC) in an Amine Absorber Column of  
an Oil Refinery**

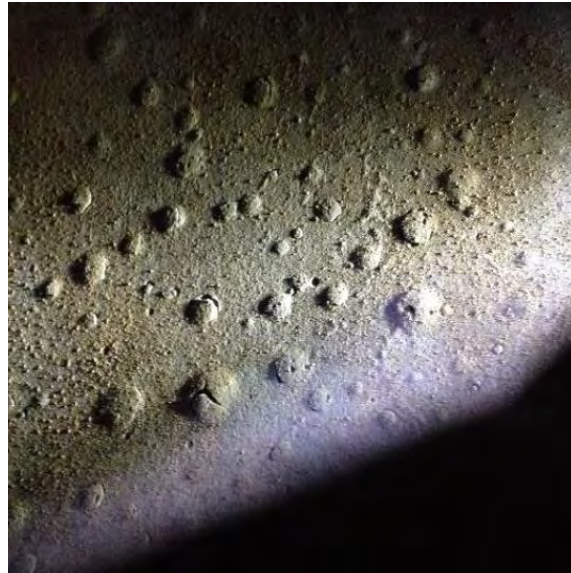
Figure 7. Blistering in internal surface

A section of absorber column shell cut for investigation. The position of section was 5m from the bottom of the column (Figure 8). In the inside diameter, blistering was evident. (Figure 7)

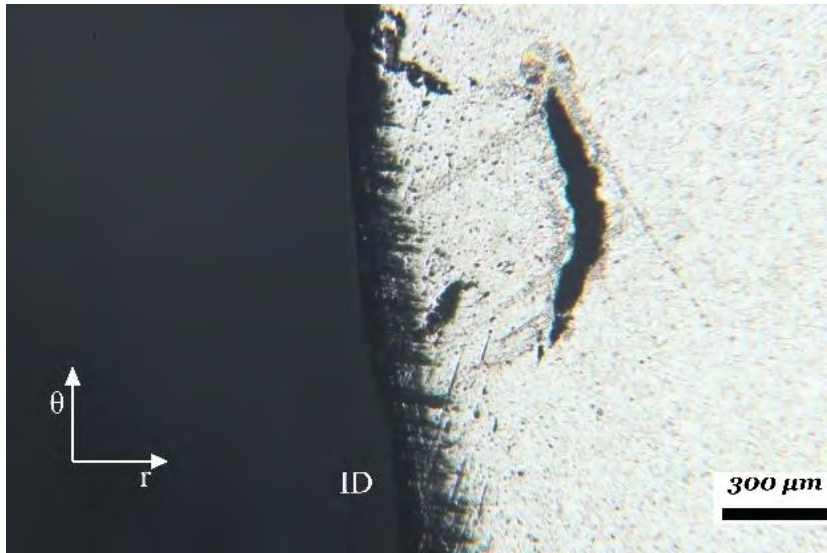
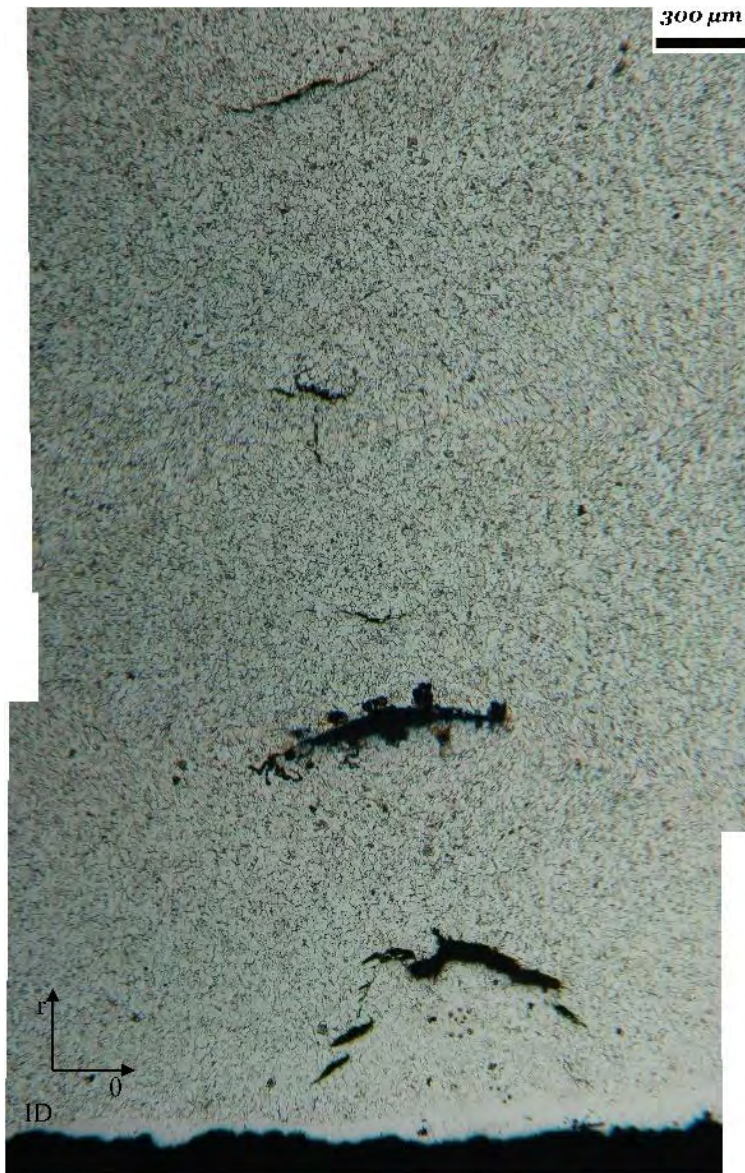
The metallographic section at location 577 is depicted in Figure 25, Figure 26, Figure 27. So many blisters/HIC cracks have formed, but they are not interconnected, at least at the plane of observation. This can explain the scattered mode of the UT signal at position 577. The propagation of HIC cracks is through the ferrite phase, between the pearlite colonies at ferrite/pearlite interfaces, as depicted in Figure 28. A similar crack propagation mechanism has been also observed by Gingel and Garat in an API 5L grade X60 pipeline steel [36].

It is important to note that location 577 exhibited only stacked HIC cracks with no evidence of crack linking. This indicates that the SOHIC sequence involves the formation of HIC cracks first, followed by through thickness linking of the HIC cracks, in agreement with observations by Crolet and Adam [38] and Ohki et al. [39]. Both HIC formation and linking involve transgranular cleavage fracture mechanisms as indicated by the fractographic analysis of the opened crack at location 500. The transgranular propagation mode is in agreement with the findings of Bruckhoff et al. [40], however the cleavage mode of linking is not in agreement with the suggestion of Pargeter [6] that linking is through a slip mechanism or of Azevedo [41] who observed ductile fracture mode in linking hydrogen blisters in an API 5L X46 steel. Slip may be involved in the transport of hydrogen, as shown by several studies [42, 43] but the propagation of the linking cracks is clearly through a cleavage mechanism. The cleavage mode of the linking cracks confirms the important influence of stress triaxiality in SOHIC since triaxiality introduces plastic constraint and promotes cleavage fracture. Triaxiality effects have been discussed by other investigators, such as the effect on hydrogen concentration by Toribio et al. [44], the effect on ductility by Mirza et al. [45] and the effect on fracture behavior by Borvik et al. [46].

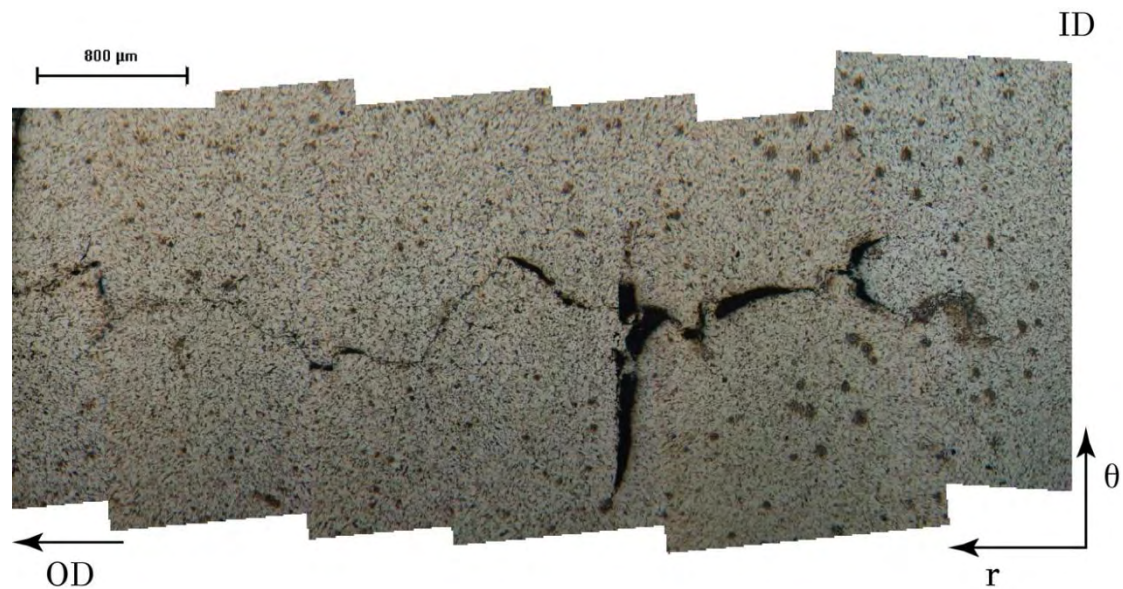
Figure 29. SOHIC at location 500.

The metallographic section at location 500 is depicted in Figure 29. The crack has initiated at 5 mm from the ID and has an overall length of 30 mm. This type of cracking is also classified as SOHIC.

Both cracks at locations 500 and 604 (Figure 19, Figure 29) are, therefore, classified as SOHIC. They interconnect blisters/HIC cracks and they propagate from the ID towards the OD under the action of the applied stress. According to API RP 571 [37], SOHIC consists of arrays of small HIC cracks, initiated at internal blisters in the rolling plane. These HIC cracks are stacked in a direction normal to the applied hoop stress and are linked by cracks normal to the stress. SOHIC should not be confused with stepwise hydrogen-induced cracking (SWC), which exhibits a not-aligned stepped morphology in the absence of stress. The limited cases of SOHIC failures that are reported in Pargeter's review [6] indicate that SOHIC requires a combination of severe hydrogen cracking conditions and stress. In the present case, the amine absorber column was operated under high  $H_2S/MDEA$  ratios for certain time periods, promoting high hydrogen charging conditions. In addition, it has been suggested [6] that triaxial loading can encourage the formation of small HIC cracks by increasing the hydrogen solubility in the steel. Stress triaxiality can be induced by the large plate thickness (91 mm). It is expressed by the ratio  $\sigma_h/\sigma$ , where  $\sigma_h$  is the hydrostatic stress and  $\sigma$  is the von Mises equivalent stress. The triaxiality ratio was calculated (see Appendix A) for the operating conditions and was found as 0.5, which is a number indicating that the material was subjected to a moderate triaxial stress state. In addition, it is interesting to note that the HIC cracks form even though the radial stress is compressive. However, these cracks do not propagate in the rolling plane, but instead they are linked in the radial direction under the action of the hoop stress.
