UNIVERSITY OF THESSALY

Ph.D. Dissertation

**STRUCTURAL INTEGRITY OF STEEL HYDROCARBON
PIPELINES WITH LOCAL WALL DISTORTIONS**

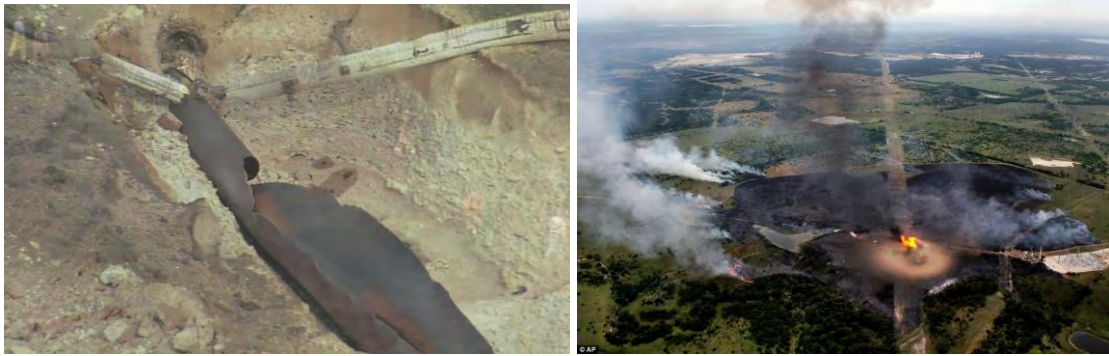
Figure 2-3: Gas pipeline explosion in North Texas; (a) ruptured pipeline (b) the burned pipeline surroundings. [<https://www.youtube.com/watch?v=RSCz-35M9hA>]

A representative example of pipeline failure due to external “hit” occurred more recently, in North Texas: In 2010 a large natural gas line in North Texas, near Granbury, erupted after utility workers accidentally hit an Enterprise Products Partners natural gas pipeline. The pipeline exploded killing one worker. The ruptured pipeline and the damaged area after the explosion are shown in Figure 2-3. [Source: <http://www.dailymail.co.uk/news/article-1284880/Texas-gas-pipeline-explosion-kills-worker-injures-seven.html#ixzz3dpBySx9h>]

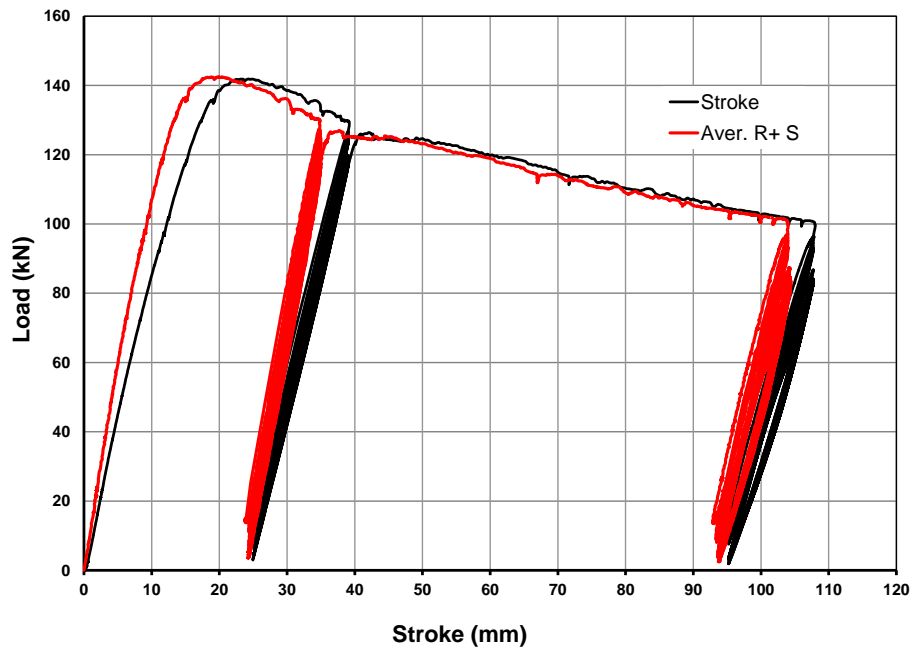
Figure 3-35: Load vs stroke curve in comparison with the load vs average LVDT's displacement curve for SP6d specimen; monotonic and cyclic bending.

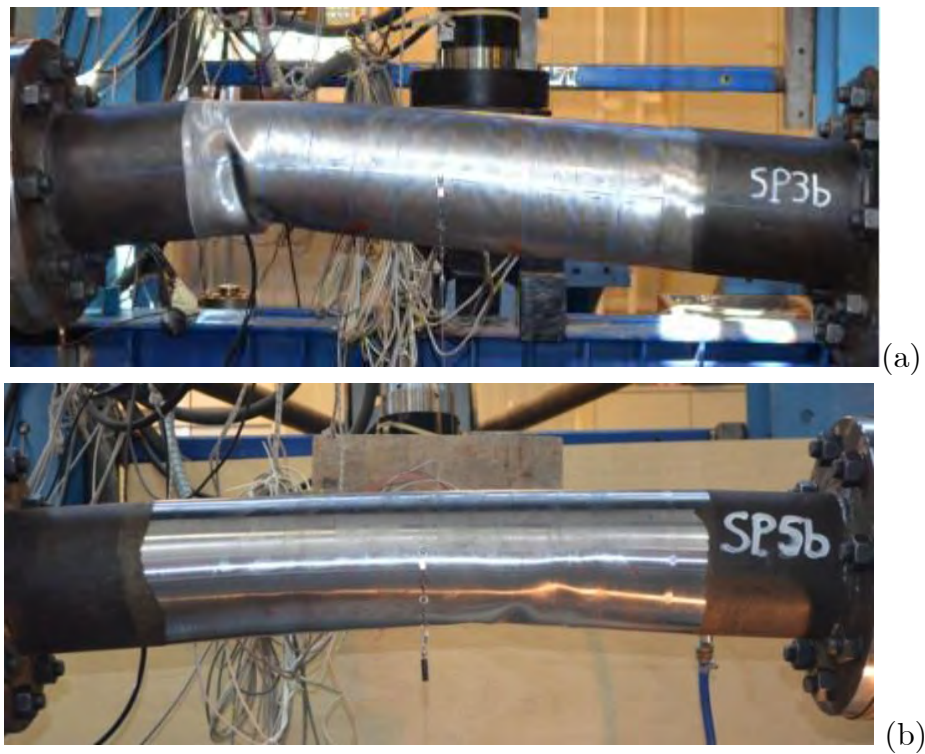
Figure 3-51: Side views of buckled specimens (a) SP3b, (b) SP5b, (c) SP6b and (d) SP7b buckled specimens.

The final buckled shapes of the specimens before the application of cyclic bending are shown in Figure 3-51. In particular, Figure 3-51c, shows that specimen SP6b buckled almost exactly at the midspan. For the most cases of pipe specimens the buckling pattern consisted of a diamond-type shape with one major and two minor buckles on each side of the bending plane, as shown clearly in Figure 3-52b. On the other hand, the buckled mode of specimens SP5b and SP8b, consisted of two main buckles perpendicular to the pipe main axis on each side of the bending plane (Figure 3-52c).

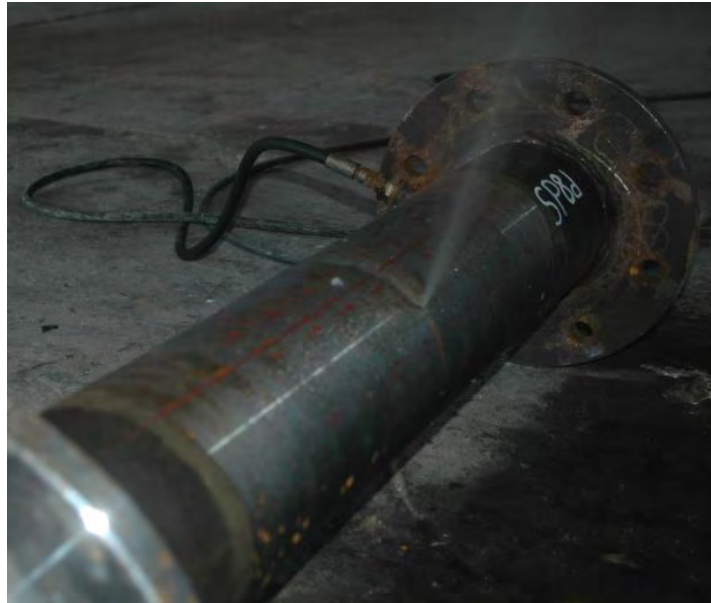
Figure 3-57: Rupture $\text{Ø}165/3$ pipe specimen SP8d due to cyclic internal pressure; wall rupture location at the "ridge" of the dent location.

The results referring to the dented specimens are summarized in Table 7. The specimens are subjected to 5,000 cycles of pressure loading with $p_{\min}=1.5\text{MPa}$ and $p_{\max}=15\text{MPa}$, referring to $\text{Ø}168.3/4.78$ specimens and 0.92 MPa to 9.20 MPa for $\text{Ø}165/3$ specimens. The maximum pressure p_{\max} corresponds to 72% of the nominal yield pressure σ_y equal to 20.55 MPa and 13.2 MPa for $\text{Ø}168.3/4.78$ and $\text{Ø}165/3$ specimens, respectively. Subsequently, the specimens, are subjected to monotonically increasing pressure up to burst. No failure or damage has been detected due to cyclic loading except from the SP8d specimen which was cracked at the "ridge" of the dent location at about 2500 cycles (Figure 3-57). The pressure level at which rupture occurs for the rest of the dented specimens SP2d and SP4d is 32MPa and 31.6MPa respectively. For the case of SP7d specimen, the pressure level is found from tests equal to 16.7 MPa. It is interesting to notice that these values are quite close to the theoretical values of burst pressure estimated from the following simplified formula, $p_{\text{burst}}=2\sigma_{\text{UTS}}(t_{\text{actual}}/D_{\text{nom}})$, equal to 30 MPa and 19.12 MPa for $\text{Ø}168.3/4.78$ and $\text{Ø}165/3$ specimens, respectively, where σ_{UTS} is the ultimate tensile stress. This result shows that the presence of a smooth dent on the pipe wall has no effect on the burst capacity of the pipe. In addition, rupture of the pipe wall occurred away from the dent area, as shown in Figure 3-58, which was also observed in a similar test on a buckled pipe reported by Dama et al (10). Furthermore, as shown in Figure 3-58c, the application of internal pressure resulted in a reduction of the dent size and a "smoothing" of the dented area.

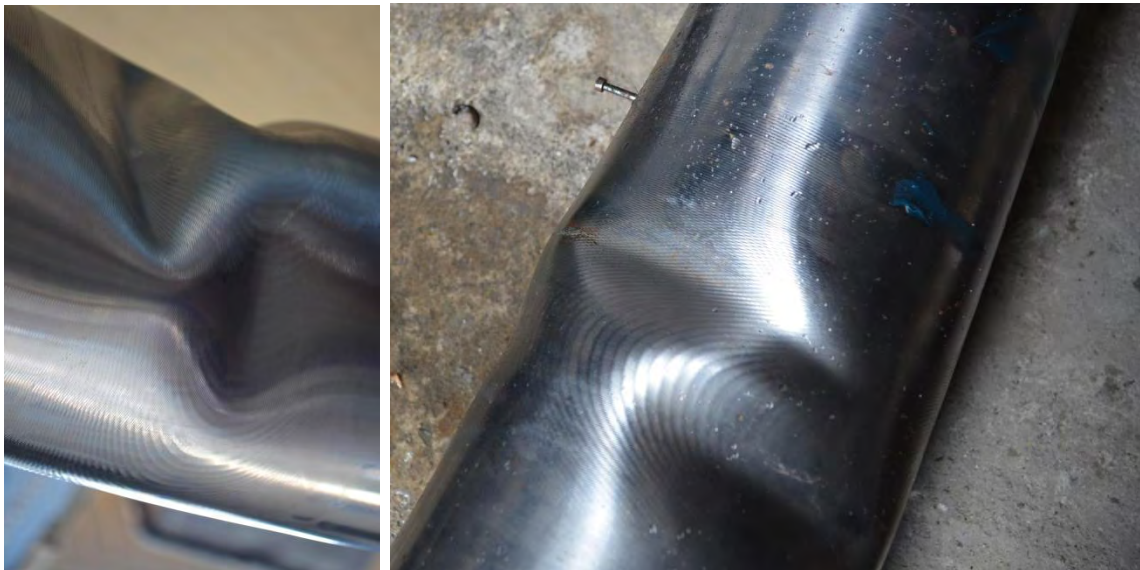
Figure 3-61: Buckled specimen SP7b: (a) buckle region prior to pressure application and (b) after cyclic internal pressure

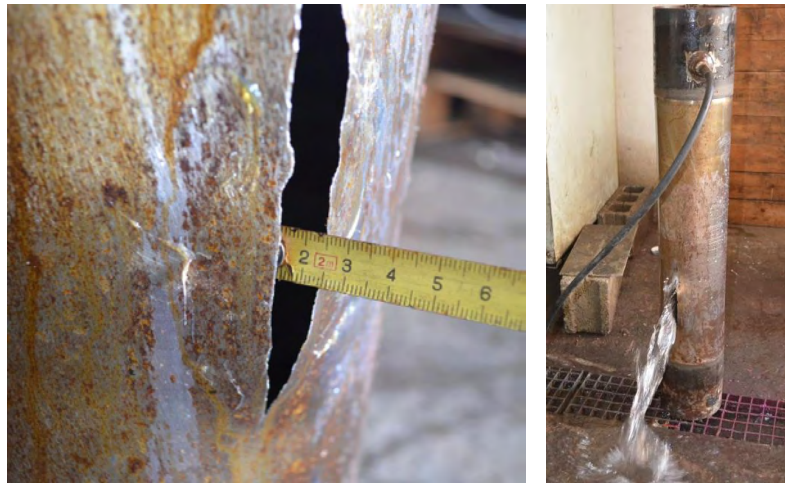
Figure 3-62: Rupture of perfect $\text{Ø}165/3$ pipe specimens; (a) thickness wall reduction at the critical region and (b) the location of the rupture.

specimen were capped with steel caps. The perfect $\text{Ø}165/3$ tube failed at a level of 50 bar (5MPa) which is about the 1/4 of the theoretical value of burst pressure. As shown in Figure 3-62, the rupture occurred at the one side of the pipe machined central part, close to the transition thickness zone. This “early” failure can be attributed to the fact that, with the application of internal pressure, the thickness value at the rupture region was decreased to 1mm. On the other hand the $\text{Ø} 168.3/4.78$ specimen failed at a burst pressure 35MPa, which is somewhat larger than the theoretical burst value. The rupture was located at the center of the specimen.

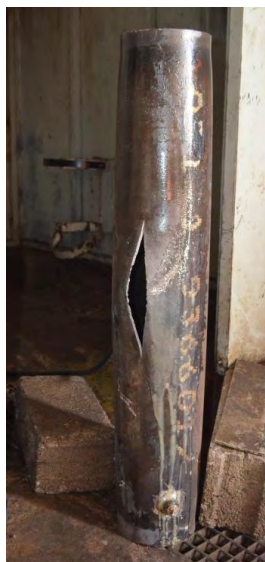
Figure 3-63: Rupture of perfect $\text{Ø} 168.3/4.78$ specimen

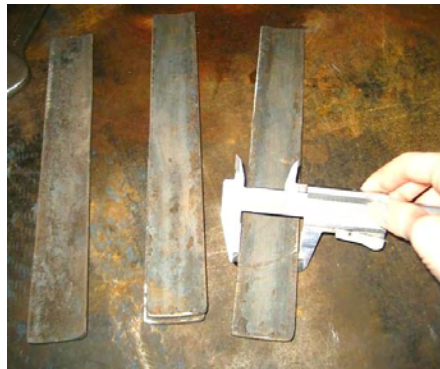
Figure 3-64: Geometry of Strip specimens

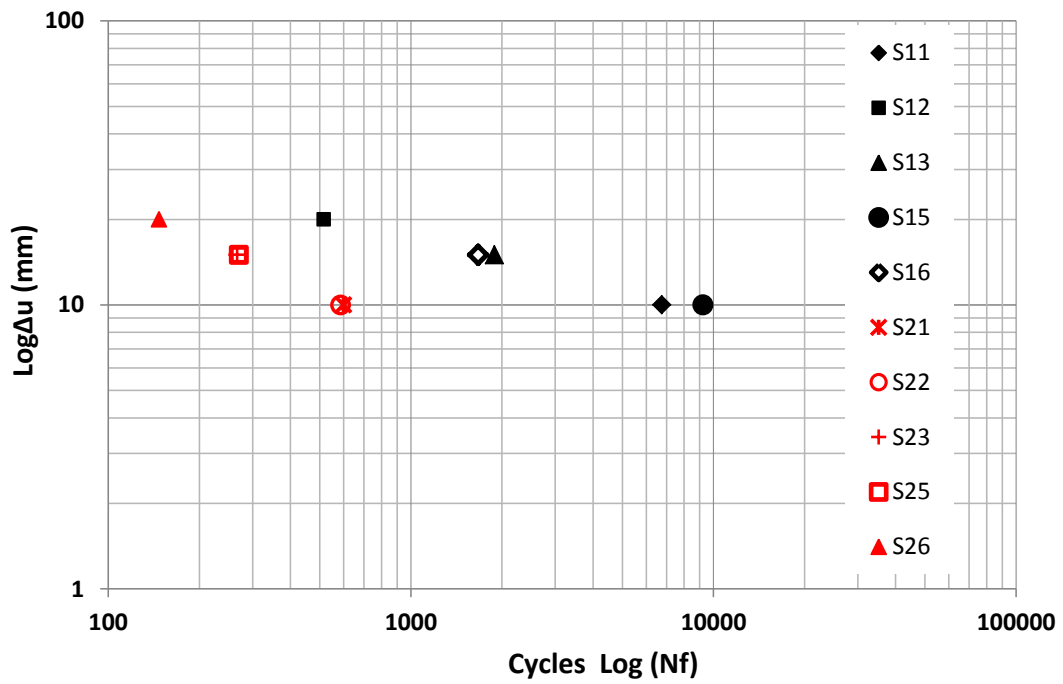
Figure 3-68: Logarithmic fatigue curves of stroke amplitude vs fatigue life

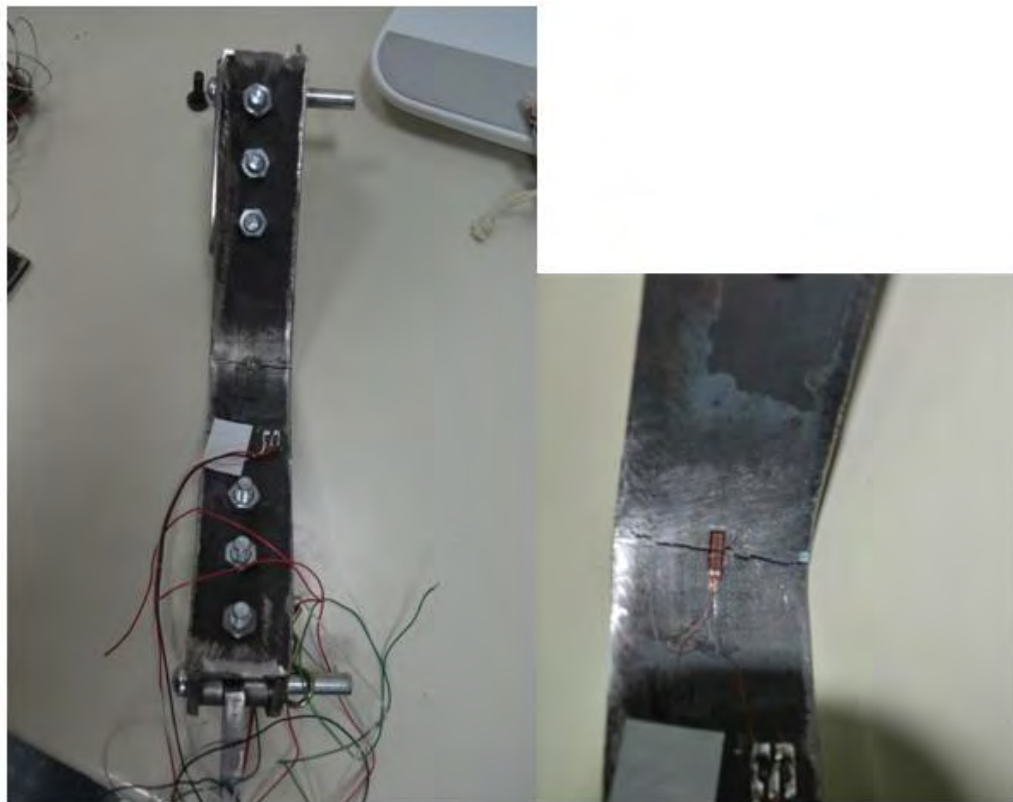
Figure 3-81: Crack development of specimen S21-View from the inner face of the strip. The crack propagated along the transverse direction.

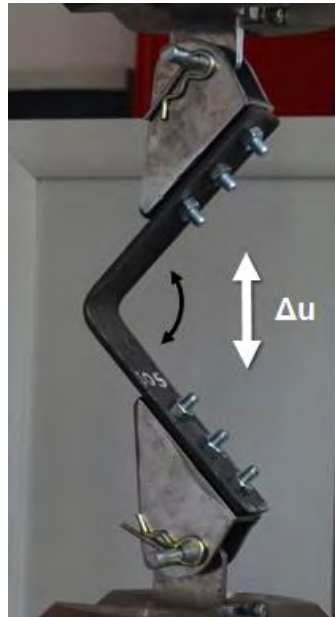
Figure 5-3: Loading and test configuration of strip specimens
