« Study of High-Temperature Hydrogen Attack in carbon-steel equipment »

Volos, 2022

Fotaki Morfo

In the present thesis, there is also the investigation of the failed heat exchanger (M-9210), from the Aspropyrgos Refinery. The failure is attributed to the High Temperature Hydrogen Attack damage mechanism. Through the metallographic study and hardness measurement the thesis will add insight on the physical process that occur during the initiation and propagation of this particular case of failure. Finally, the gathered information and the results of the specimen examination will be discussed.

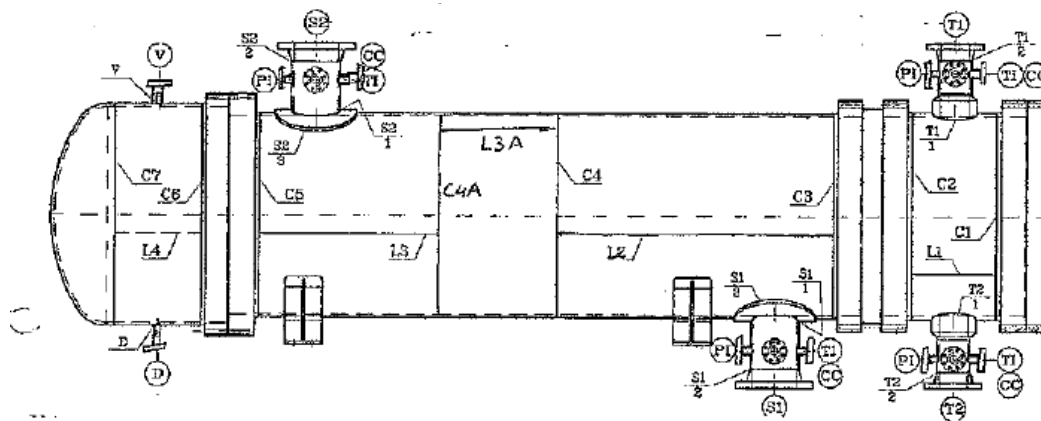
Figure 13. Drawing of the M-9210 exchanger.

The Aspropyrgos Refinery of the Hellenic Petroleum Group (HELPE) faced the failure of a heat exchanger in 2014. Leakage appeared on the outer surface of the heat exchanger M-9210 while a cleaning process of the exchanger tube was being held. Steam leaked out of a crack of about 0.5m long near the welded area, the L3 part of Figure 13 drawing below

(Figure 13). They assigned the Laboratory of Materials of the University of Thessaly the investigation of the causes of this incident.

The material of the heat exchanger from the Aspropyrgos refinery was carbon-steel (SA 516M Gr.70). According to the material certificate, the carbon (C) content was 0.15 (%wt.). It was an hypoeutectoid carbon steel tube that operated at 310°C and 2.9 MPa. The operating temperature and hydrogen partial pressure exceeded the limits for carbon-steel (welded and non PWHT) and carbon steel (welded and PWHT) designated by the Nelson curves. The chances of the failure being contributed to HTHA are very high. There may also be a synergy of other mechanisms related to HTHA, but they contributed to the initiation of the crack and not the final failure [1].
