## **Failures in Marine Structures**

Diploma Thesis

Tilemachos I. Solinis

Volos, 2023

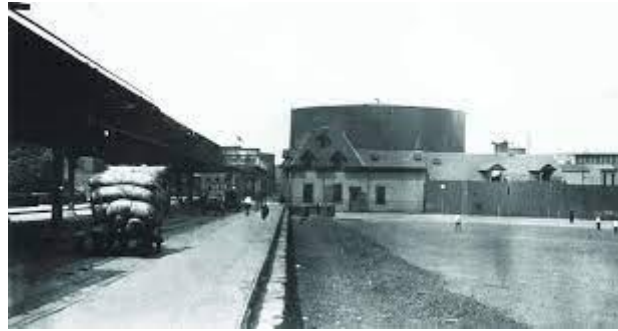
*Figure 1: The molasses tank.*

The tank's design was flawed, as the steel used was not thick enough to handle the increasing pressure. The internal pressure rose due to fermentation inside the tank, which increased the levels of carbon dioxide. Additionally, thermal shock, which is defined as fluctuations in temperature, could cause stress in materials, particularly brittle ones. On the day prior to the accident, the temperature had risen from  $-17^{\circ}\text{C}$  to  $5^{\circ}\text{C}$ , putting further strain on the already weakened tank. A 2014 analysis revealed the metallurgical reasons for the failure. The steel lacked carbon and manganese, making it brittle when cooled below  $13^{\circ}\text{C}$ . The operating conditions at the time of the failure were  $4^{\circ}\text{C}$ , which was significantly lower than the transition temperature. Another cause of the failure was the presence of fatigue cracks that had developed around a critical point. The tank had been filled multiple times, which subjected the panels to intermittent cyclic loads. These factors, along with the lack of structural assessments (such as inspections and ignoring warning signs like groaning noises), led to the catastrophe [3].

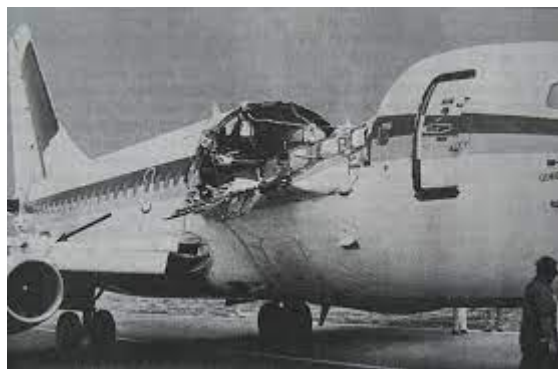
fatality and a few injured passengers. An investigation later determined that the accident was caused by a combination of factors. The airline's maintenance and inspection program were found to be lacking, as fuselage inspections were only performed at night, making it difficult to detect any flaws. The fatigue cracking originated from the knife edge connected to the countersunk rivet holes, which transferred concentrated stresses along the rivets due to geometric discontinuity and lap joint disbonding. The fuselage failure mechanism occurred as a result of several instances of site fatigue cracking near the rivet holes, which diminished the safety factor of the fuselage. It is important to note that the incident occurred after 19 years of service, although the ideal design life was 20 years. This highlights the importance of fatigue prevention, which prompted changes in aviation safety standards and procedures [5].

*Figure 4: The plane after the accident.*

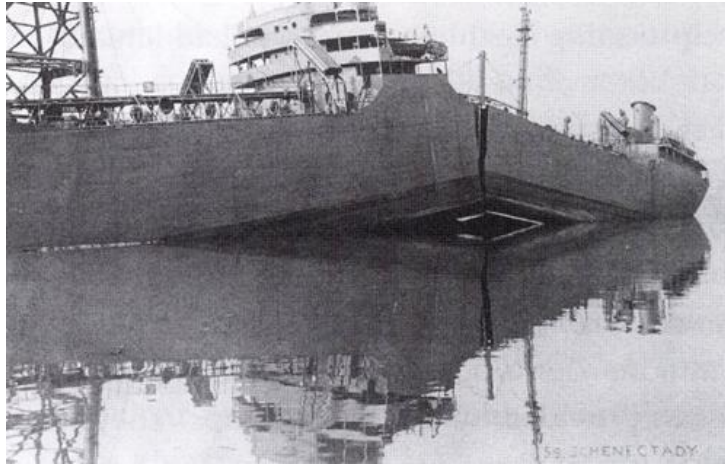
In January 1943, the T2 tanker named "Schenectady" was docked at the shipyard where it was built in Oregon, USA. The ship had successfully completed her sea trials and was ready for her first mission. The 152m vessel was moored at a harbor where the water temperature was 4°C, the water was still, and the air temperature was -3°C. Suddenly, the ship broke into two separate parts amidships without any prior warning, accompanied by a loud sound. A similar accident occurred at New York when the liberty ship "Manhattan" approached the harbor and suddenly failed in two pieces during sailing. A total of seven ships experienced a similar failure.

*Figure 53: The SS Schenectady T2 tanker.*

After several investigations, a report was issued which concluded all the root causes of the failure of liberty ships. The report suggested modifying the ship's design to reduce stress concentrations in parts of the ship that were noticed to be problematic, as well as improving the welding quality to diminish initial flaws and residual stresses. However, the report did not take into consideration the steel properties and fracture toughness of the material, which could lead to brittle fracture. Therefore, it was claimed that the root causes were the low weldability of the steel used for ship construction, as well as stress concentration due to deficient design and poor welding (initial defects) [60].

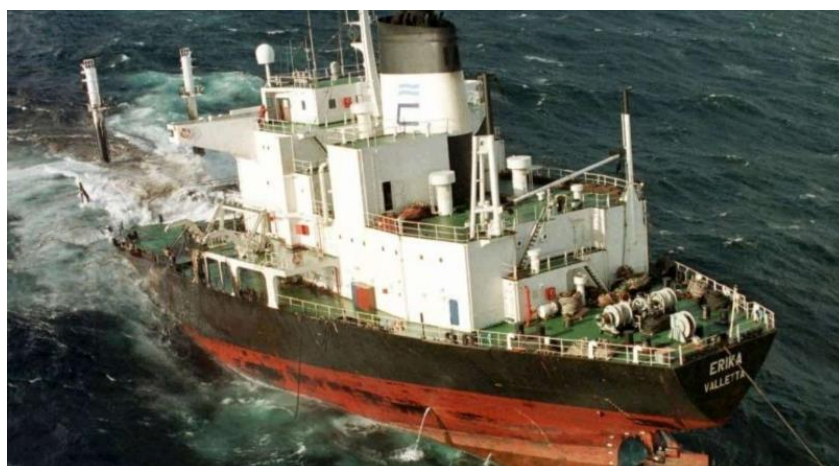
On the 11th of December 1999, the M/T Erika, a 24-year-old, Malta-registered ship, was travelling from Dunkirk to Livorno, carrying 30,884 tons of heavy oil, when it experienced structural failure during a heavy storm. The ship was travelling at 6.5 knots through harsh weather conditions, with wind speeds of about 7-8 Beaufort and waves reaching heights of 5-6 meters. Immediately after the initial failure, the ship obtained a significant list, and when it returned to a stable state, it broke off amidships after several hours. The crew managed to abandon the ship safely, without reporting any injuries or human loss. The disaster of the Erika ship was in the Bay of Biscay, causing significant ecological catastrophe along the coasts of France due to the hazardous cargo itself and the severe conditions, which impeded the oil spill confinement efforts by the responsible authorities.

*Figure 55: The sinking of M/T Erika.*

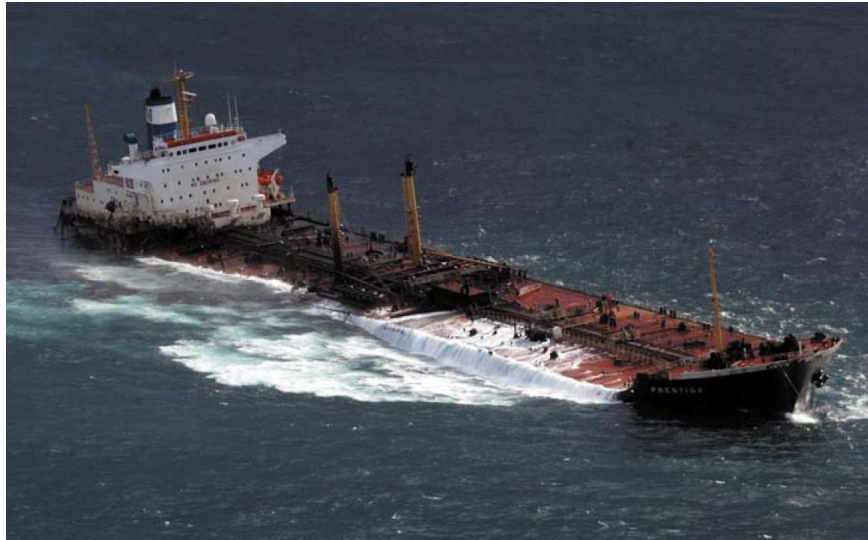
The most likely reason that triggered the failure of the ship was the large wave that struck the structure due to the heavy storm. The wave impact caused a crack and deformation at the side shell of the 3rd starboard wing tank. The 2nd and 3rd tanks were empty during the voyage, and the wave's influence led to the emergence of the hull's weaknesses. After the cracking of the 3rd tank, the increased internal pressure, in conjunction with the deformation that had occurred, resulted in breaching the bulkhead between the two tanks and water ingress. The initial failure originated in an empty ballast tank and could have been the result of several damage mechanisms.

*Figure 57: The ship at the early stage of the failure.*

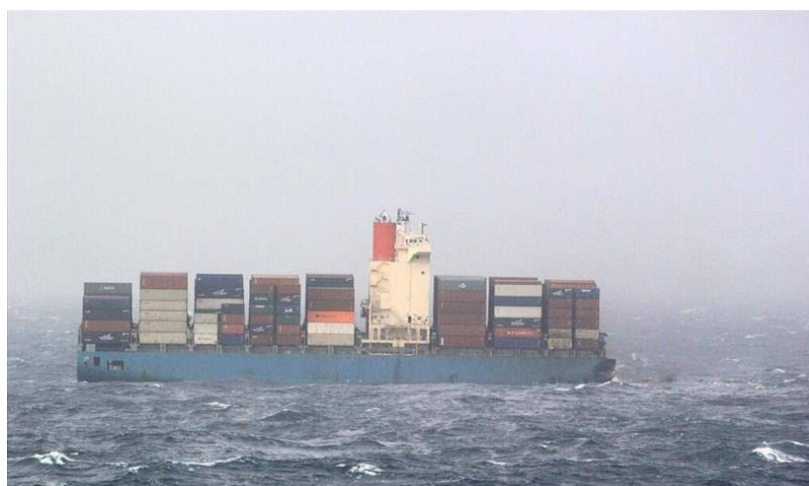
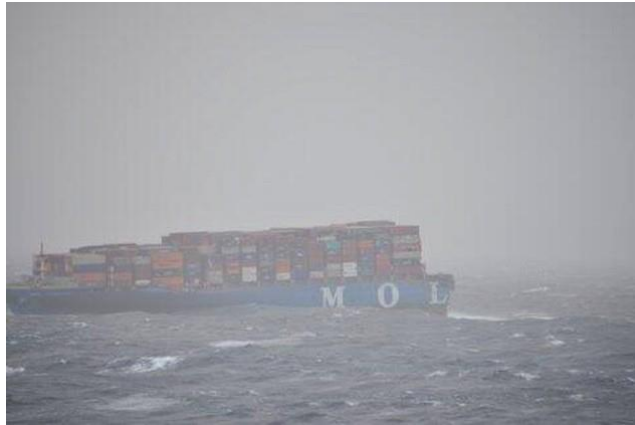
The aft part of the ship, which was carrying 1,700 containers and 1,500 tons of fuel, sank almost immediately after being fully separated. The fore part of the ship remained afloat, and attempts were made to tow it. However, a wildfire broke out onboard, and the fore part eventually sank at 19:00 UTC on July 10th, 2013, carrying the remaining 2,400 containers and 1,600 tons of fuel. The technical investigation of the disaster was assigned to the bureau responsible for the ship (Class NK), the Committee on the Safety of Large Container Ships, and the International Association of Classification Societies (IACS).

Figure 61: (a) The aft part of the ship, (b) The fore part.

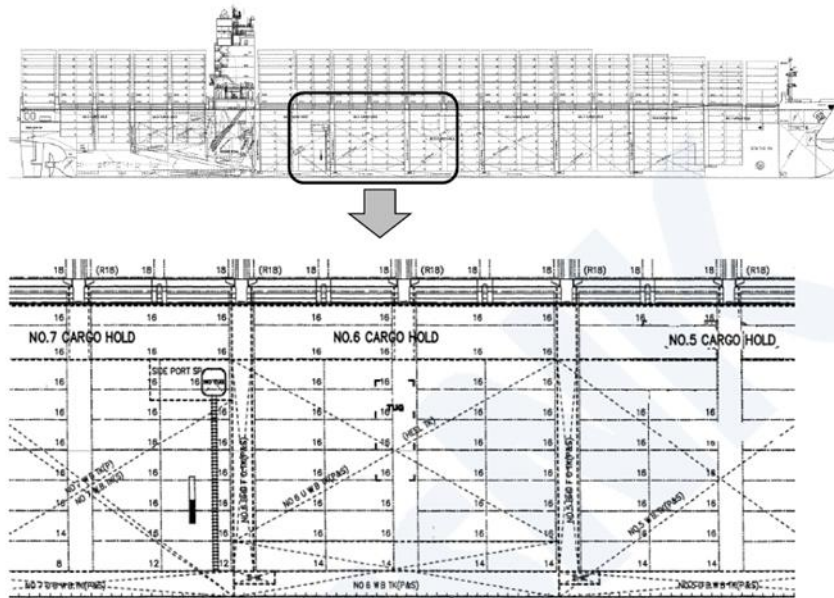
The ship, while sailing, was hit by two waves that caused a fracture in the hull amidships. The ship was subjected to a hogging condition, which is defined as the convex deformation of the hull in the longitudinal direction. The observed fracture was considered to have initiated from the bottom of the ship, the part that was submerged into the sea, and propagated along the structure, leading to the upper deck as the point of fracture that failed last. The fracture that cut the ship in two halves was assumed to have initiated from the No.6 cargo hold bottom shell plates.

Figure 62: Ship design and the layout of the midship part.

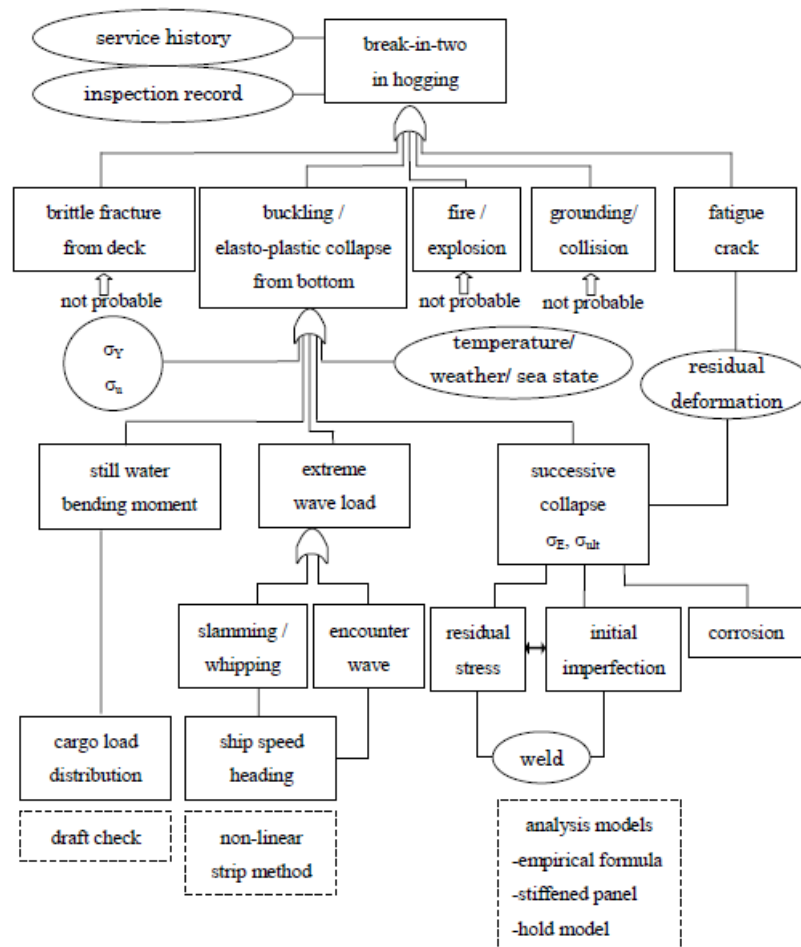
It is important to follow a procedure that includes all possible causes of the failure, based on the conditions that existed during the accident. The possible causes can be found in the following table:

Figure 63: An analysis of possible failure factors.

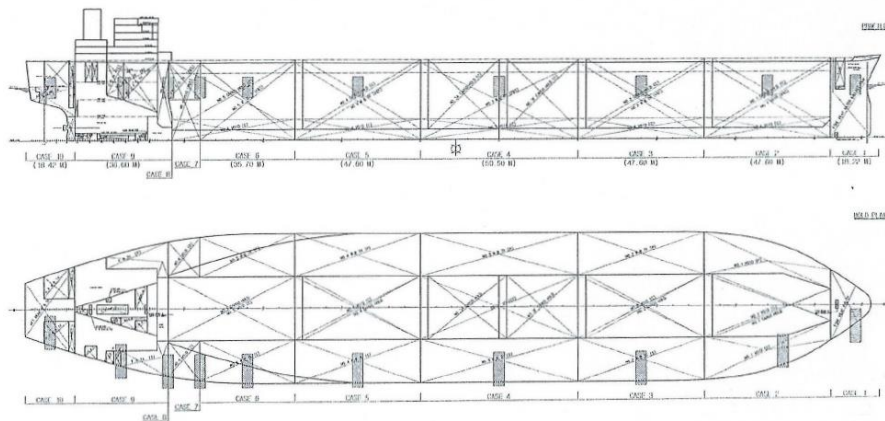
The failure had probably begun from the No. 2 Port Ballast Tank. The reason for the fracture of the ship was a combination of damage mechanisms that deteriorated the structural condition of the ship over time. Material fatigue, corrosion, permanent defects, multi-port discharges, and weather conditions that the ship had to withstand between her departure and the accident led to a significant reduction in the ship's hull strength. The ship was a single-hull ship and was built as a Very Large Crude Carrier (VLCC) in 1993 at Mitsubishi Heavy Industries in Japan. The ship was designed, constructed, and supervised according to Class NK standards. The steel that was used for critical sections of the ship was steel grade AH, which was mainly utilized for decks, side and bottom shell plating, as well as longitudinal and horizontal girders. Steel grade AH36 was used for the longitudinal bulkheads between the tanks and the vertical stiffeners that support the bulkheads. In 2008, the ship underwent an extensive conversion from VLCC to VLOC, which was a major endeavor not only from an engineering perspective but also from the standpoint of standards and rules that should have included requirements for such wide modifications.

Figure 67: The modified ship design.

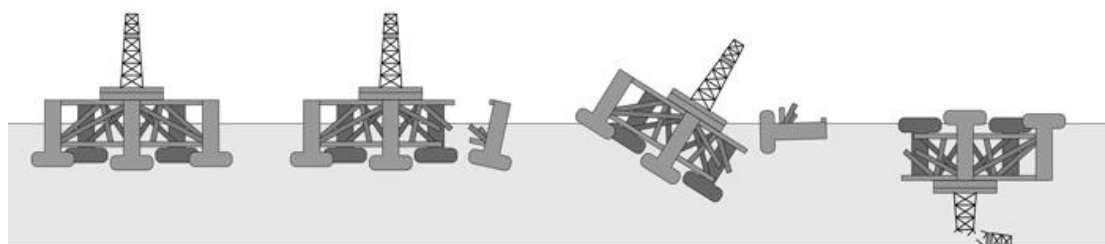
production jacket at the Edda field. The weather conditions were characterized by a wind speed of about 7-8 on the Beaufort scale (16-20 m/s) and significant wave heights of about 6-8m. Shortly before the accident, people witnessed the feeling of a sharp crack and a shivering motion. Five out of six cables that stabilized the platform, ensuring its safety, broke from the seafloor, leaving only one to prevent the Alexander L. Kielland from capsizing. The rig reached a slope of 30°, putting its stability at stake. Many issues emerged during the evacuation procedure as the lifeboats and the overall process proved insufficient due to design deficiencies. The remaining cable prevented the capsize for about 14 minutes and eventually broke, leading to the devastating accident. Out of the 212 people onboard, only 89 managed to survive the accident.

*Figure 70: The sequence of events at the moment of the failure leading to the capsizing of the platform.*
