UNIVERSITY OF THESSALY  
SCHOOL OF ENGINEERING  
DEPARTMENT OF MECHANICAL ENGINEERING

# Failure mechanisms in heat exchangers

Submitted in partial fulfillment of the requirements for the degree of Diploma in  
Mechanical Engineering at the University of Thessaly  
Volos, 2023

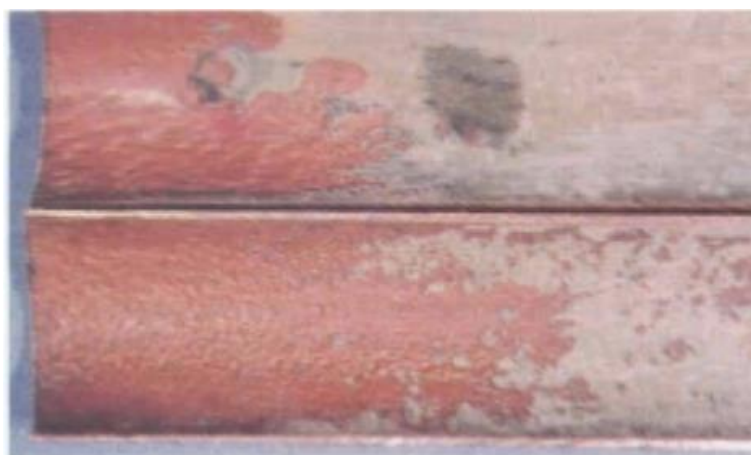
Figure 2-11: Erosion-corrosion attack [39].

We detect this failure mechanism usually below the shell inlet nozzle, inside the U-bend area of tubes, particularly the tighter bends, in the entrance area of tubes, or at the point of contact with baffles and tubes [3]. When tubes contain fluids like inferior crude oil special attention must be given because of the nitrogen and sulfur compounds that crude oil contains. These compounds impose a high risk of failure [40].
