# **Corrosion in Marine Structures**

UNIVERSITY OF THESSALY

DEPARTMENT OF MECHANICAL ENGINEERING

Submitted in partial fulfillment of the requirements for the degree of Diploma  
in Mechanical Engineering at the University of Thessaly

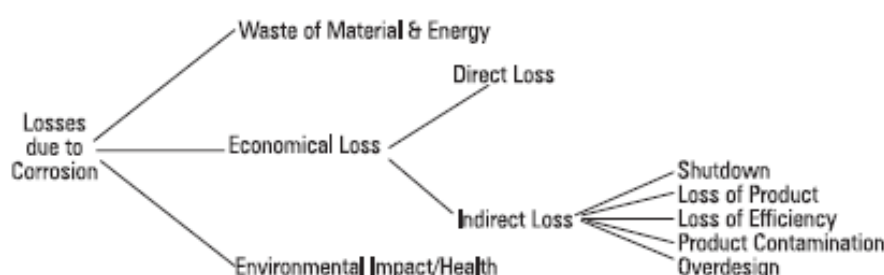
Figure 1. 1 Classification of Corrosion losses

The consequences of corrosion are various, and they have a large extent, so research into its mechanisms is critical. Furthermore, a significant amount of metals and alloys (40%) are destroyed annually due to corrosion. These implications can be divided into three aspects, economy, energy saving, and environmental and human safety. [1,2,5]

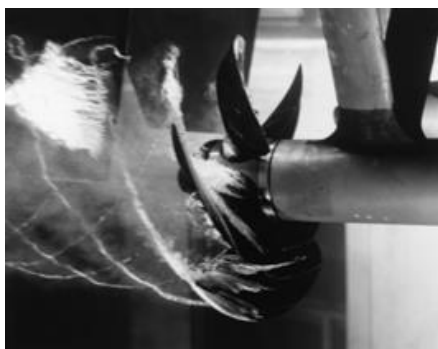
*Figure 2. 7 Bubbles formed at the edges of the propeller, where the velocity is highest.*

Lastly, at high flow rates, when the fluid passes through areas of low pressure, bubbles, and cavities are generated and collapse with the rise of the pressure. The shape of some marine applications causes the acceleration of the fluid's velocity and consequently, creates a local reduction of the pressure (Figure 2.7). The bubble collapse is capable of the destruction of the oxidation film of the material. This phenomenon is cavitation, and it is a form of erosion-corrosion that is a serious threat to the marine industry. [16]

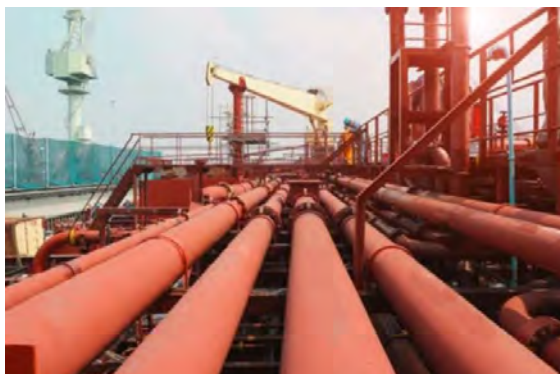
*Figure 3. 3 Exterior piping and fittings*

- The superstructure which is the additional construction to the upper deck and is where the bridge is located as well as the accommodations. (Figure 3.3) This

- Pipes and fittings from water ballast tanks, oil tanks, and ventilation pipes, which are located outside, at the upper deck (Figure 3.3), are liable to corrosion. They are mainly manufactured by copper-nickel alloys and carbon steel. If they are severely corroded, seawater might permeate into the tanks and contaminate the fuel, damage the tanks, and even afflict the ship's stability [35].

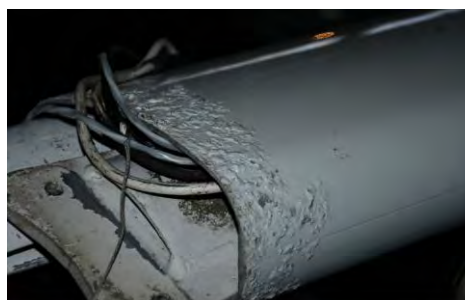
Figure 3. 5 Galvanic Corrosion on a mast that appears as bubbles.

- Rigging for sailing vessels which includes mast and ropes are structures that support the sails. Masts are made from aluminum and the most frequent form of corrosion that occurs is galvanic due to their contact with steel brackets and fittings on the base. Galvanic corrosion is enhanced by the presence of sea spray and the salinity of the marine atmosphere [38]. (Figure 3.5)

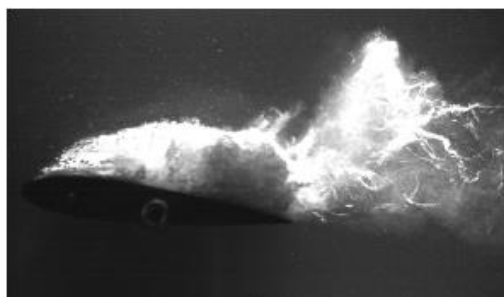
*Figure 3. 23 Sheet and Cloud Cavitation on a Hydrofoil*

As the phenomenon evolves, breakage under stable sheet cavities might be developed. Particularly, a re-entrant jet that flows from the trailing edge to the front end of a sheet cavity causes it to collapse. As a result, the sheet cavity sheds near its leading edge and is hurled downstream as a cloud or mist of small bubbles and it is called cloud cavitation. (Figure 3.22) It is a highly unstable and dangerous form of damage since it provokes noise and oscillations to the flow which cause a vast degradation of the solid material. [45], [44].

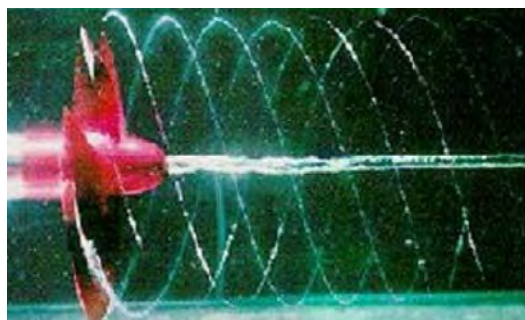
Figure 3. 24 Tip vortex cavitation on a propeller.

Lastly, vortex types of cavitation are evident at the leading edge of the propeller blade, the tip of the blade, and the boss or hub of the propeller. They are mainly provoked due to the low pressure in the areas where the vortices shed. The primary form that is the first to appear is tip or hub vortex cavitation which is developed due to the high water flow angle relative to the propeller blade. It deforms the edge of the blade and deteriorates the dynamic performance of the propeller, affecting the thrust, the load distribution, and producing oscillation. Sometimes, vortices tend to collapse on the tip

of the blade, causing serious erosion damage and pitting (Figure 3.23). Also, vortex cavitation generates noise which was often used to detect the location of the ships. [42], [43], [44]

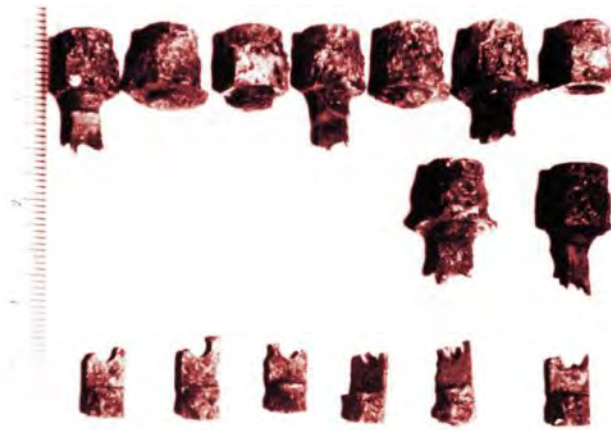
Figure 3. 26 Remains of iron bolts used in the 1763 frigate incident

The first technical report, submitted in 1763, that galvanic corrosion appeared to have provoked problems to a vessel concerned the English frigate “Alarm”. This frigate had been reinforced with copper so that the wood on the vessel was not polluted by shipworms. The copper plates attached to the ship were fixed with iron nails and after two years of the ship sailing, during the maintenance period, it was discovered that most of the copper placed had been lost. Further investigation showed that the iron nails used were corroded and caused the detachment of the copper plates which led to the conclusion that direct contact between copper and iron should be avoided in seawater environments [54]. In Figure 3.24 the remains of the iron bolts used in the frigate are shown with corrosion damage being obvious.

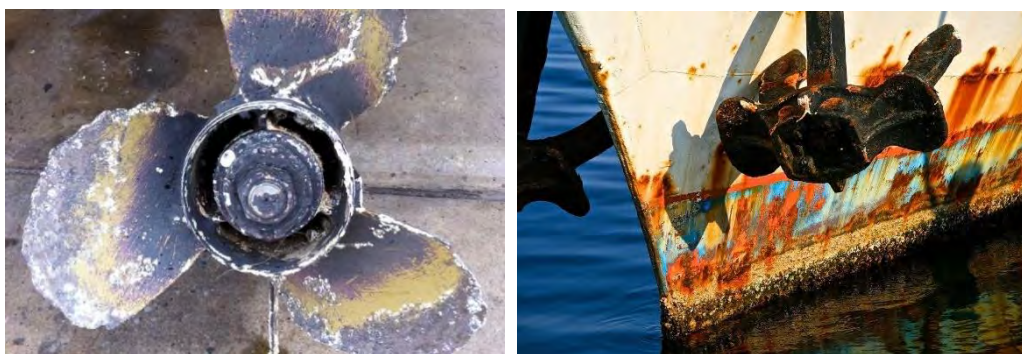
Figure 3. 30 (a) Galvanic corrosion on ship propeller, (b) Galvanic corrosion caused by metallic paint

The primary ship components affected by galvanic corrosion are the hull of the ship where usually different metal components attach like aluminum or bronze. Moreover, the Hull is constantly in touch with seawater (the conductive mean). Another typical area where galvanic corrosion appears is on the ship propellers which are typically made of bronze and come in contact with steel shafts. Furthermore, fasteners and fittings which were discussed before are common galvanic corrosion instances because they are used for the bonding of different materials, causing galvanic reactions. Last but not least, the paint used in ships causes big problems with galvanic corrosion and is one of the main maintenance concerns for vessels.

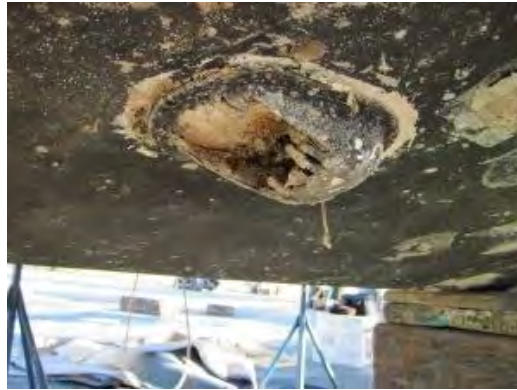
*Figure 3. 31 Bronze intake strainer destroyed from galvanic corrosion.*

To sum up, galvanic corrosion is a big failure factor that should be taken into consideration by marine engineers when designing marine structures or health monitoring of already built structures [58]. Figure 3.29 is one common example of galvanic corrosion of a bronze intake strainer on a steel boat that has been destroyed from galvanic corrosion.

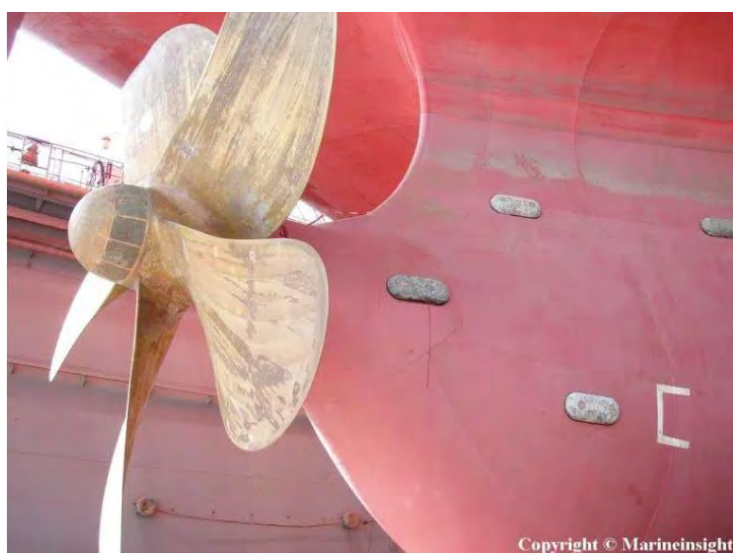
Figure 4. 2 Bronze intake strainer destroyed from galvanic corrosion.

Sacrificial anodes are normally fastened to the ship's hull with bolts or welds. The anodes are positioned on the hull at key points, like the waterline, the vicinity of the propeller, and the bilge, where corrosion is most prone to happen. (Figure 4.2)

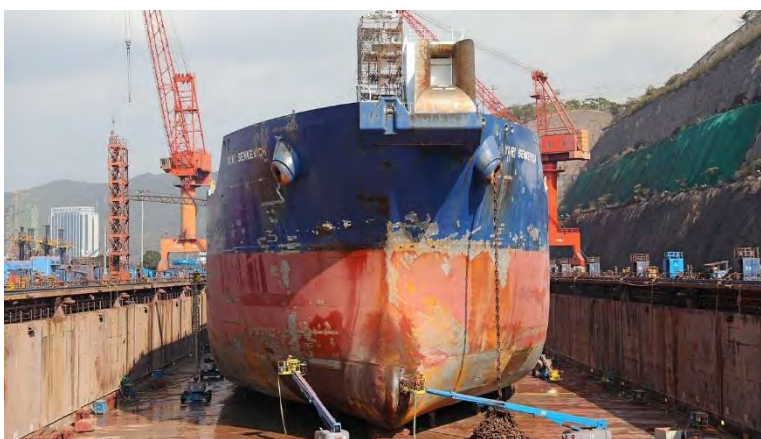
*Figure 4. 3 Large Vessel during maintenance of sacrificial anodes*

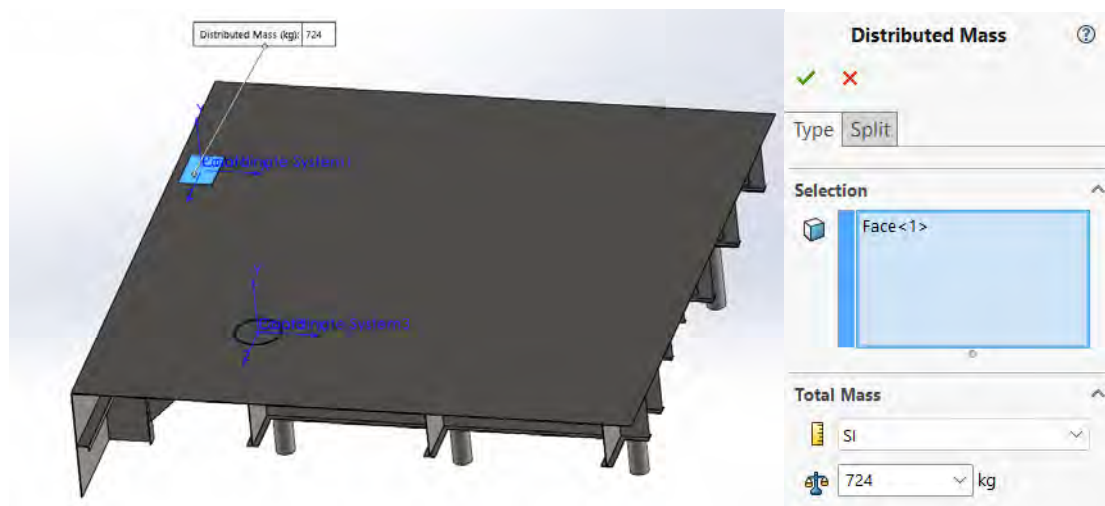
Figure 5.18 Weight distribution on the deck-mounted chock

Furthermore, distributed mass was applied according to the given weight of the chock and the roller (Figure 5.16 and Figure 5.17).
