# Corrosion-induced Hydrogen Embrittlement in High-Strength Al-Alloys

THESIS

Submitted in partial fulfillment of the requirements for the degree of  
Doctor of Philosophy in Mechanical Engineering  
of the Department of Mechanical and Industrial Engineering  
University of Thessaly

**Helen Kamoutsi**  
Dipl. Mechanical Engineer,  
University of Thessaly

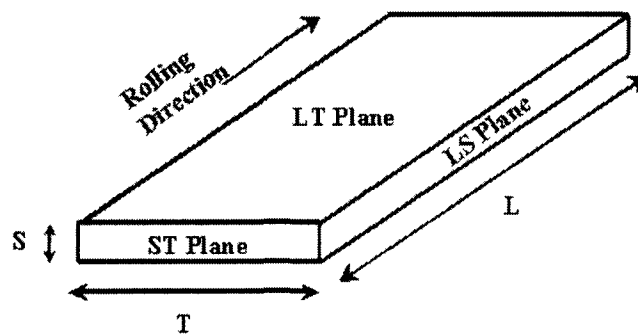
Fig. 3. 1: Labelling scheme used for directions and planes.

The labeling scheme used to identify the orientations and planes of the alloys is shown in Fig. 3. 1.

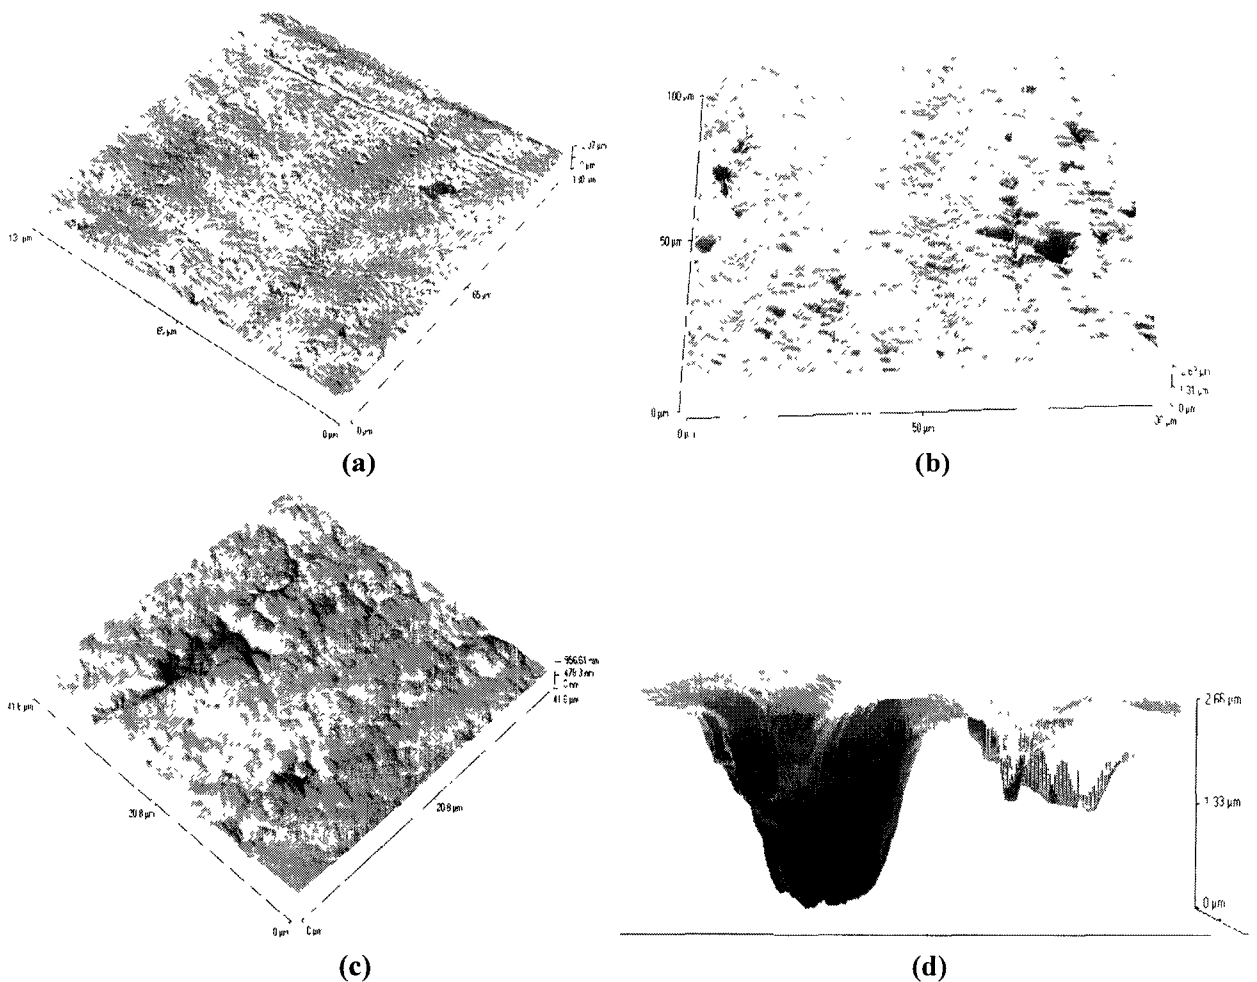
Fig. 4. 11: Alloy 2024-T3 (LT plane), for 2 hours in the corrosive solution EXCO (a), (b), (c) and (d).

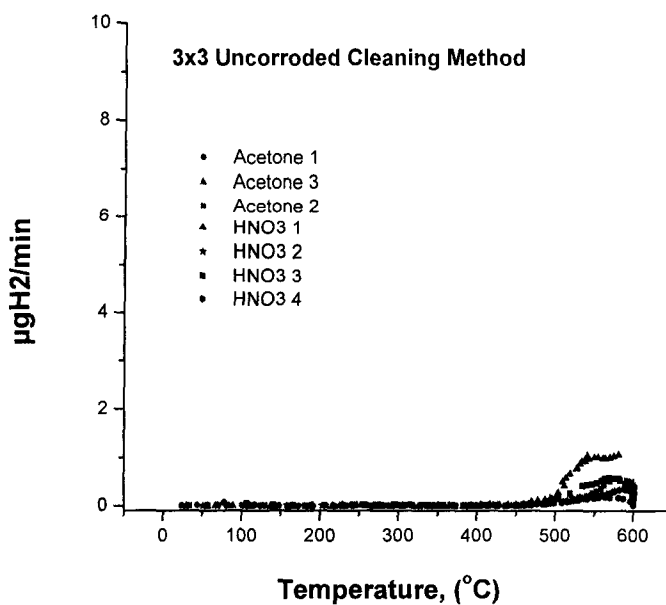
Fig. 4. 30: Hydrogen in Uncorroded Specimen of 3mm (b).

The remaining candidate cleaning method A was further tested for possible interference with hydrogen uptake. Thus, multiple uncorroded specimens were measured for hydrogen, some of them as received, others just washed with acetone and others cleaned according to method A. The results proved totally insensitive to the treatment, as indicated from the representative data of Fig. 4. 30. Based on the above assessment, method A was used in the rest of the present investigation.

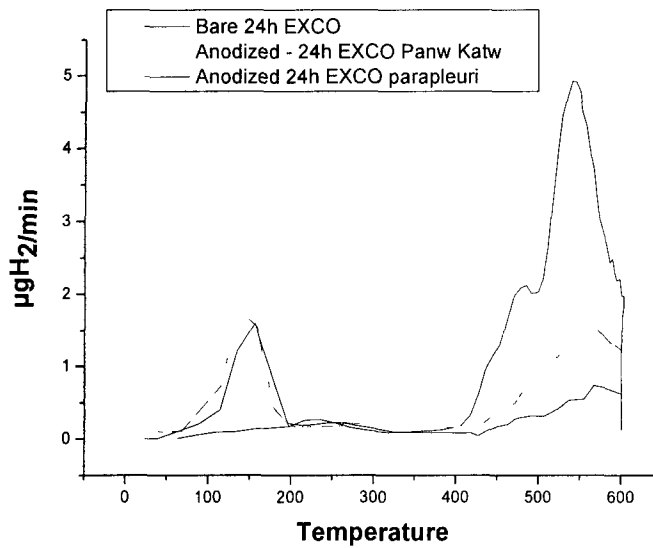
Fig. 4. 47: Effect of anodizing in the side surface of specimen that have suffered corrosion for 24 hours.

Hydrogen measurements in partly anodized specimens showed that hydrogen uptake decreases with respect to non-anodized material. In particular, Fig. 4. 47 compares hydrogen evolution spectra from three specimens, one of which is bare, the other has anodized rolling surfaces and the last has anodized rolling surfaces plus 50% of the side surface. The gradual reduction of measured hydrogen with the percent of surface covered indicates that anodizing is not as efficient as Al-cladding in the protection of partly bare specimens. However, the reduction of measured hydrogen in the specimen with covered rolling surfaces is larger than expected from the relative contributions of rolling and side surfaces of bare material (as discussed in the previous paragraph). Thus, anodizing also appears to offer some synergistic effect, possibly of electrochemical nature.
