Corrosion-induced Hydrogen Embrittlement in High-Strength Al-Alloys

THESIS

Submitted in partial fulfillment of the requirements for the degree of
Doctor of Philosophy in Mechanical Engineering
of the Department of Mechanical and Industrial Engineering
University of Thessaly

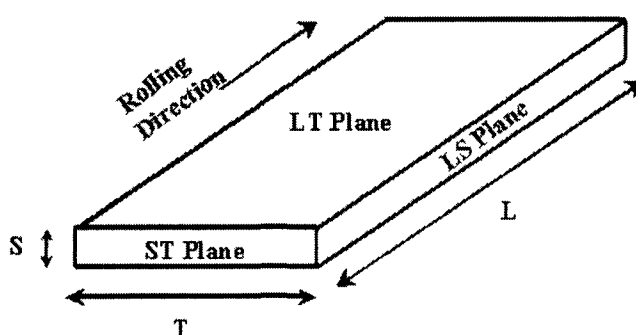
Fig. 3. 1: Labelling scheme used for directions and planes.

The labeling scheme used to identify the orientations and planes of the alloys is shown in Fig. 3. 1.

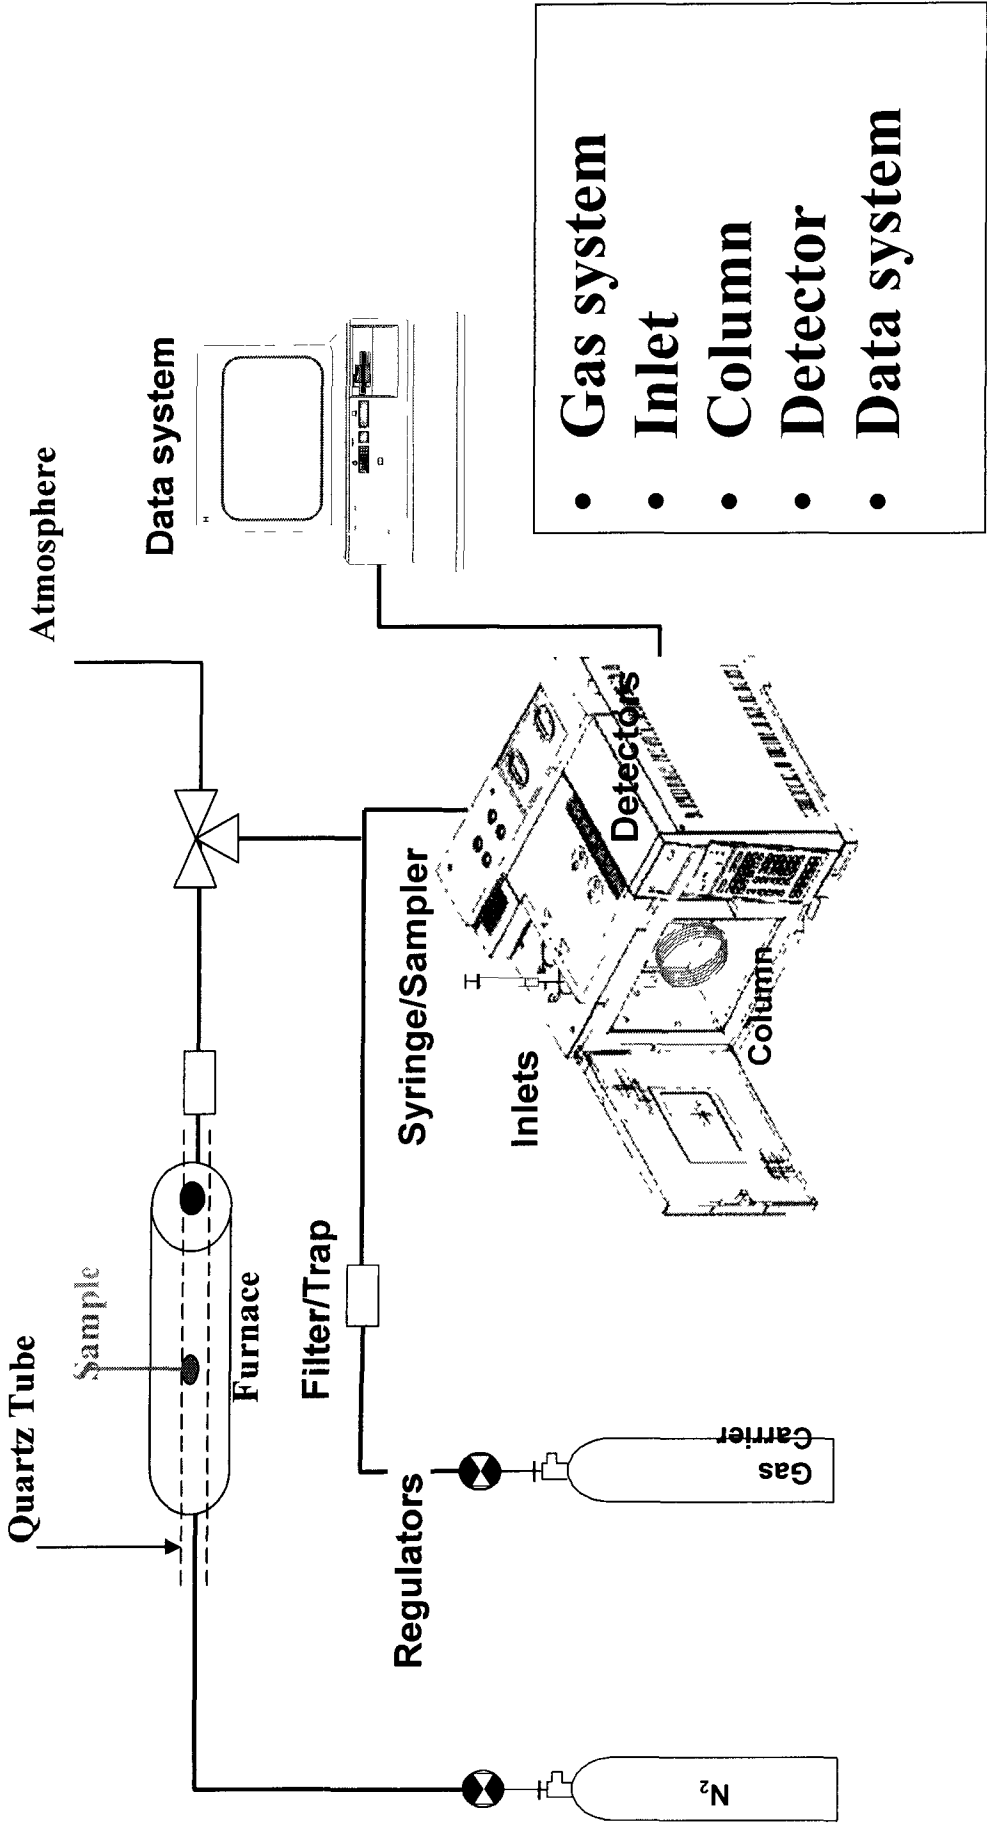
Fig. 3. 2: Gas Chromatography experimental setup.

For the determination of hydrogen quantity trapped in the material's microstructure an in-house experimental setup was used. This setup consists of a furnace with a system of automatic temperature control, a supply of inert gas (high-purity nitrogen) and a gas chromatograph equipped with a valve for sampling gases as is shown in Fig. 3. 2. The sample was placed in a 10 mm diameter quartz tube and held in place by an inert porous diaphragm, permeable to the gas (quartz wool). The tube was inserted in the furnace and subjected throughout the experiment to a flow of $Q=20\text{ml/min}$ high purity nitrogen. This flow was then driven to a gas chromatograph equipped with a TCD detector. Calibration runs were performed using standard $\text{H}_2 - \text{N}_2$ mixtures, of volume concentration 1000 and 10000 ppm. Blind experiments were conducted with an empty tube heated up to 600°C and no hydrogen was detected. The temperature of furnace was increased at a rate of approximately 5°C/min and the nitrogen current swept along everything that was emitted by the sample and carried it in the gas chromatograph. The sampling was performed manually through the gas-sampling valve about every 2 minutes.

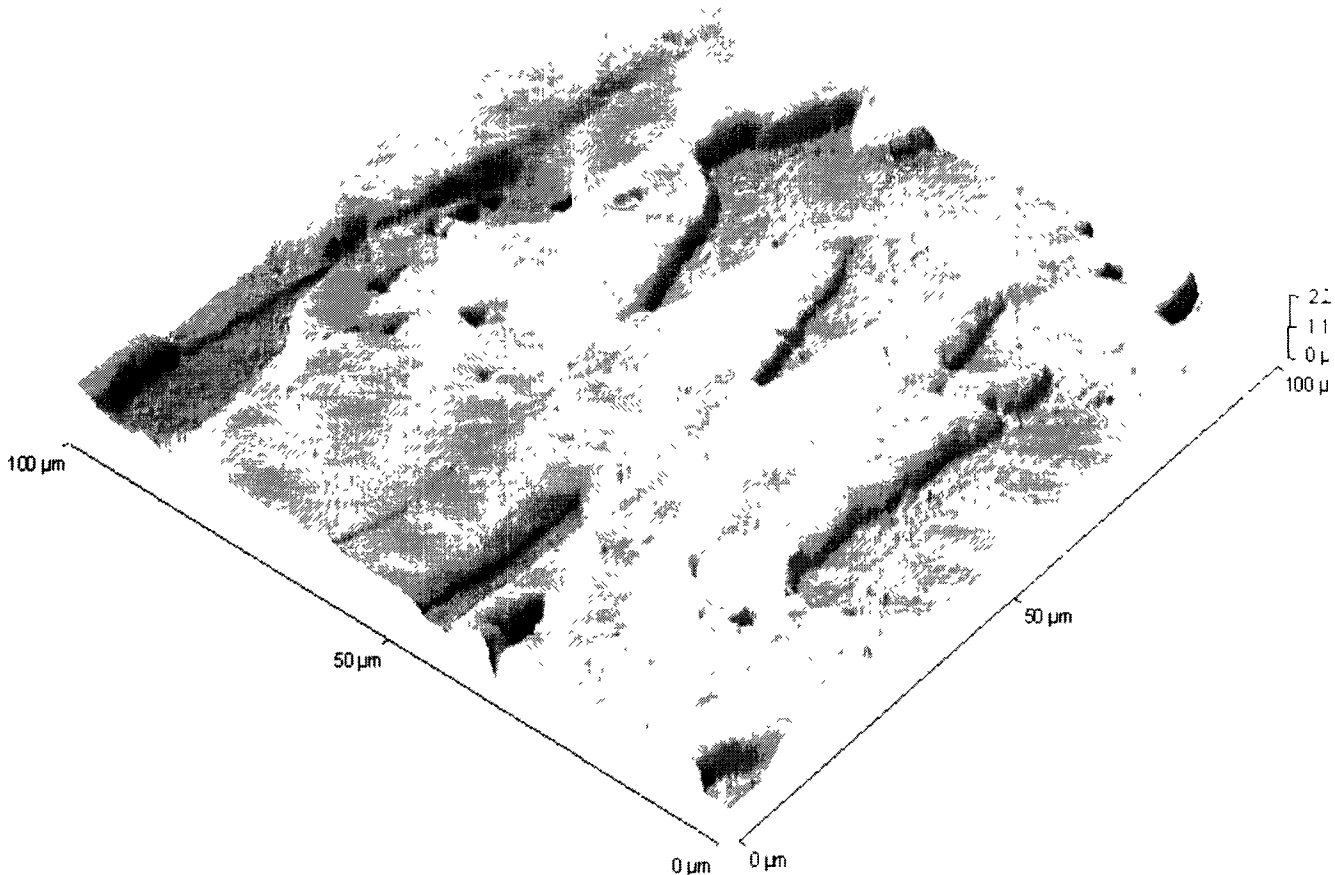
Fig. 4. 1: Tree-dimentional depiction of alloy 2024-T3microstructure (LS plane).

A representative 3D surface topography of uncorroded but metallographically prepared (ground, polished and etched) 2024-T3 is shown in Fig. 4. 1, which depicts the LS plane of the plate in a 100x100 μm scan. The grain structure is made evident by the selective attack of grains (due to different orientation) from the Keller's reagent used for etching. Voids are also present at the grain boundaries or inside the grains. They are formed probably due to the removal of inclusions or second-phase particles during specimen preparation. In order to characterize these voids, a line profiling technique was used. Fig. 4. 2 depicts a 2D image of the surface and the position of two line scans. These scans are presented in Fig. 4. 2a and Fig. 4. 2b respectively. The line scans are obtained by moving the AFM tip selectively over the prescribed path while measurements in the z-direction are possible. The line scan in Fig. 4. 2a is over two voids in the grain interior. The voids have lateral dimensions 8x4 μm and depth of the order of 1 μm (800nm), while they possess a level

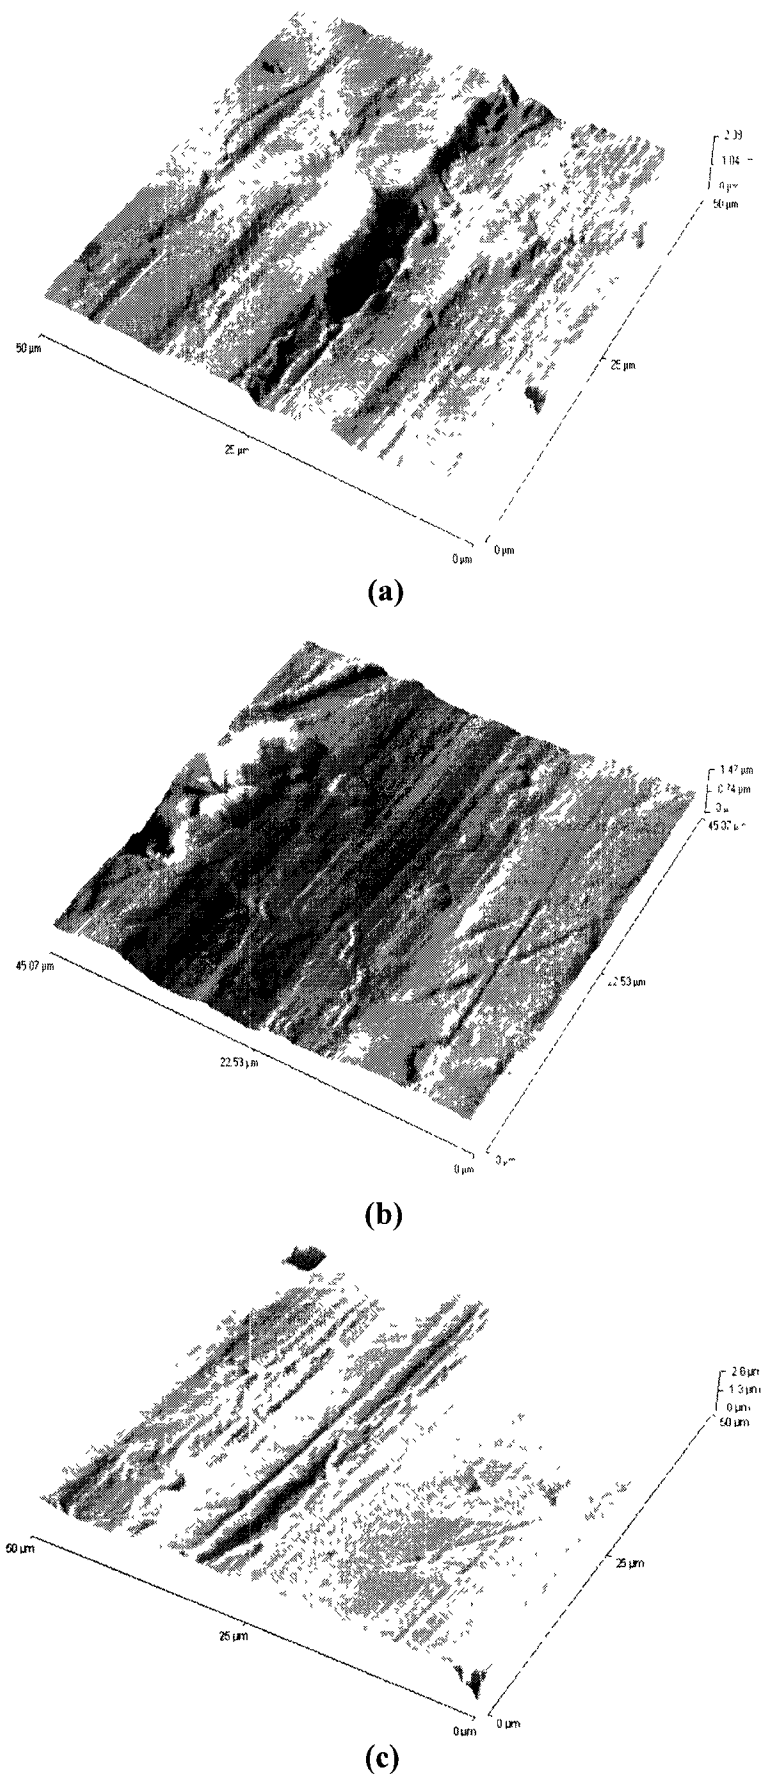
Fig. 4. 3: AFM topographies of as received aluminum alloy 2024 2.4mm LT plane. (a) Through (c).

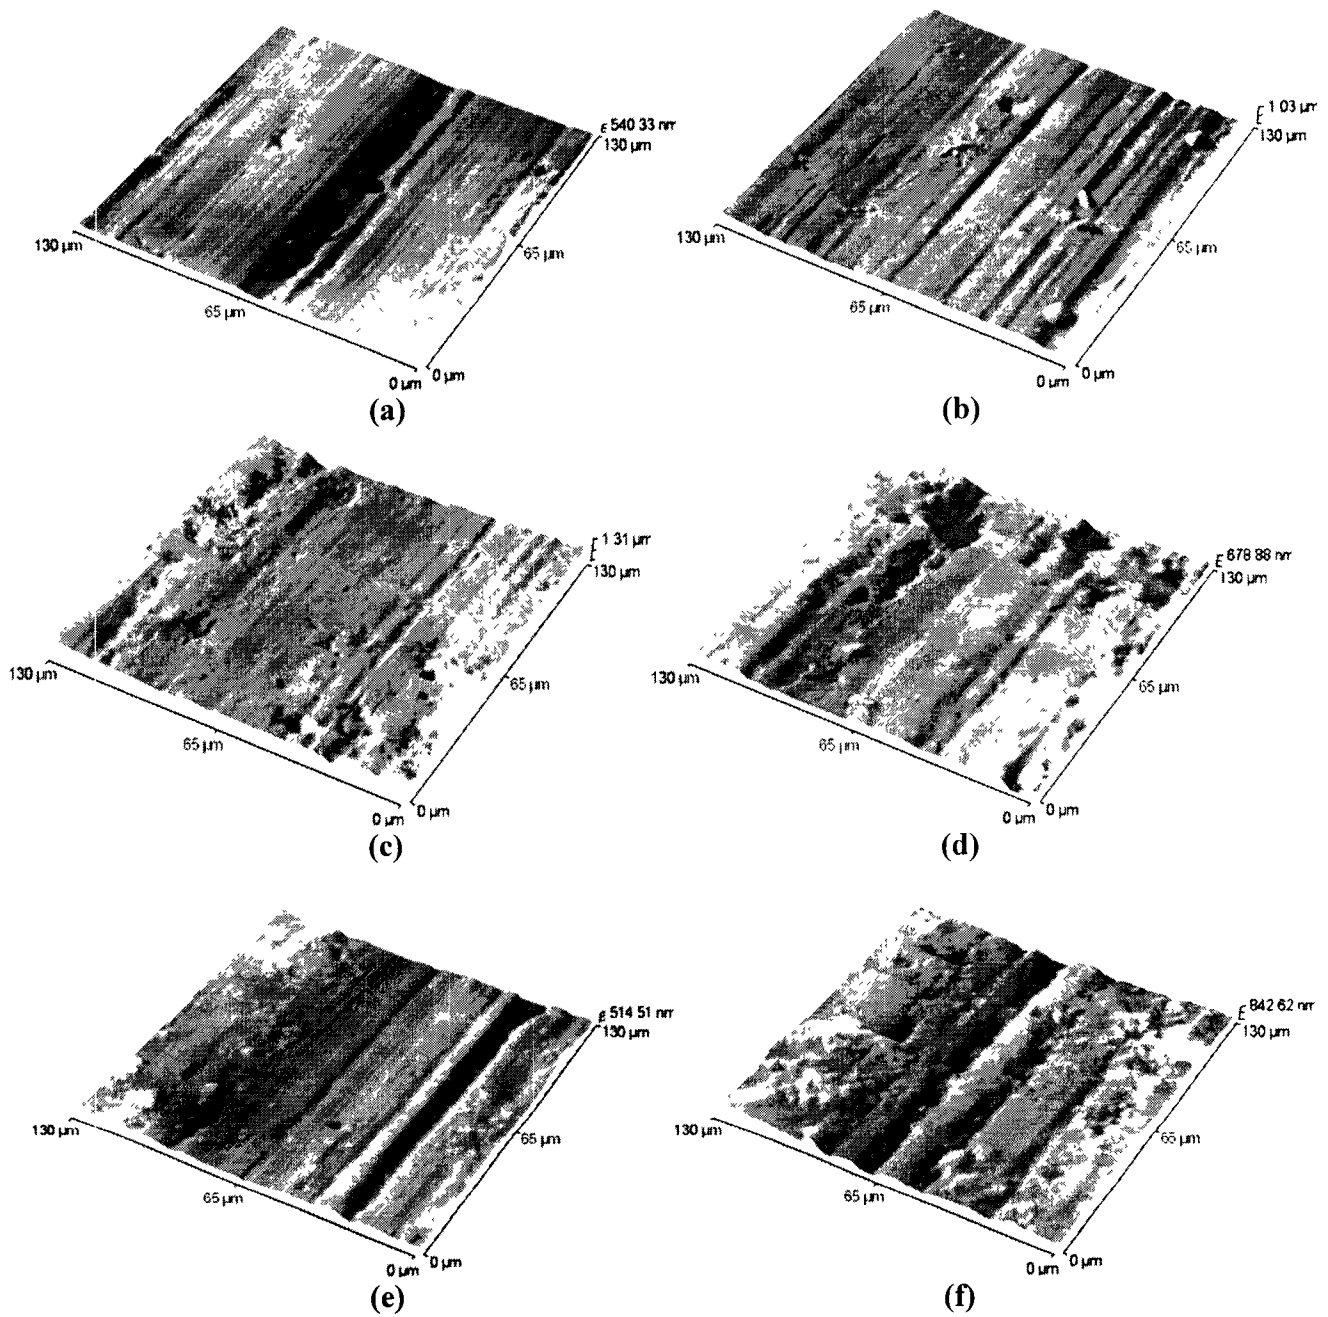
Fig. 4. 4: AFM topographies for the as received aluminum alloy 2024 3mm, LT plane. (a) through (f).

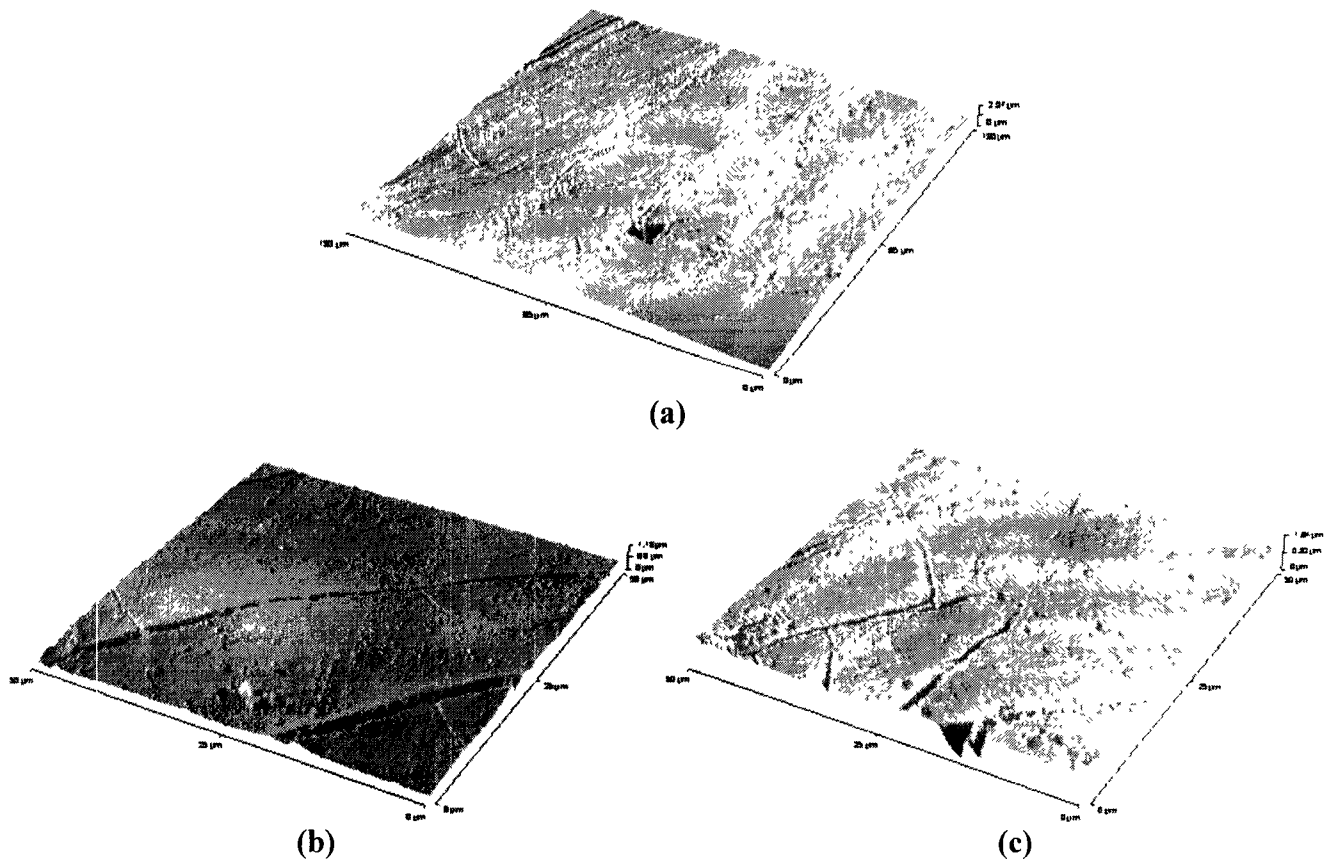
Fig. 4. 6: Alloy 2024-T3 (LT plane), 15min in the corrosive solution EXCO

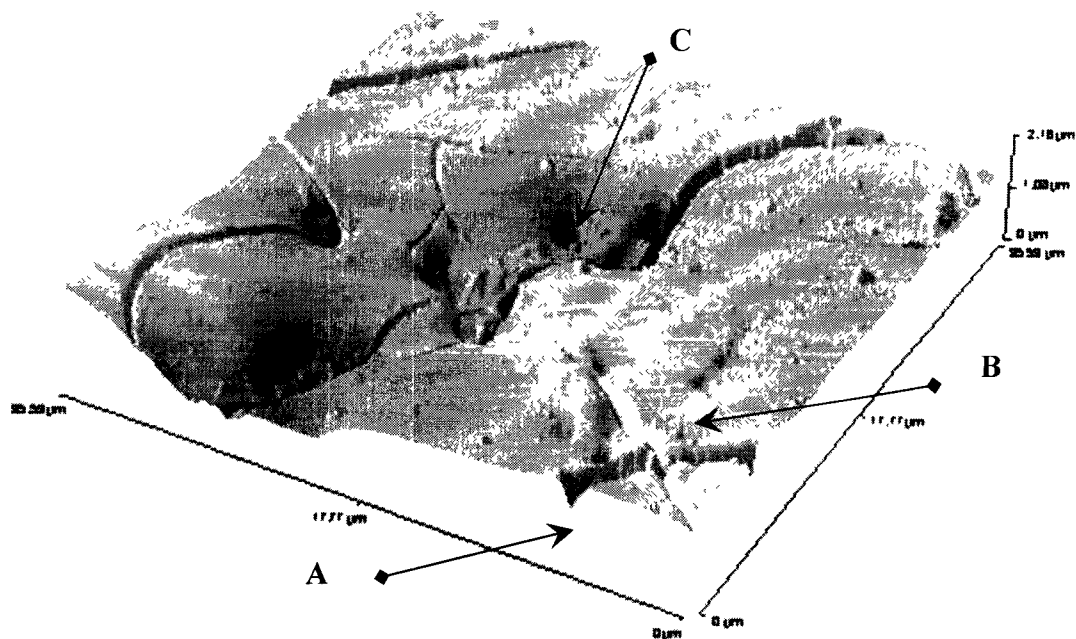
Fig. 4. 8: Alloy 2024-T3 (LT plane), 15min in the corrosive solution EXCO. 3D depiction of corrosion, Initiation of pitting (arrow C) corrosion (50x50μm).

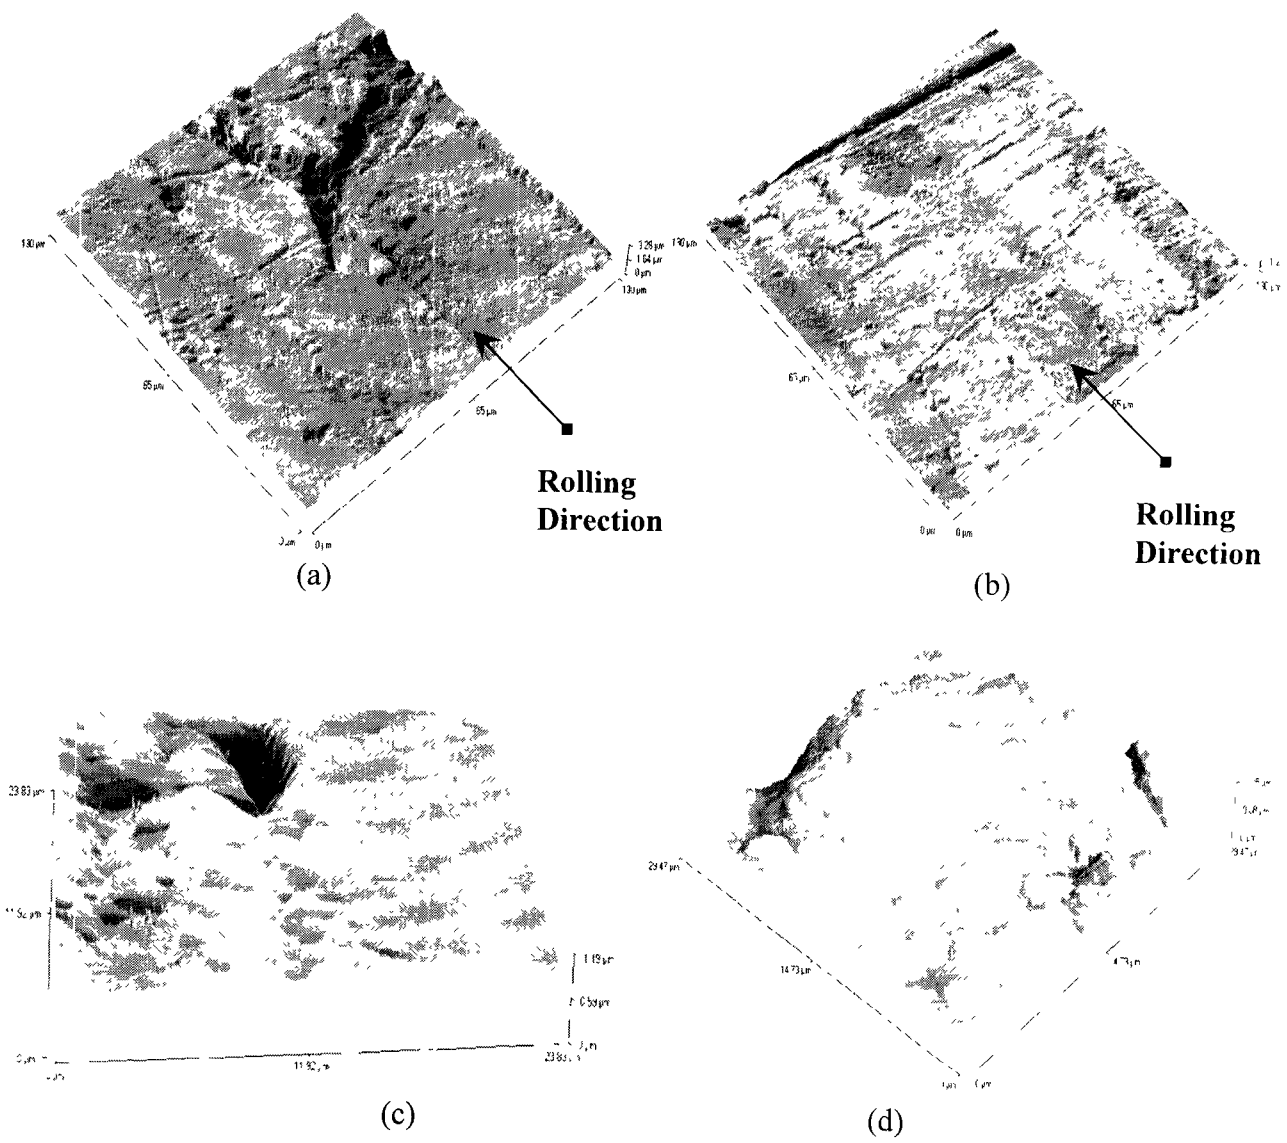
Fig. 4 9: Alloy 2024-T3 (LT plane), 30min in the EXCO solution (a) and (b) different areas (130x130μm), (c) and (d) magnification of previous topographies (30x30μm).

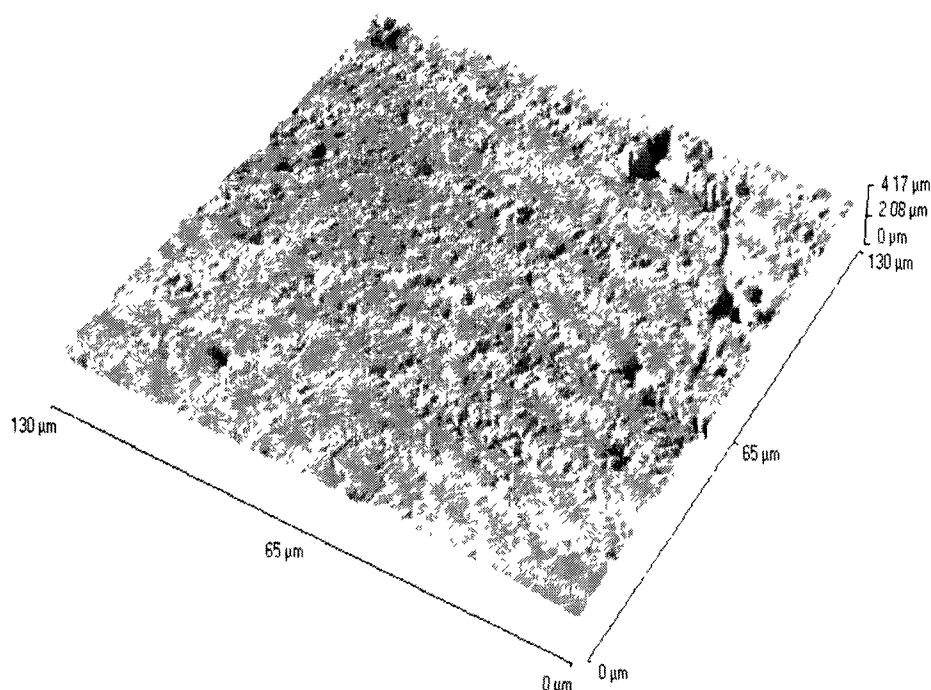
Fig. 4. 12: Alloy 2204-T3 (LT plane), for 4 hours in the corrosive solution EXCO.

After 4 hours exposure the roughness increases again to Ra=207 and RMS=272nm. Pit depth varies from 1 to 3 μ m. Pit clustering and pit-to-pit interaction (Fig. 4. 12) are again visible, signaling the onset of intergranular corrosion.

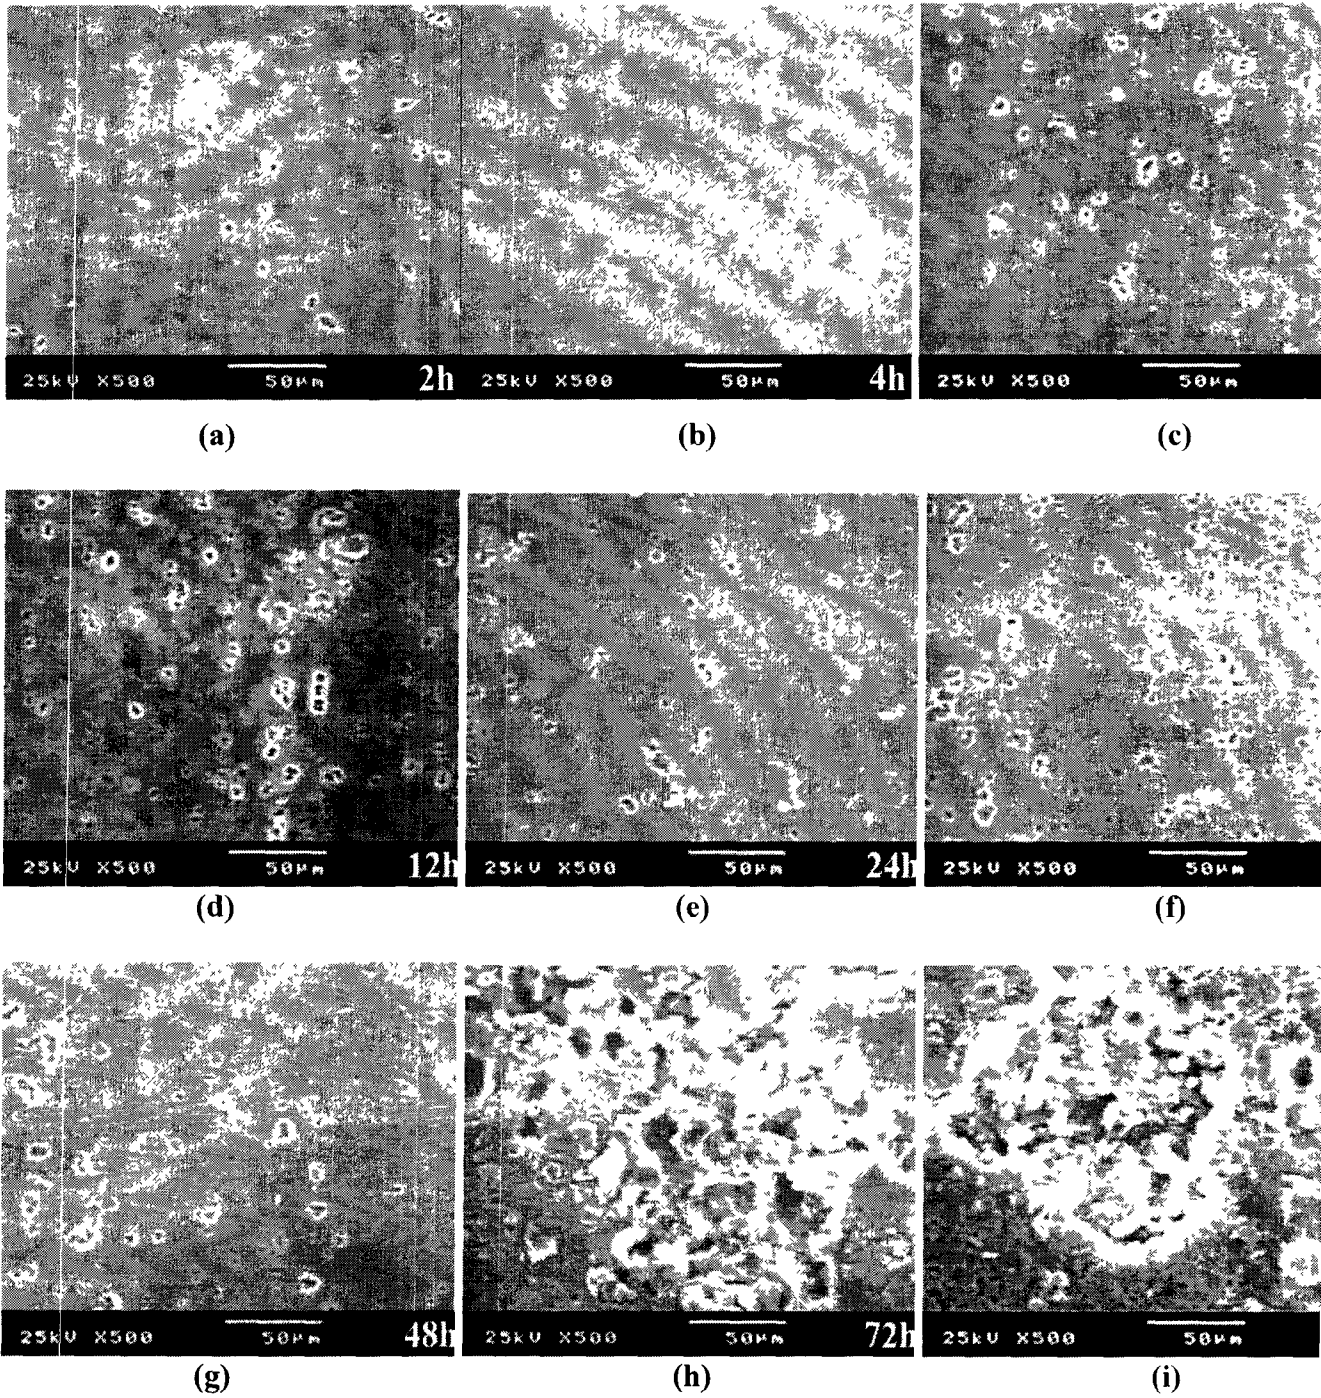
Fig. 4. 14: SEM topographies of Alloy 2024 (LT plane), exposed in EXCO for 2 to 96 hours (details in the text).

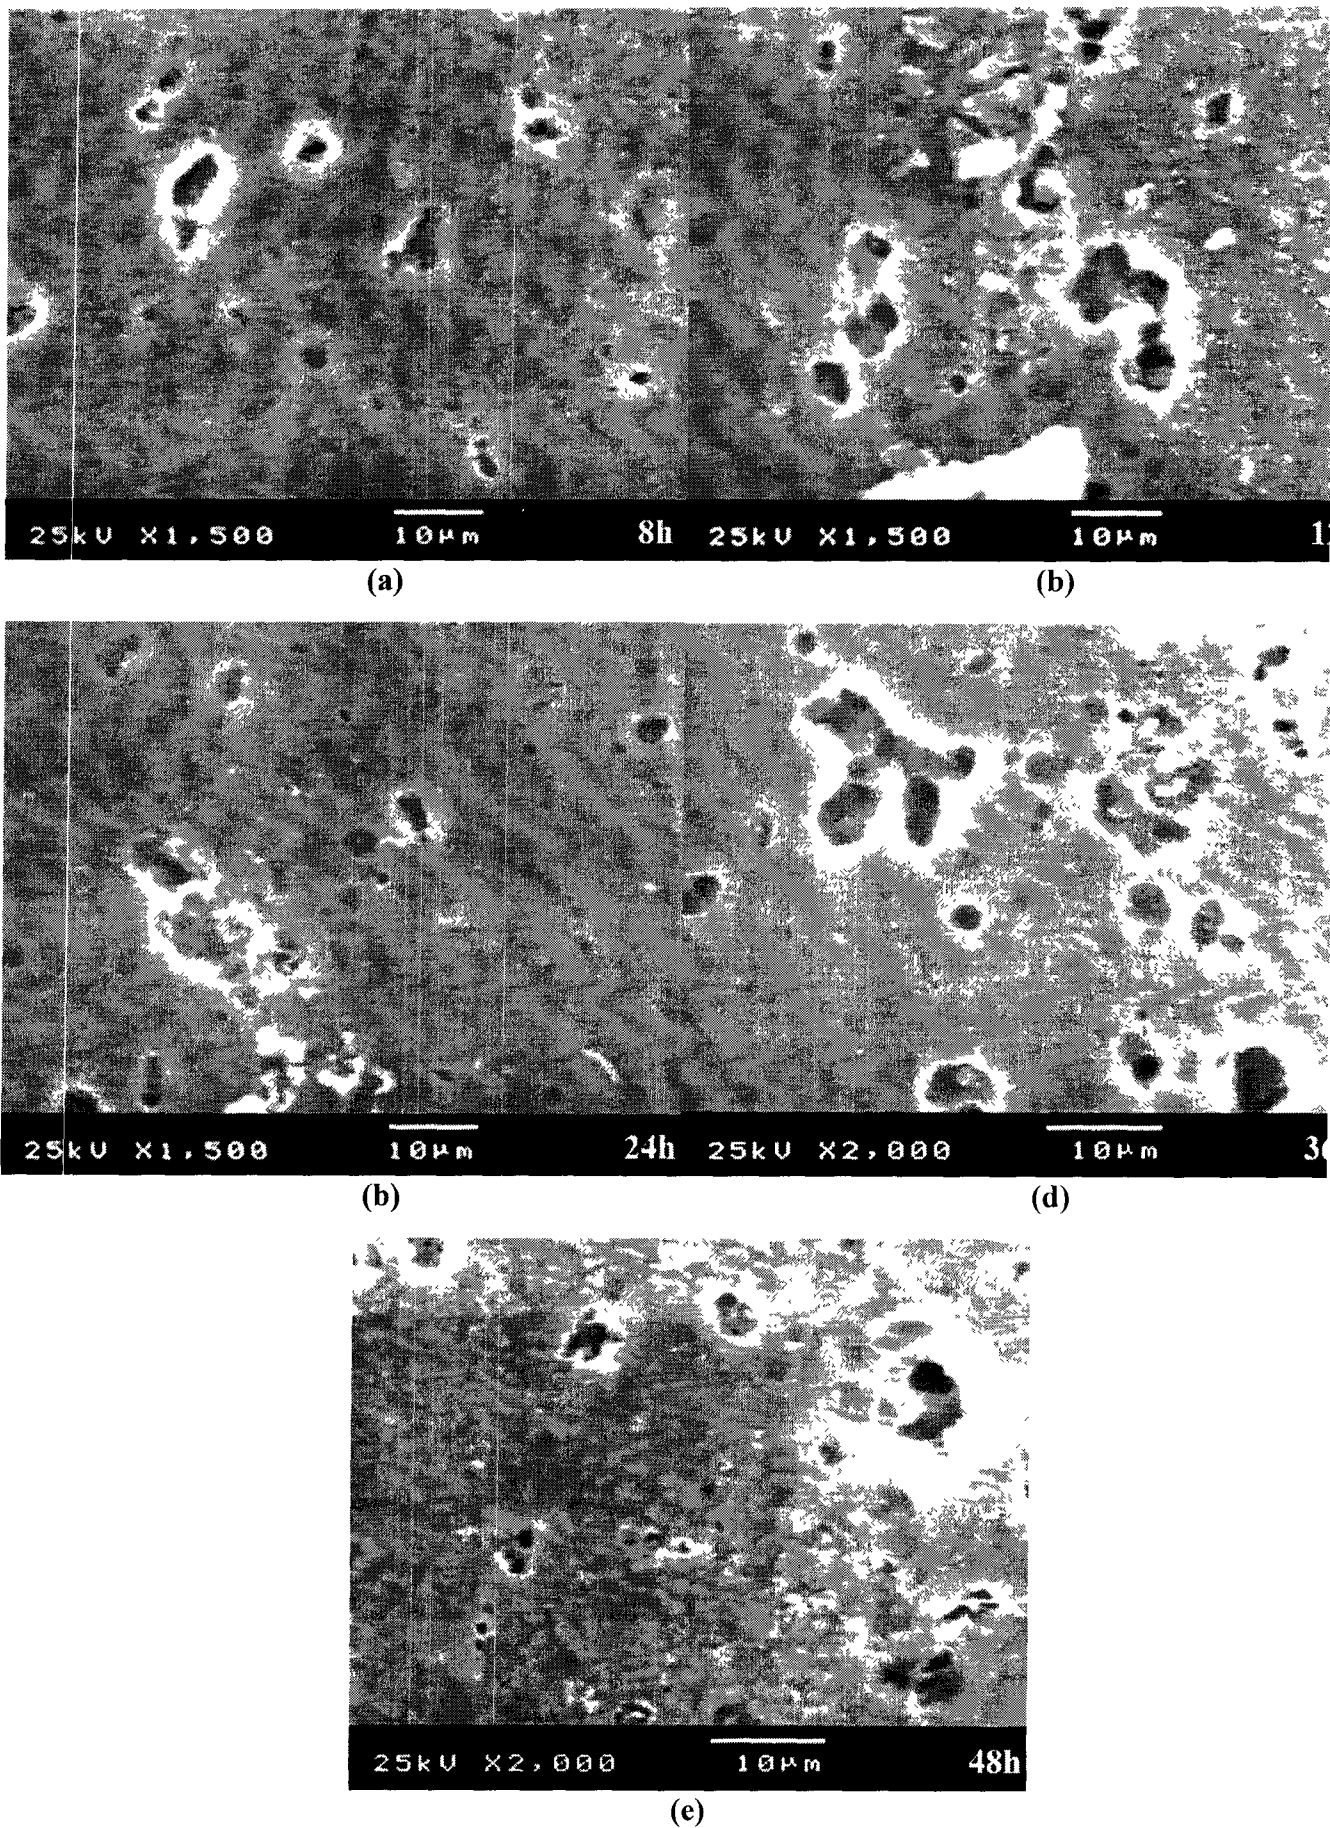
Fig. 4. 15: SEM topographies of Alloy 2024 (LT plane) exhibiting pit-to-pit interactions and pit clustering after exposure in EXCO for the indicated times.

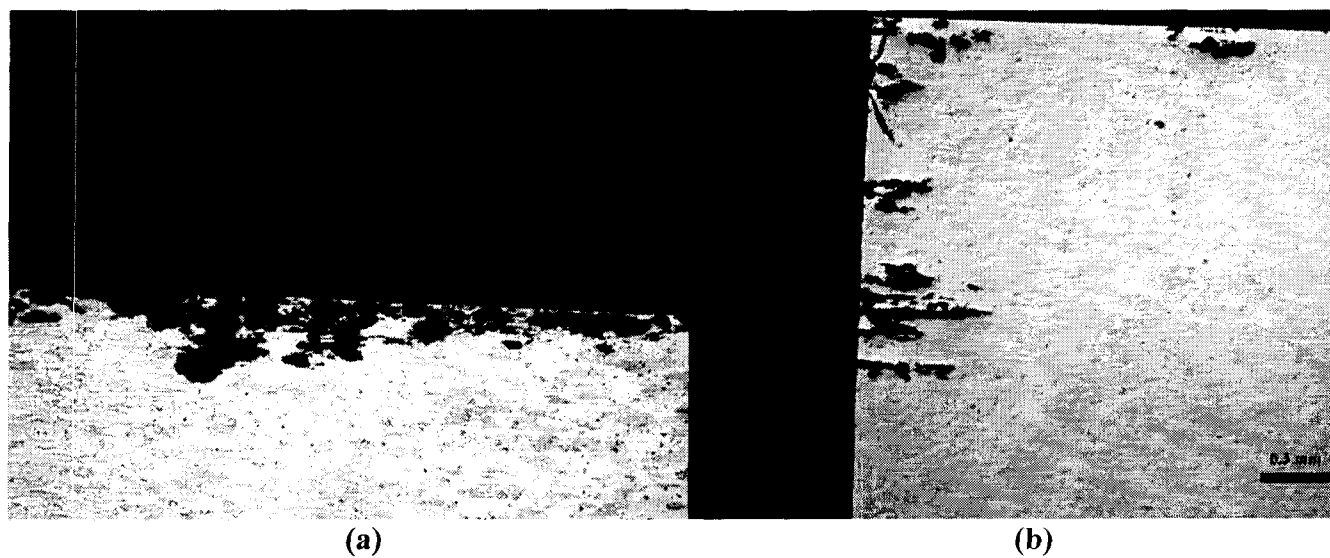
Fig. 4. 20: Alloy 2024, 48 hours EXCO exposure. Spreading of corrosion beneath surface by intergranular corrosion.

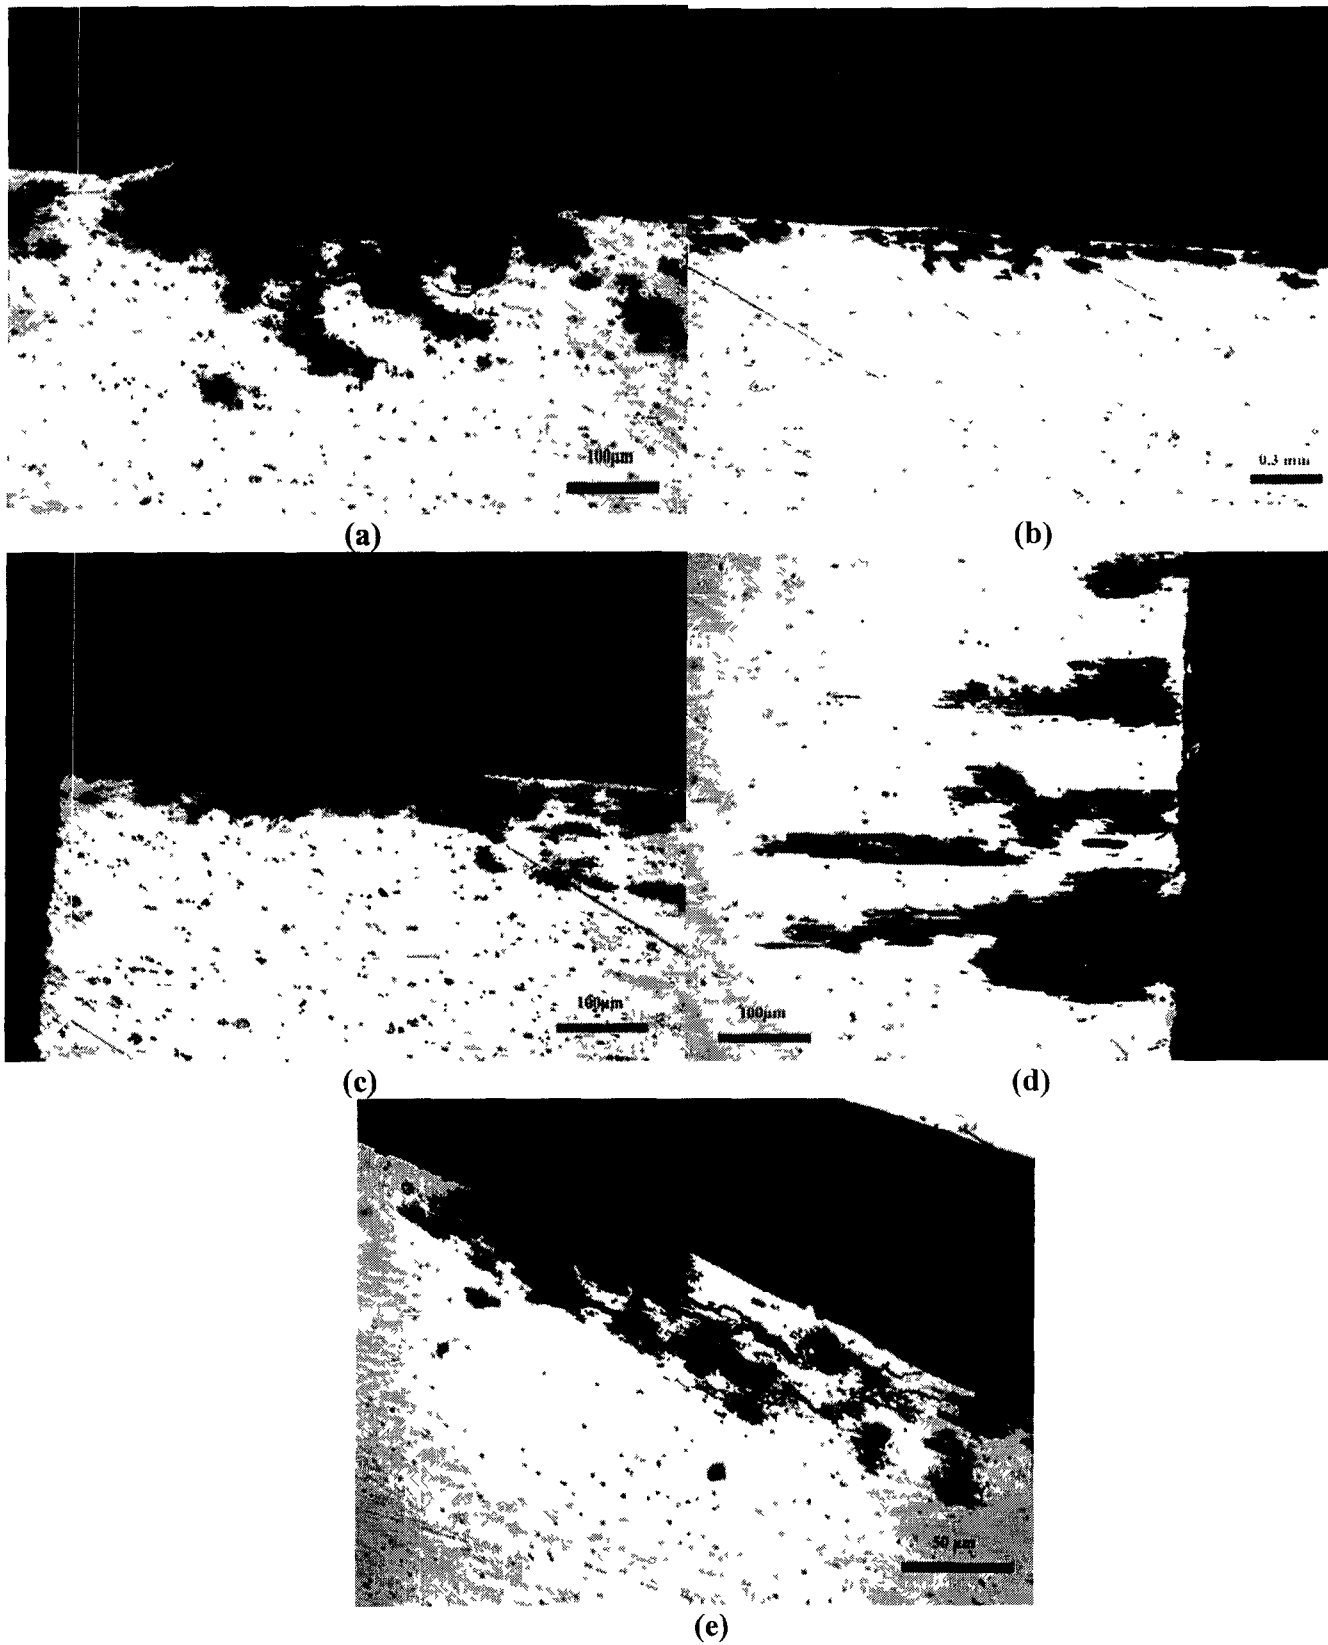
Fig. 4. 21: Alloy 2024, 72 hours EXCO exposure. Spreading of intergranular corrosion and exfoliation.

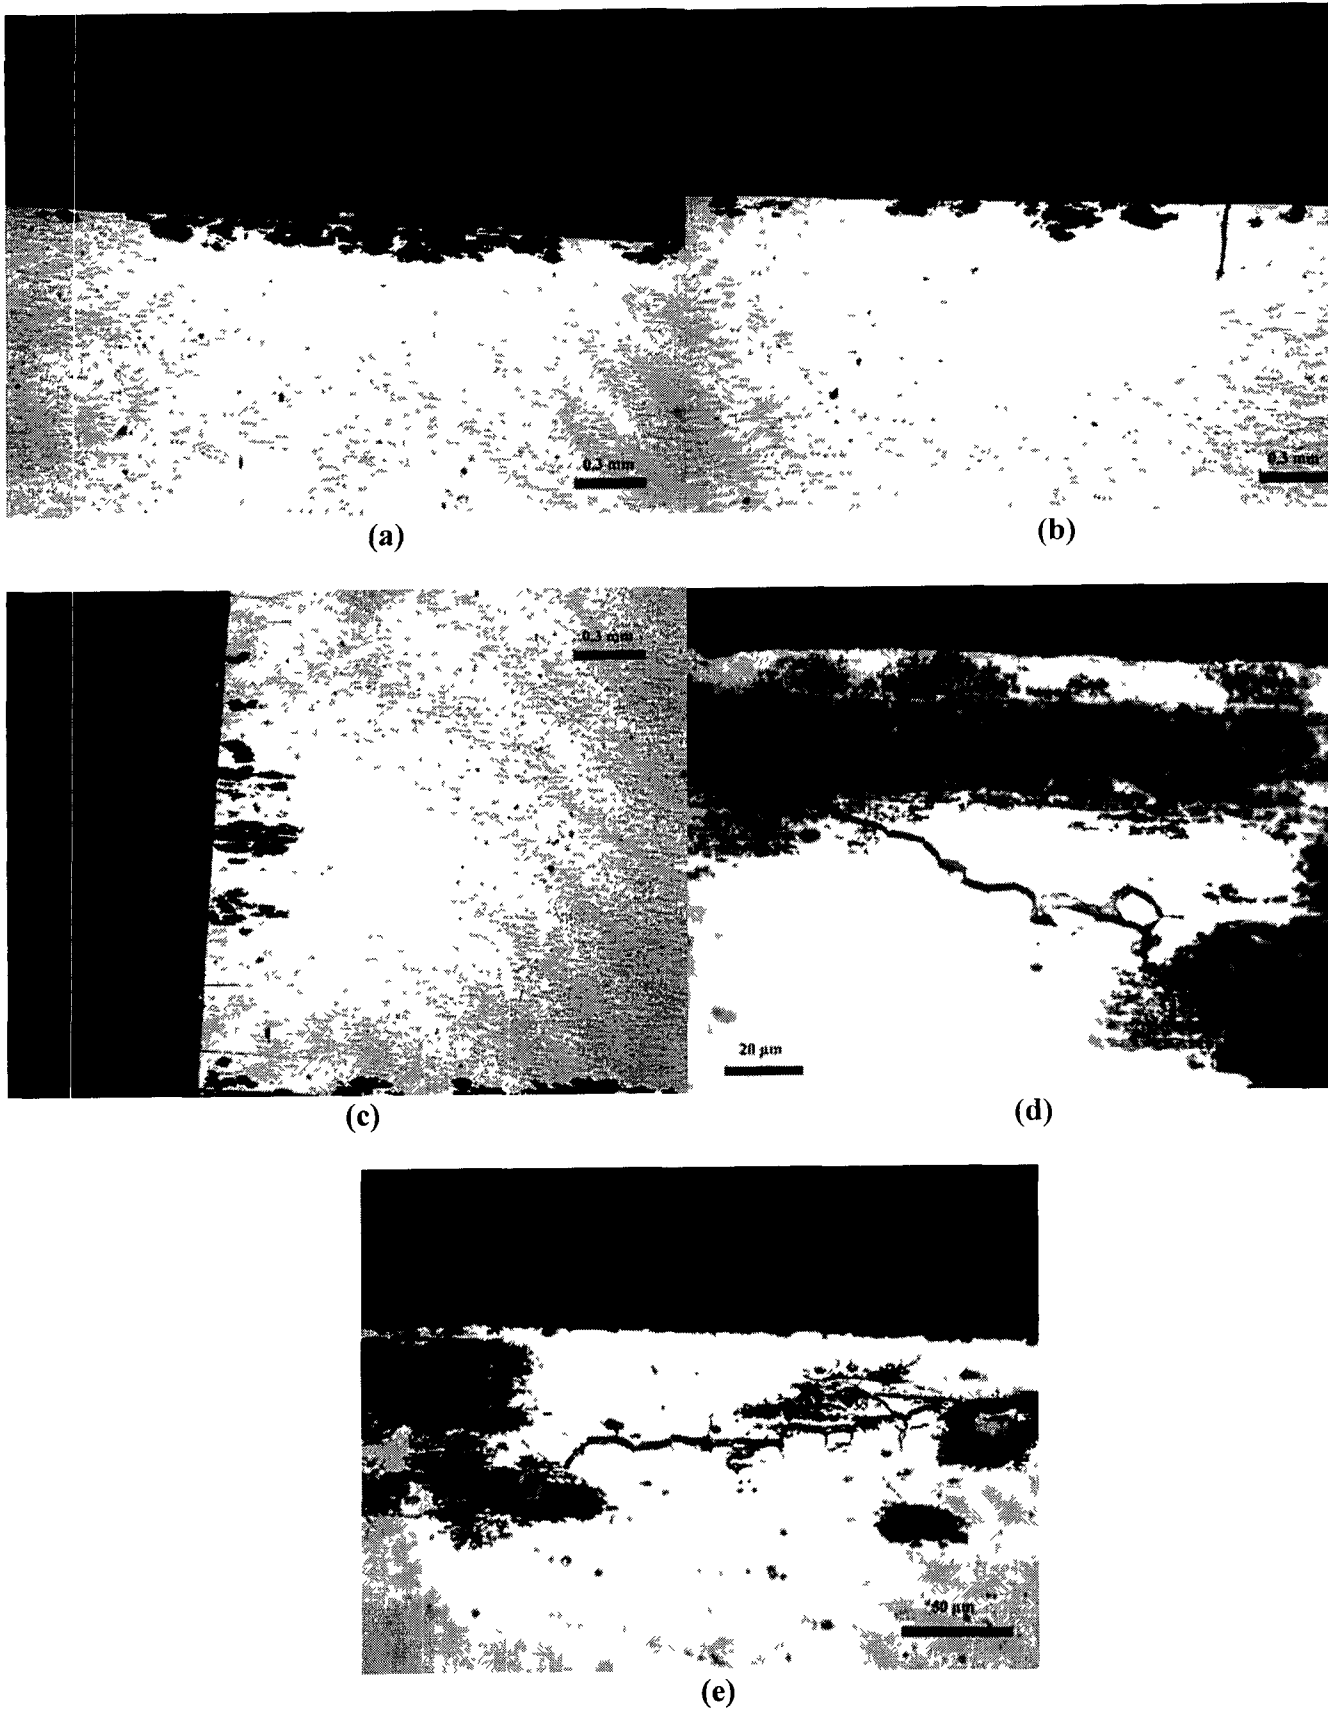
Fig. 4. 22: Alloy 2024, 96 hours EXCO exposure. Spreading of corrosion .Beneath the surface by intergranular corrosion leading to exfoliation.

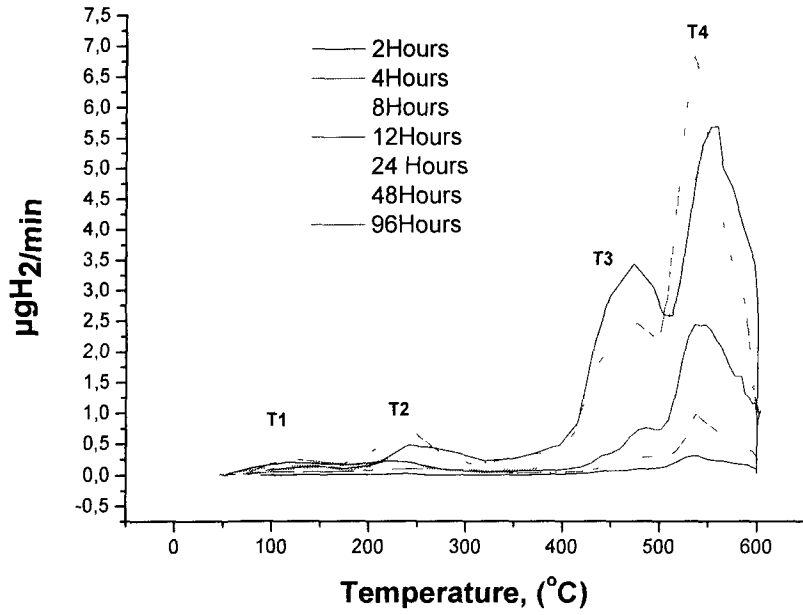
Fig. 4. 23: Desorption of H₂ in specimens of aluminium alloy 2024-T3 for continuous heating up to 600 °C. Thickness of material 1,8 mm.

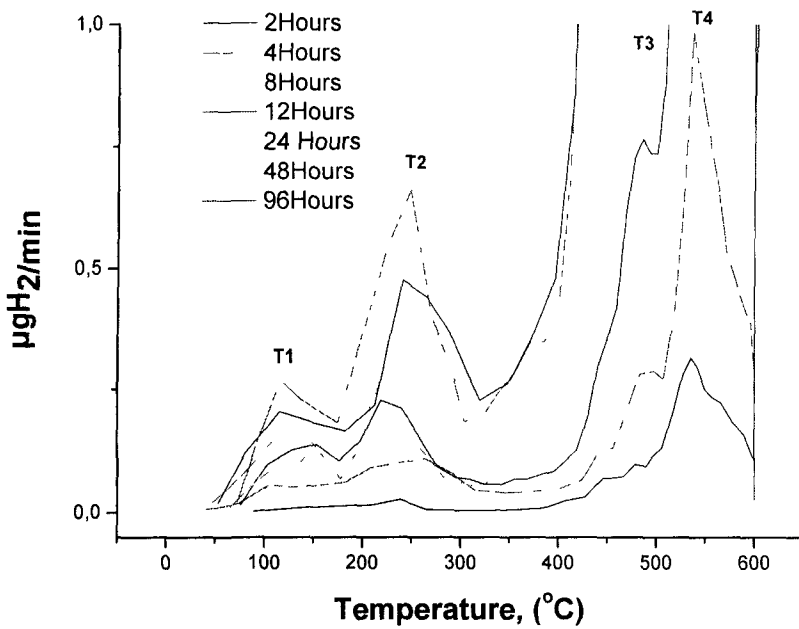
Fig. 4. 24: Magnification of Previous Figure in the region up to 1.0 µgH₂/min.

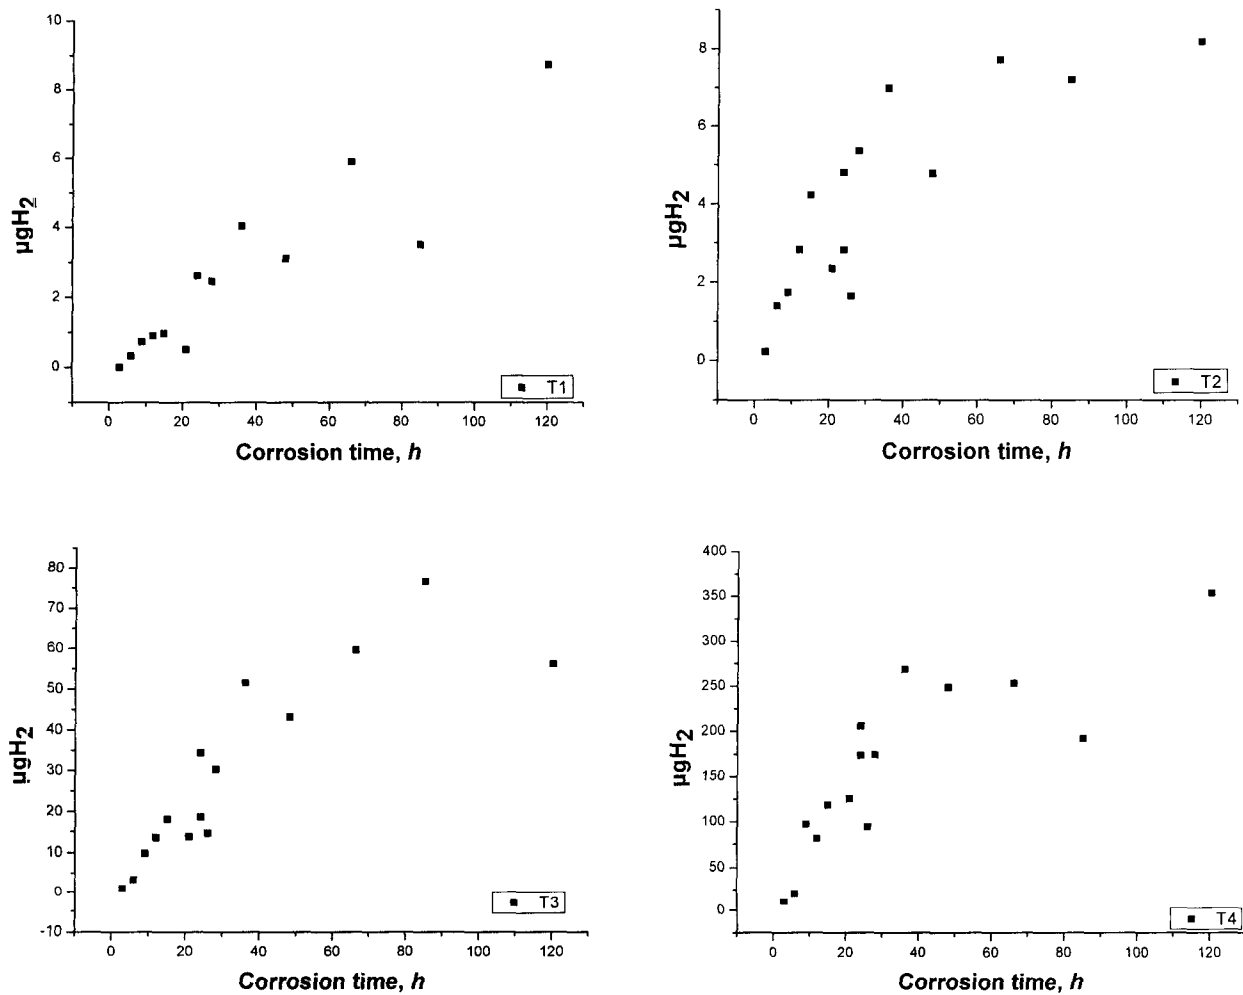
Fig. 4. 25: Amount of hydrogen desorpted from the four trapping states (T1-T4) as a fuction of corrosion exposure time.
