Corrosion-induced Hydrogen Embrittlement in High-Strength Al-Alloys

THESIS

Submitted in partial fulfillment of the requirements for the degree of
Doctor of Philosophy in Mechanical Engineering
of the Department of Mechanical and Industrial Engineering
University of Thessaly

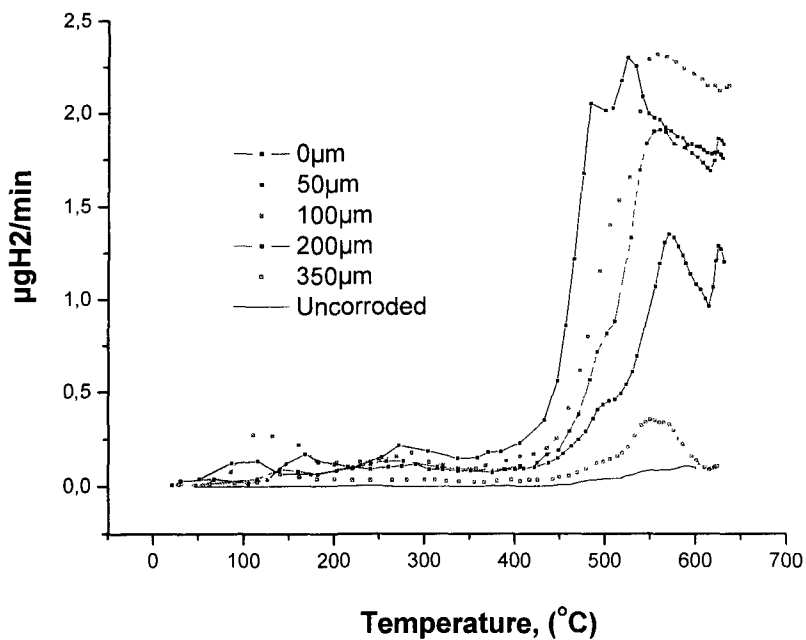
Fig. 4. 26: H₂ evolution as a function of temperature for specimens with varying removal depth.

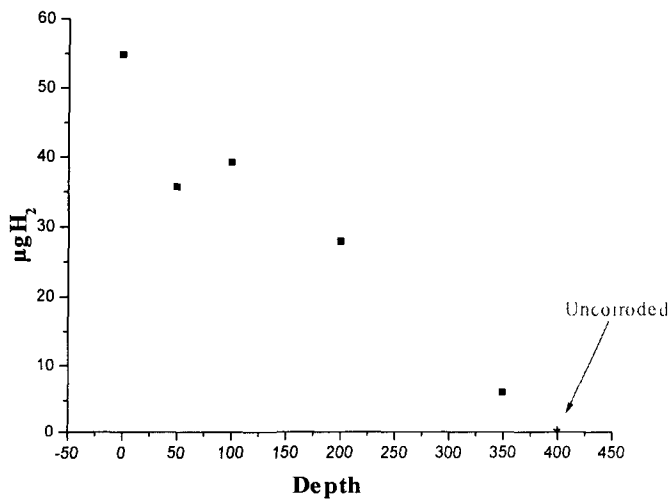
Fig. 4. 27: Total amount of H₂ (µg) for different removal depths. 24h exposure to EXCO solution (2.4 mm).

The fractographic analysis for conditions C and CR presented above correlate with the hydrogen profile in the material (Fig. 4. 27) and the tensile data of Fig. 4. 32. The hydrogen affected zone extends below the corrosion layer. This is the embrittled (quasicleavage) zone between the intergranular corrosion and the ductile uncorroded matrix seen in the above fractographs. Removal of the corrosion layer (CR) removes the effects of corrosion but leaves the hydrogen embrittled zone in place. This is the reason for the incomplete restoration in ductility for condition CR. Only in condition CRH, where all hydrogen has also been removed, there is a complete restoration of ductility.

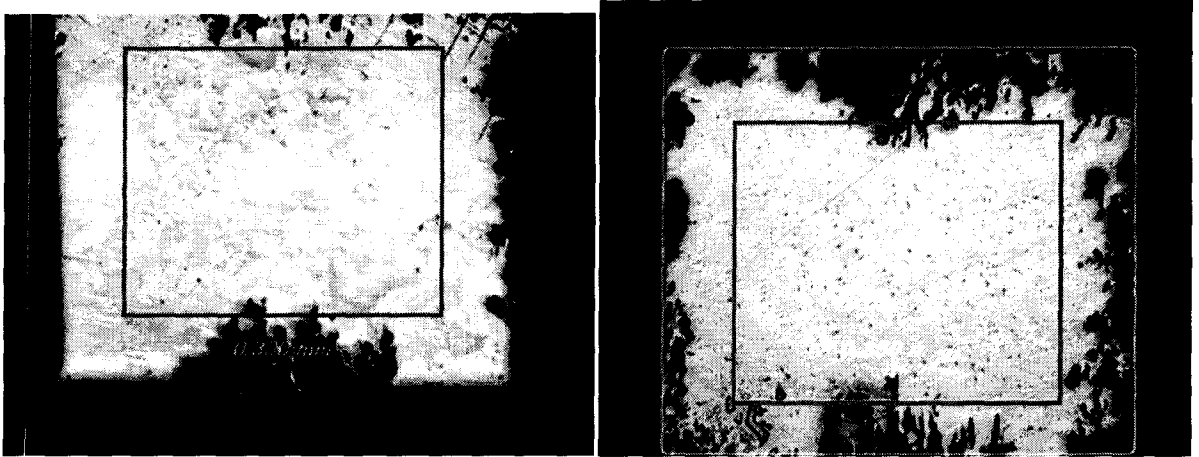
Fig. 4. 28: Depth of Attack 2.4mm

The depth-of-attack is defined as the maximum depth the corrosion front has reached within a certain exposure time. For 24h exposure the depth-of-attack is about 350 μ m as shown in Fig. 4. 28 and Fig. 4. 29.

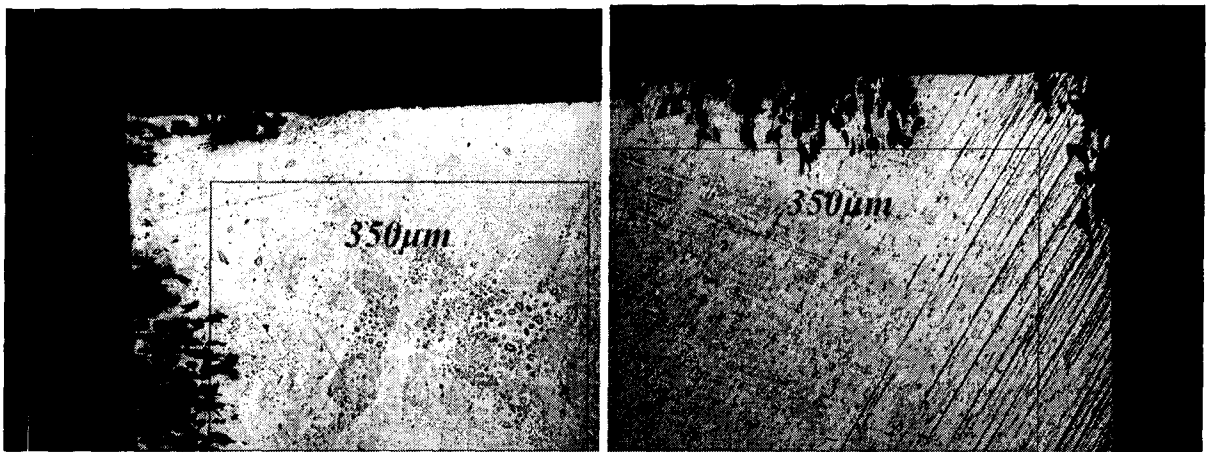
Fig. 4. 29: Depth of Attack 3 mm.

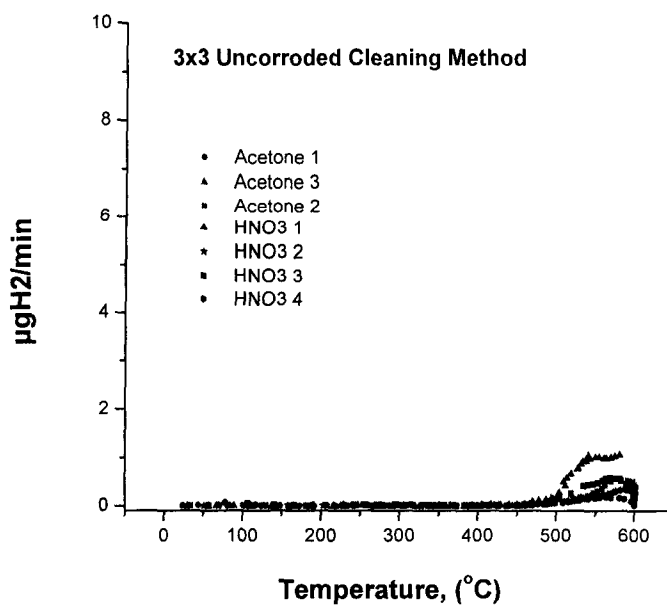
Fig. 4. 30: Hydrogen in Uncorroded Specimen of 3mm (b).

The remaining candidate cleaning method A was further tested for possible interference with hydrogen uptake. Thus, multiple uncorroded specimens were measured for hydrogen, some of them as received, others just washed with acetone and others cleaned according to method A. The results proved totally insensitive to the treatment, as indicated from the representative data of Fig. 4. 30. Based on the above assessment, method A was used in the rest of the present investigation.

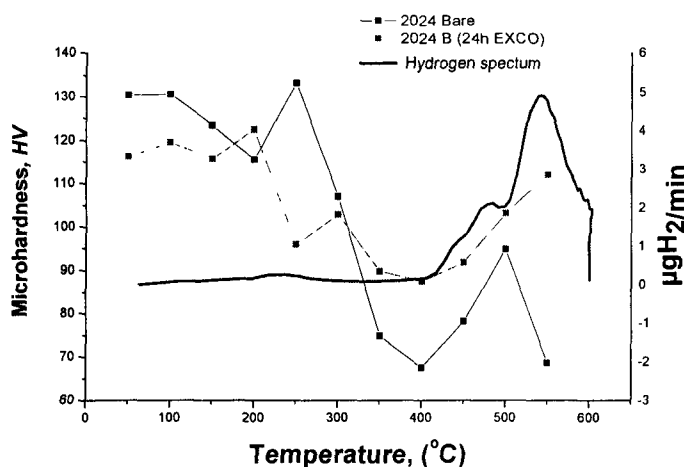
Fig. 4. 31: Microhardness profile versus temperature for alloy 2024.

The results of the measurements appear in Fig. 4. 31 together with the corresponding hydrogen spectrum for 24h EXCO. The hardness of the uncorroded (bare) material generally decreases with temperature up to 400°C due to overaging (a slight increase at 250°C is attributed to a secondary ageing peak), while it rises again above 400°C due to dissolution and reprecipitation. The corroded material exhibits a similar behavior in general. However there are two distinct differences in the hardness values. The corroded material appears softer than the uncorroded up to 300°C and harder above 350°C. The first temperature region incorporates states T1 and T2. Hydrogen in the T1 state is trapped in interstitial sites and dislocations while T2 hydrogen is trapped at particle/matrix interfaces. Recent research indicated that hydrogen might aid dislocation motion by altering the binding energy between dislocations and solute atoms [95, 96]. On the other hand hydrogen at matrix/particle interfaces might alter the interaction energy between dislocations and particles for coherency hardening in a way similar to that proposed for lattice dislocation. The result is that hydrogen in T1 and T2 states probably aids dislocation motion in overcoming either the lattice resistance or semicoherent particle resistance and the corroded material appears softer.

The second temperature region (above 300°C) incorporates states T3 and T4. T3 hydrogen is trapped in Mg hydride formation, while T4 hydrogen is trapped in the main hardening phase (θ or S). It is apparent from Fig. 4. 31 that hydrogen affects the dissolution and reprecipitation process or even the overaging (coarsening) process in the alloy and the corroded alloy appears harder. However more work is needed to clarify this behavior.

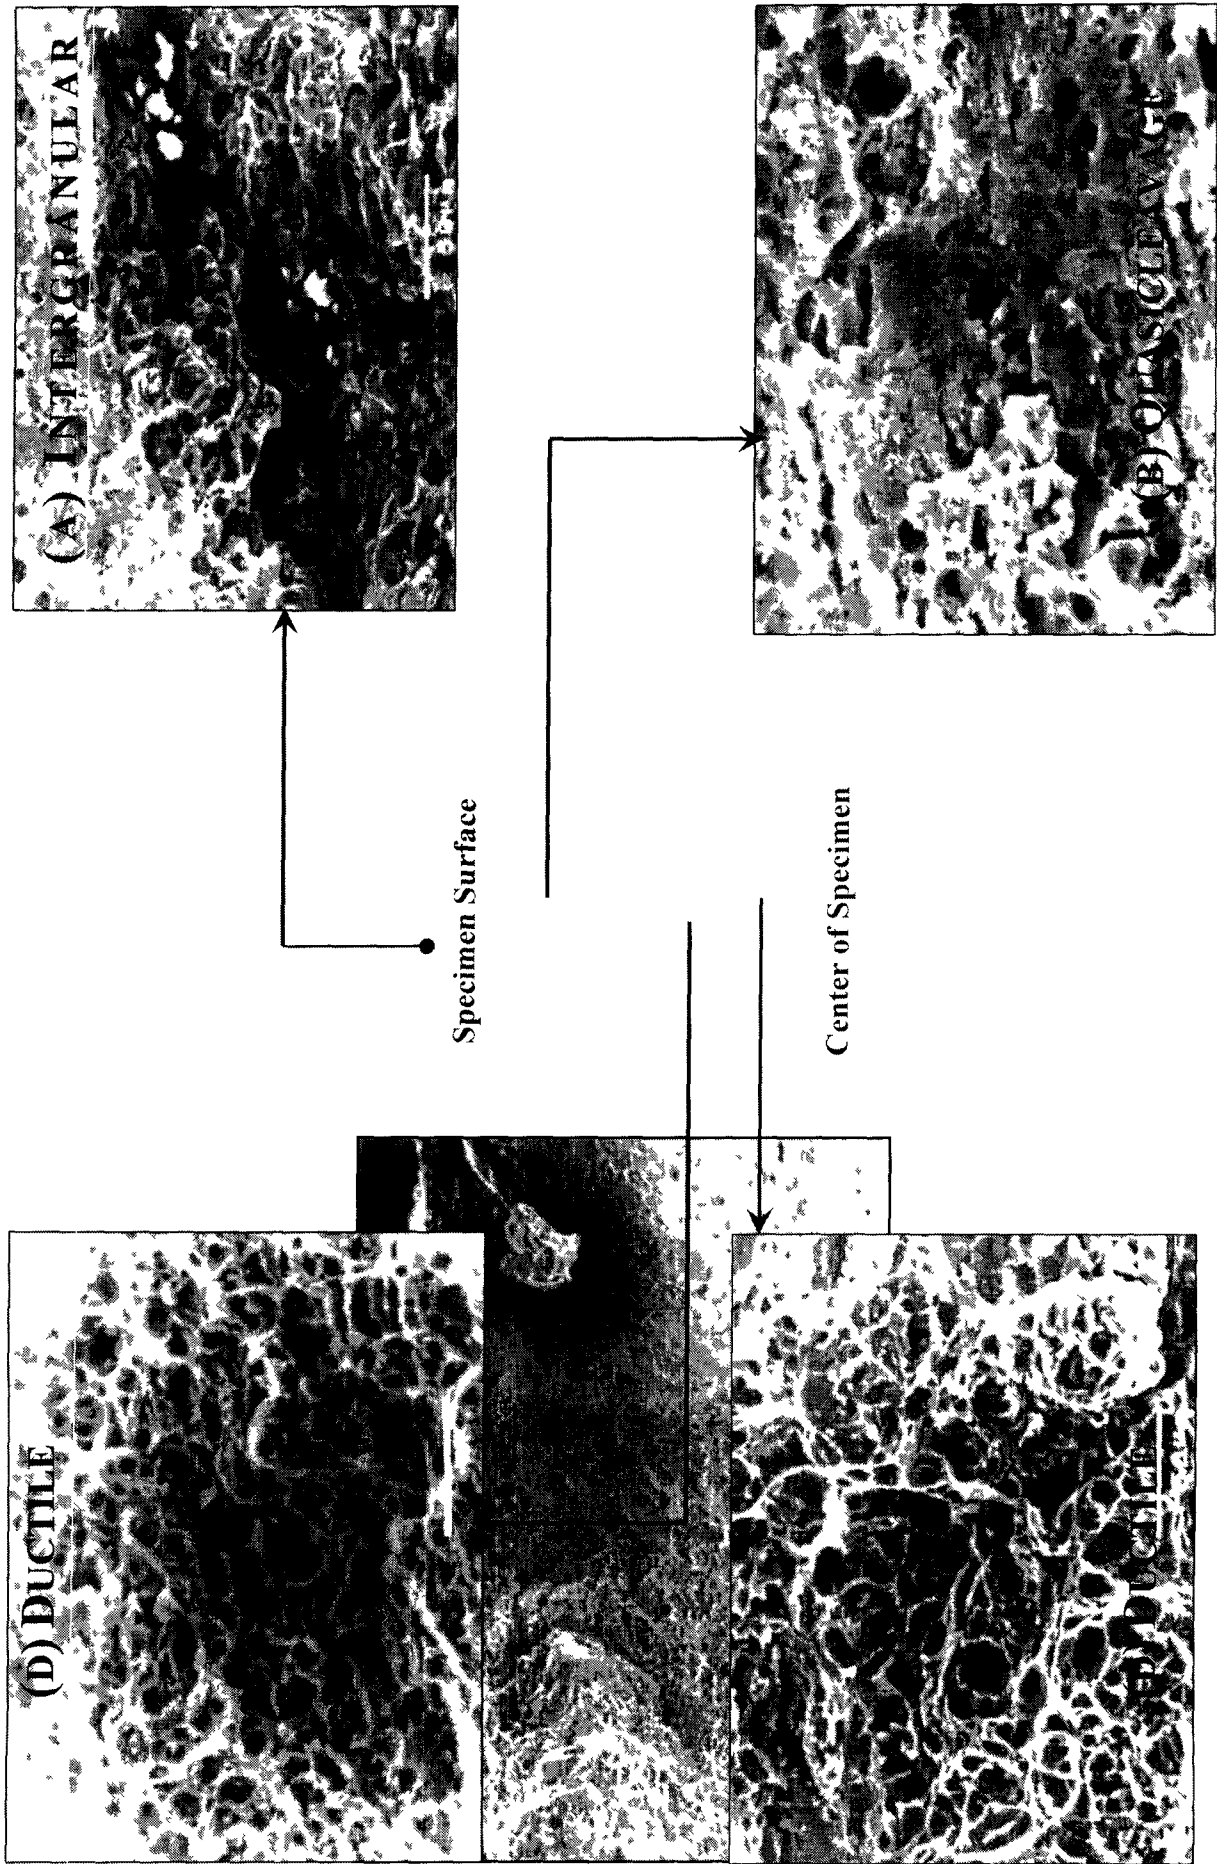
Fig 4 33 Fracture surfaces of condition C (corroded 24h) specimen. Individual photos correspond to different modes of fracture from the specimen surface (on start of corrosion) through the centre of the specimen.

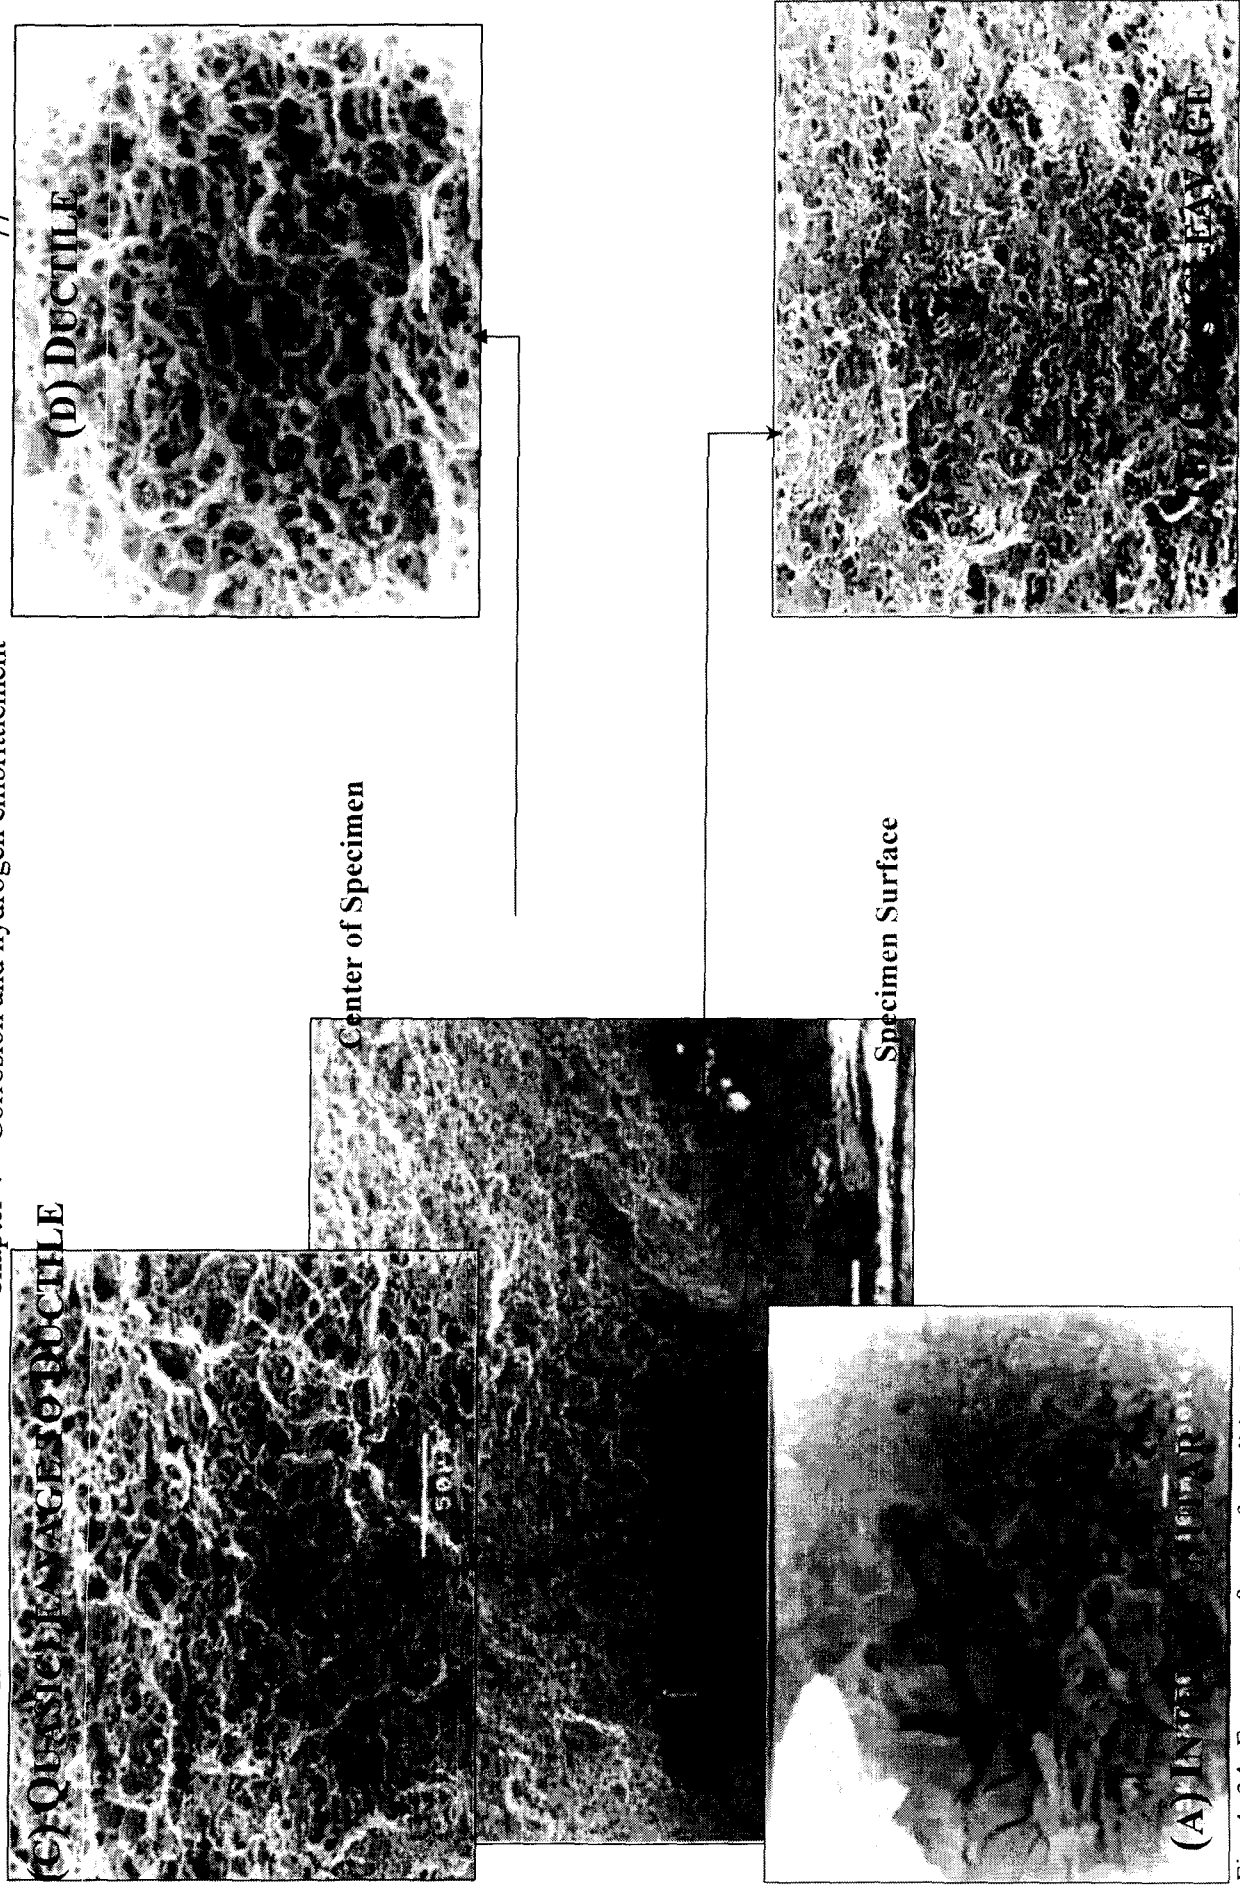
Fig. 4. 34: Fracture surfaces of condition C (corroded 24h) specimen, bottom surface. Individual photos correspond to different modes of fracture from the specimen surface (on start of corrosion) through the center of the specimen.

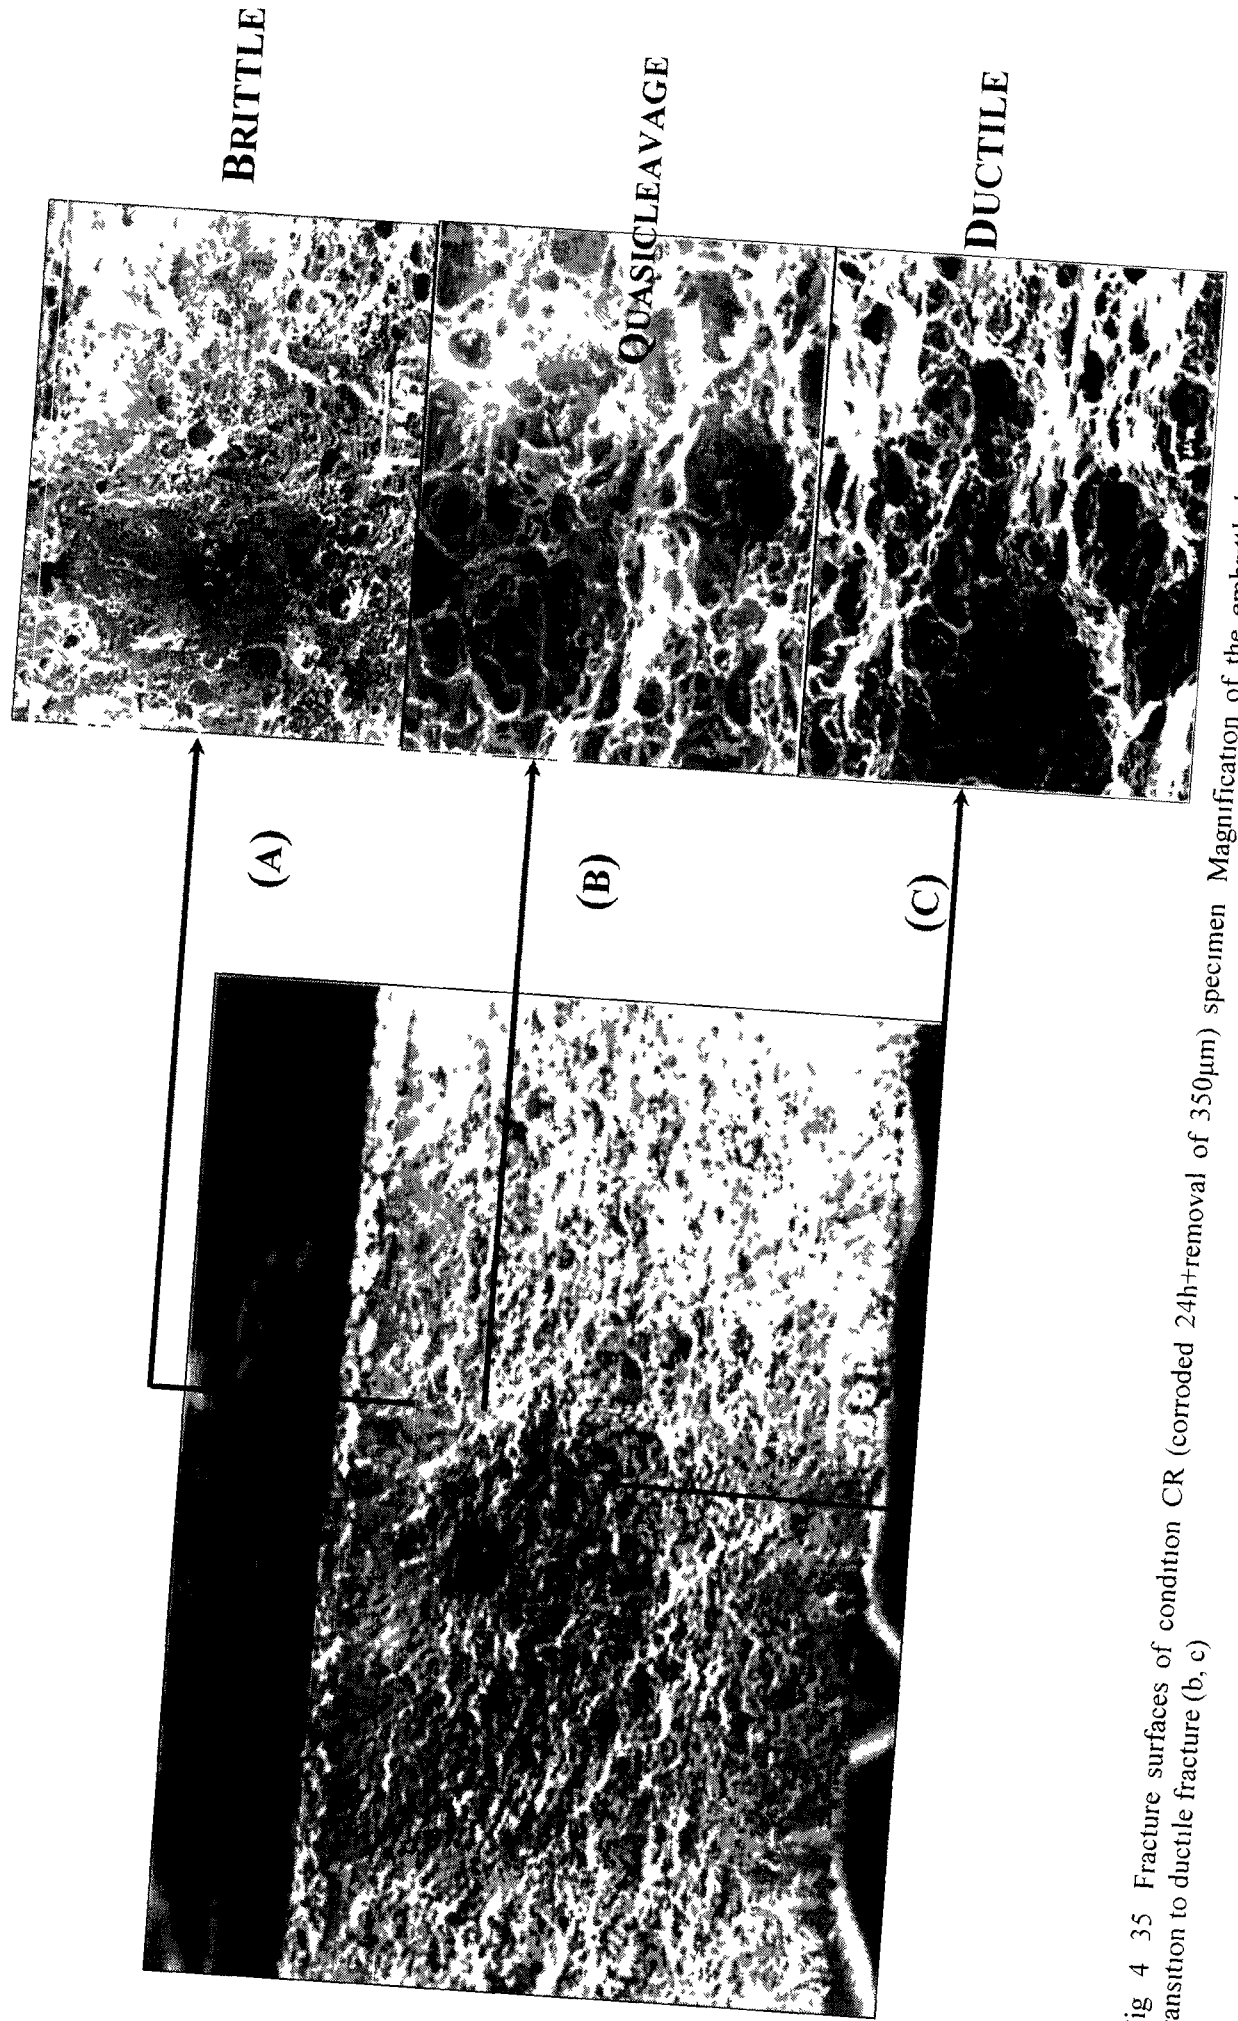
Fig 4 35 Fracture surfaces of condition CR (corroded 24h+removal of 350µm) specimen Magnification of the embrittled region quasi-cleavage (a), transition to ductile fracture (b, c)

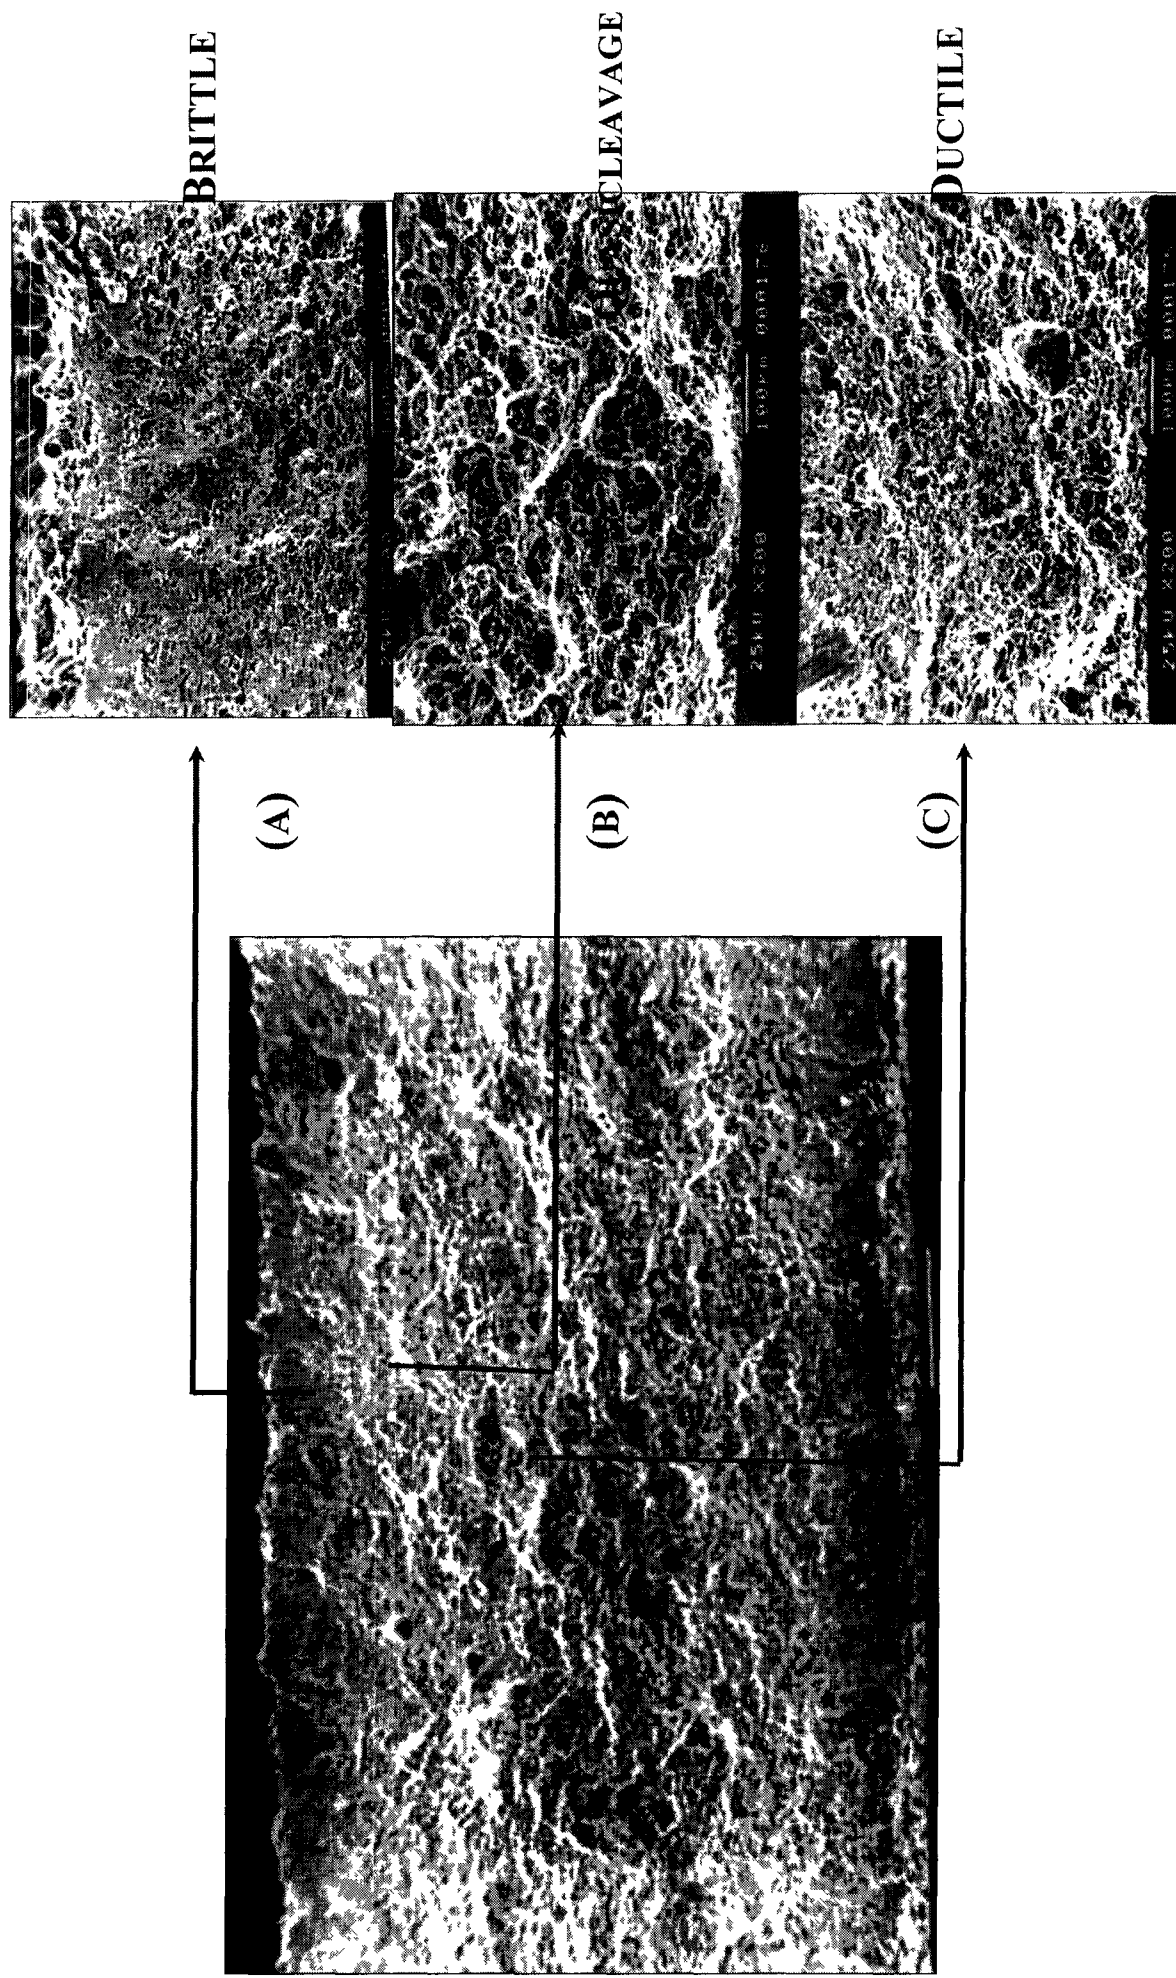
Fig. 4. 36: Fracture surfaces of condition CR (corroded 24h+removal of 350µm). Embrittled zone (a), the transition to ductile (Fig.15b) and the ductile region in the interior of the specimen (Fig.15c).

Fig. 4. 36: Fracture surfaces of condition CR (corroded 24h+removal of 350μm). Embrittled zone (a), the transition to ductile (Fig.15b) and the ductile region in the interior of the specimen (Fig.15c).	44
Fig. 4. 37: Fracture surfaces of condition CRH (a) (corroded 24h+removal of 350μm) and RH (b) specimen. Both exhibit ductile mode of fracture.....	44
Fig. 4. 38: Fracture surfaces of condition CRH (a) and RH (b) surface zone of mixed intergranular/dimple nature.	44
Fig. 4. 39: Rounded features (a), grain boundaries (b).....	44
Fig. 4. 40: Fracture surfaces of condition CRH in LT direction intergranular character of the surface zone.	44
Fig. 4. 41: Specimen with similar total side area (0.34-0.14gr) but different weight (106 versus 116 mm ²) Results of hydrogen desorption versus temperature (a). Specimen with similar weight (0.13-0.14gr) but different total side area (106 versus 58mm ²) Results of hydrogen desorption versus temperature (b).	44

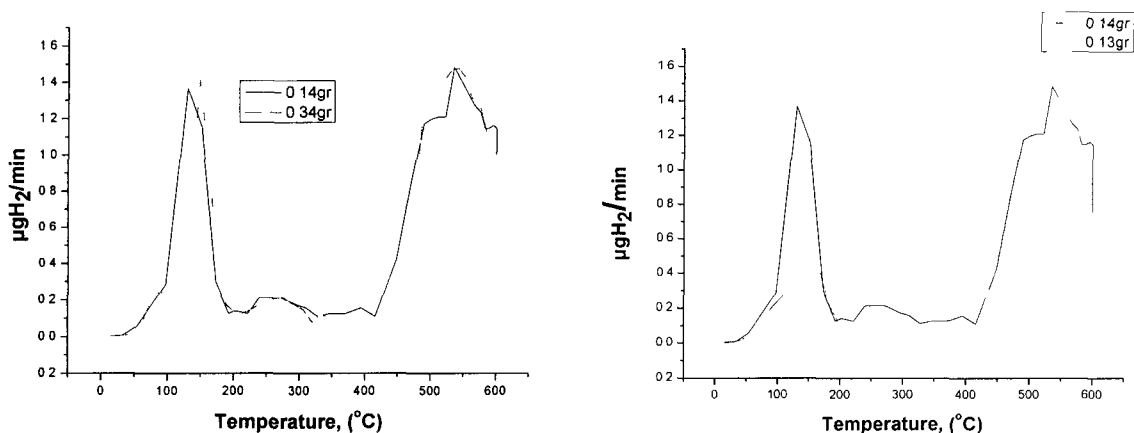
Fig. 4. 41: Specimen with similar total side area (0.34-0.14gr) but different weight (106 versus 116 mm^2) Results of hydrogen desorption versus temperature (a). Specimen with similar weight (0.13-0.14gr) but different total side area (106 versus 58 mm^2) Results of hydrogen desorption versus temperature (b).

Hydrogen entering the material is produced by the surface reactions of corrosion. Thus, the amount of hydrogen eluting during heating of corroded specimen is expected to correlate better with the surface exposed to corrosive attack rather than with the weight of the specimen. This expectation is confirmed by the data, as in the representative hydrogen evolution spectra of Fig. 4. 41a and b, corresponding to specimens exposed to the EXCO solution for 24 hours. Fig. 4. 41a compares two specimen of the same weight but different surface areas, and demonstrates that larger surface leads to larger amount of trapped hydrogen. Fig. 4. 41b shows that specimens with similar surface areas but very different weights produce similar spectra.

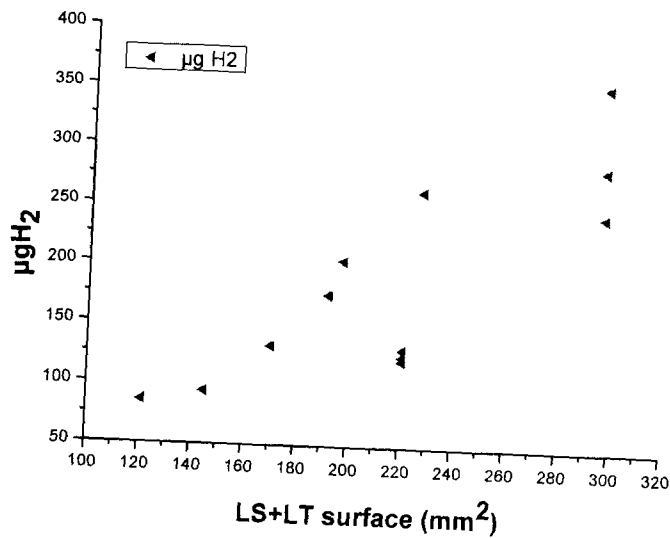
Fig. 4. 42: The results of hydrogen desorption versus the side surface.

A more extensive compilation of data, which confirms the good correlation between specimens area and hydrogen trapped during corrosion, is shown in Fig. 4. 42. Here, the total quantity of released hydrogen is plotted as a function of the exposed surface area, and a systematic dependence is observed.

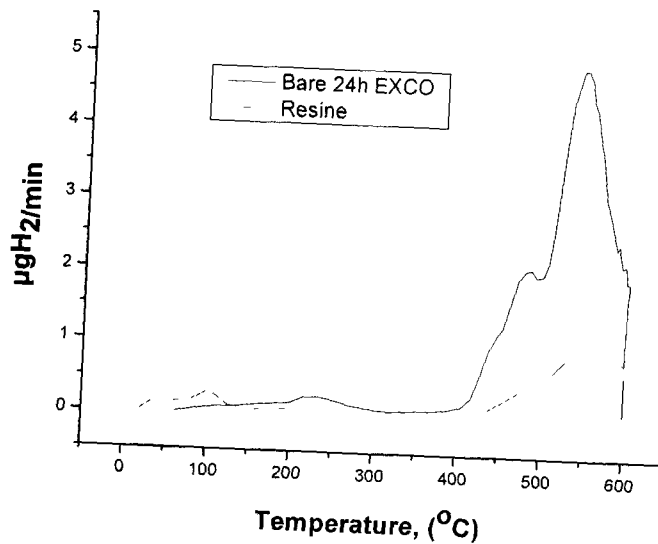
Fig. 4. 43: Comparative diagram with and without resin on the side surface.

A comparative assessment of the above data provided evidence that the side surface (LS) is more active than the flat surface (LT) in promoting corrosion and hydrogen uptake. In order to substantiate this tentative conclusion, a series of specimens were corroded only after their side surface was isolated from the corrosive solution. In this way, the amount of hydrogen measured was associated exclusively with the rolling surface. The material used to seal the side surface was a special resin, which solidifies under vacuum and does not react with the corrosive solution.

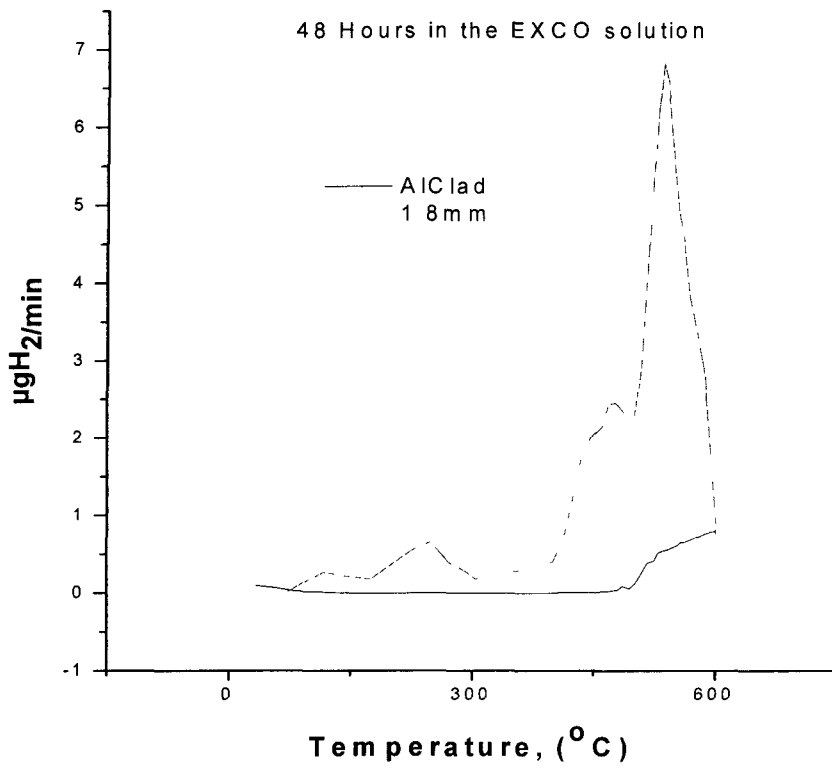
Fig. 4. 45: H₂ desorption spectra of 2024-T3 Al Clad specimens.

Two different surface protections were tested for susceptibility to hydrogen uptake, Al cladding and anodizing. Cladding is based on high purity Al (1230) and proved a very efficient means of protection. Fig. 4. 45 shows the difference in hydrogen evolution spectra of two 1.8 thick specimens (one bare the other cladded), subjected to 48 hour exposure to the corrosive solution.

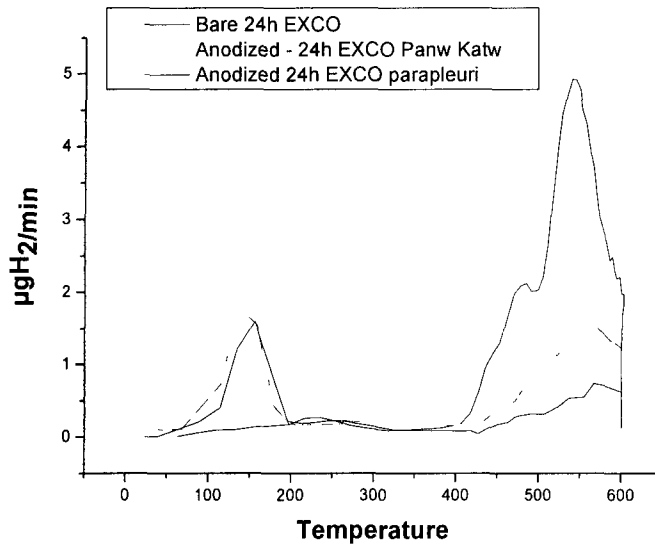
Fig. 4. 47: Effect of anodizing in the side surface of specimen that have suffered corrosion for 24 hours.

Hydrogen measurements in partly anodized specimens showed that hydrogen uptake decreases with respect to non-anodized material. In particular, Fig. 4. 47 compares hydrogen evolution spectra from three specimens, one of which is bare, the other has anodized rolling surfaces and the last has anodized rolling surfaces plus 50% of the side surface. The gradual reduction of measured hydrogen with the percent of surface covered indicates that anodizing is not as efficient as Al-cladding in the protection of partly bare specimens. However, the reduction of measured hydrogen in the specimen with covered rolling surfaces is larger than expected from the relative contributions of rolling and side surfaces of bare material (as discussed in the previous paragraph). Thus, anodizing also appears to offer some synergistic effect, possibly of electrochemical nature.

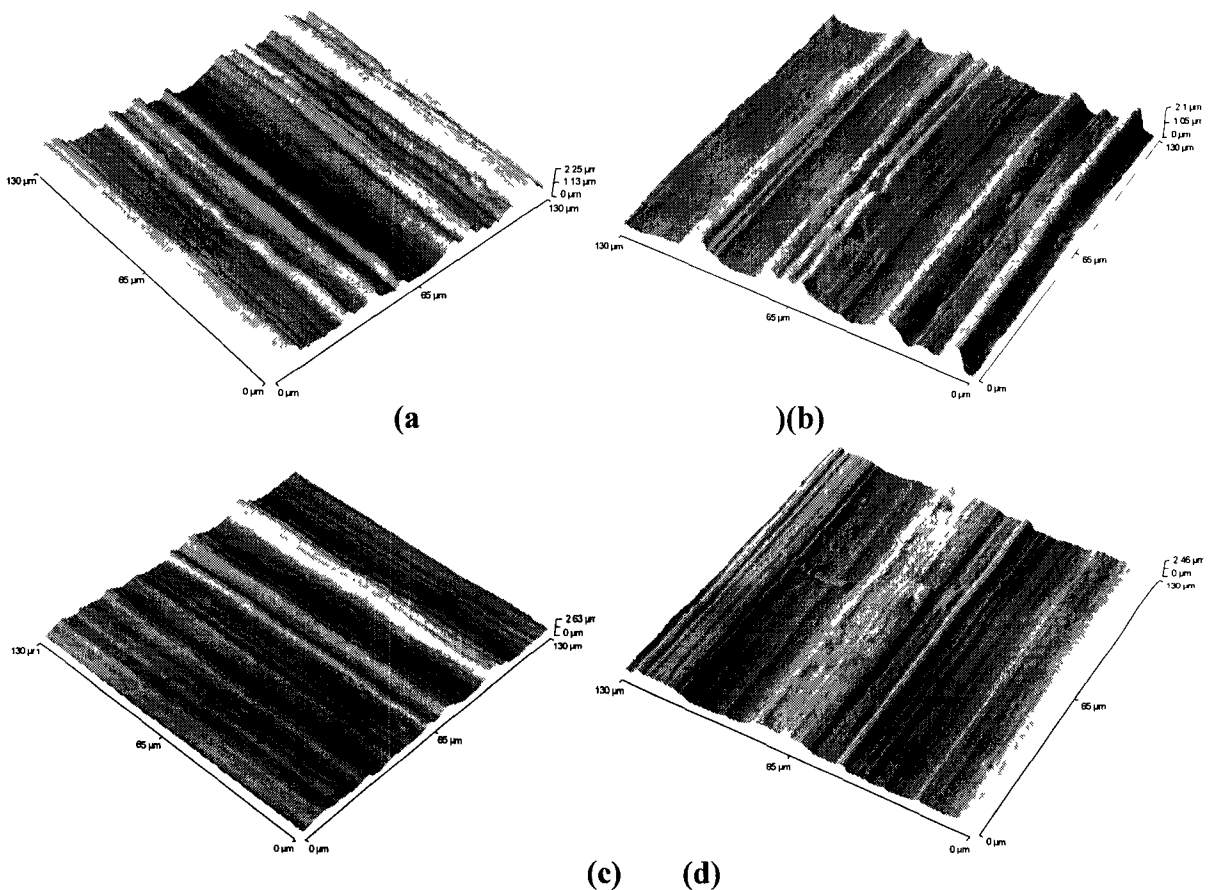
Fig. 4. 48: AFM topographies for the as received aluminum alloy 6013, LT plane. (a) through (d).

In comparison to the 2024 alloy, the surface of 6013 corroded for short times (up to 4 hours) exhibits a higher degree of non-uniformity, which is evident even from the uncorroded (as receiver) material Fig. 4. 48, the rolling marks are more intense than in the case of alloy 2024. Pitting, oxide film cracking and rolling marks are present from the beginning of corrosion attack. Fig. 4. 49 shows oxide film cracking for different exposure times. Fig. 4. 50 shows characteristic rolling marks at different exposure times. These marks are more intense than in the case of alloy 2024. Finally Fig. 4. 51 shows pitting corrosion at different exposure times. Pit depth increases with exposure time. Also pit-to-pit interactions and pit clustering are mechanisms that aid the evolution of corrosion damage also in alloy 6013.

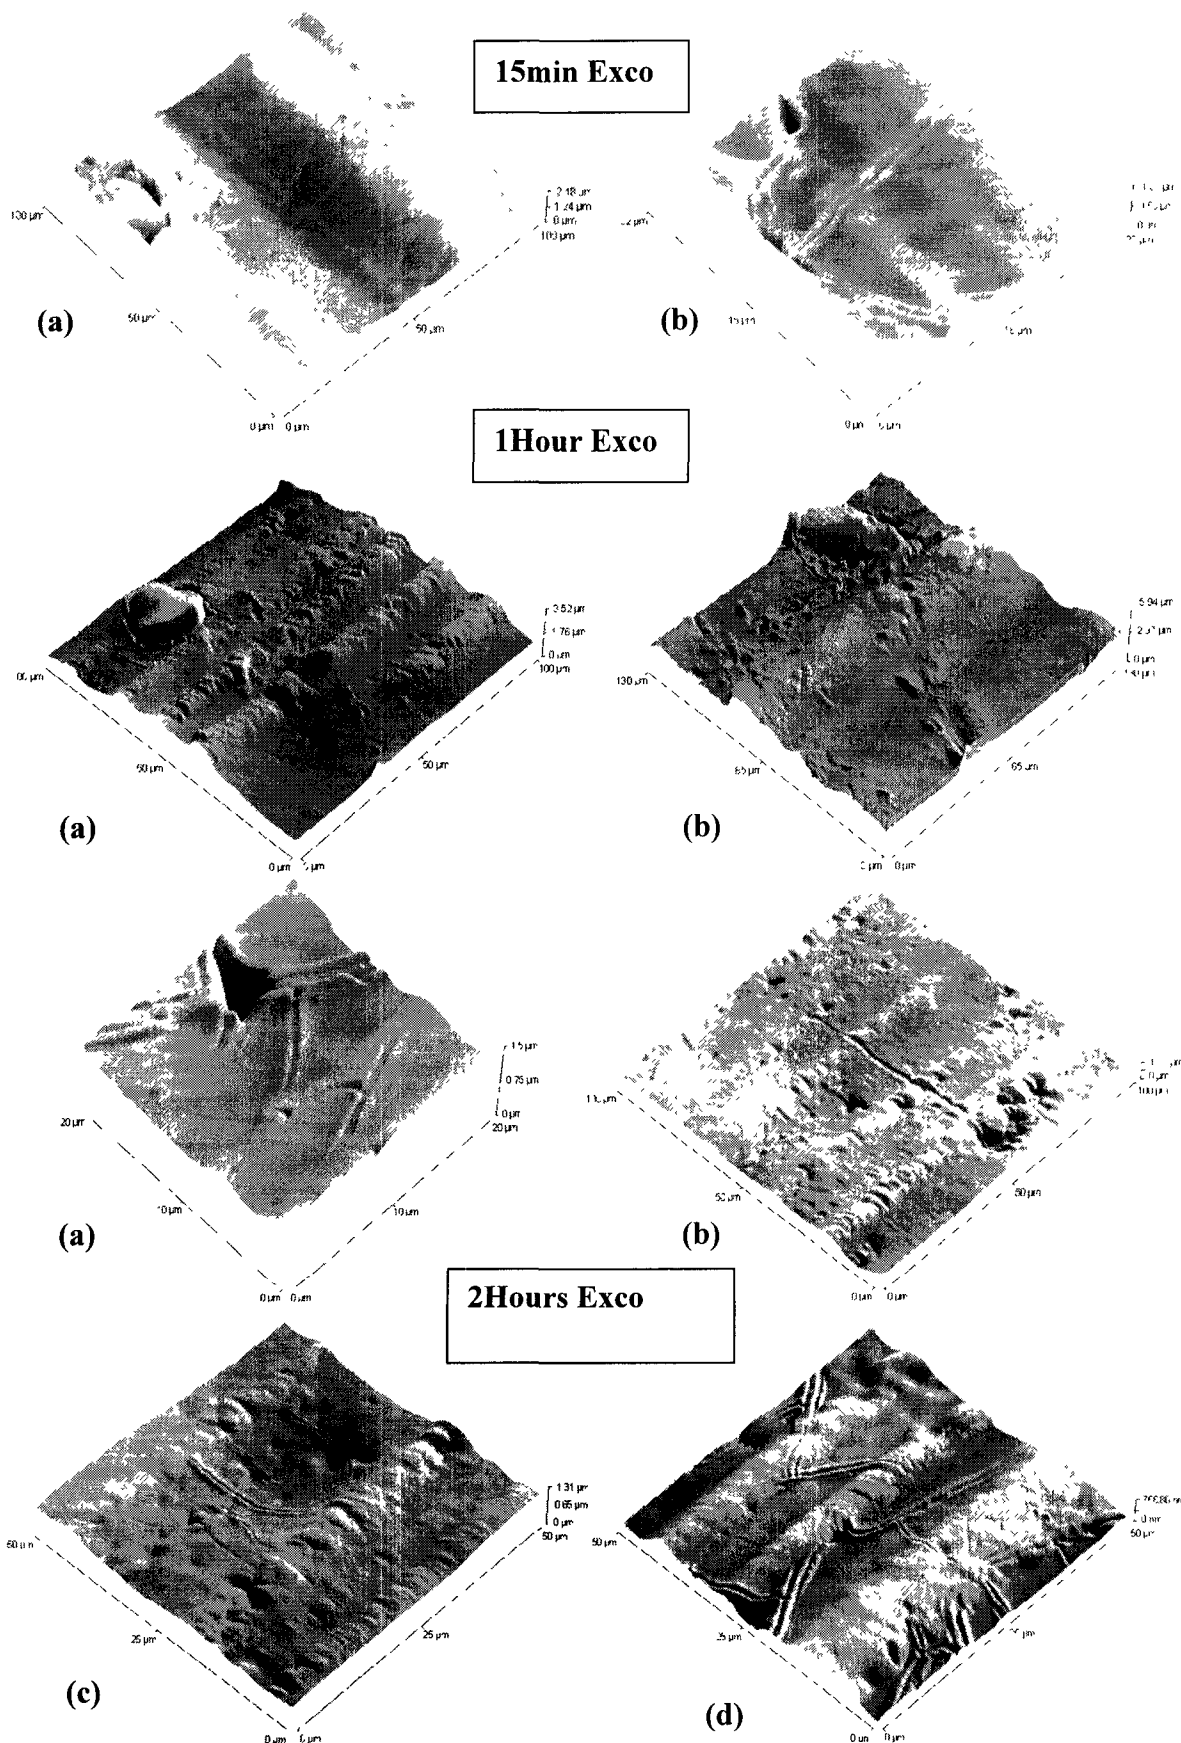
Fig. 4. 49: Alloy 6013-T6 (LT plane), for different exposure times in the corrosive solution EXCO. Fragmentation and spalling of surface oxide.

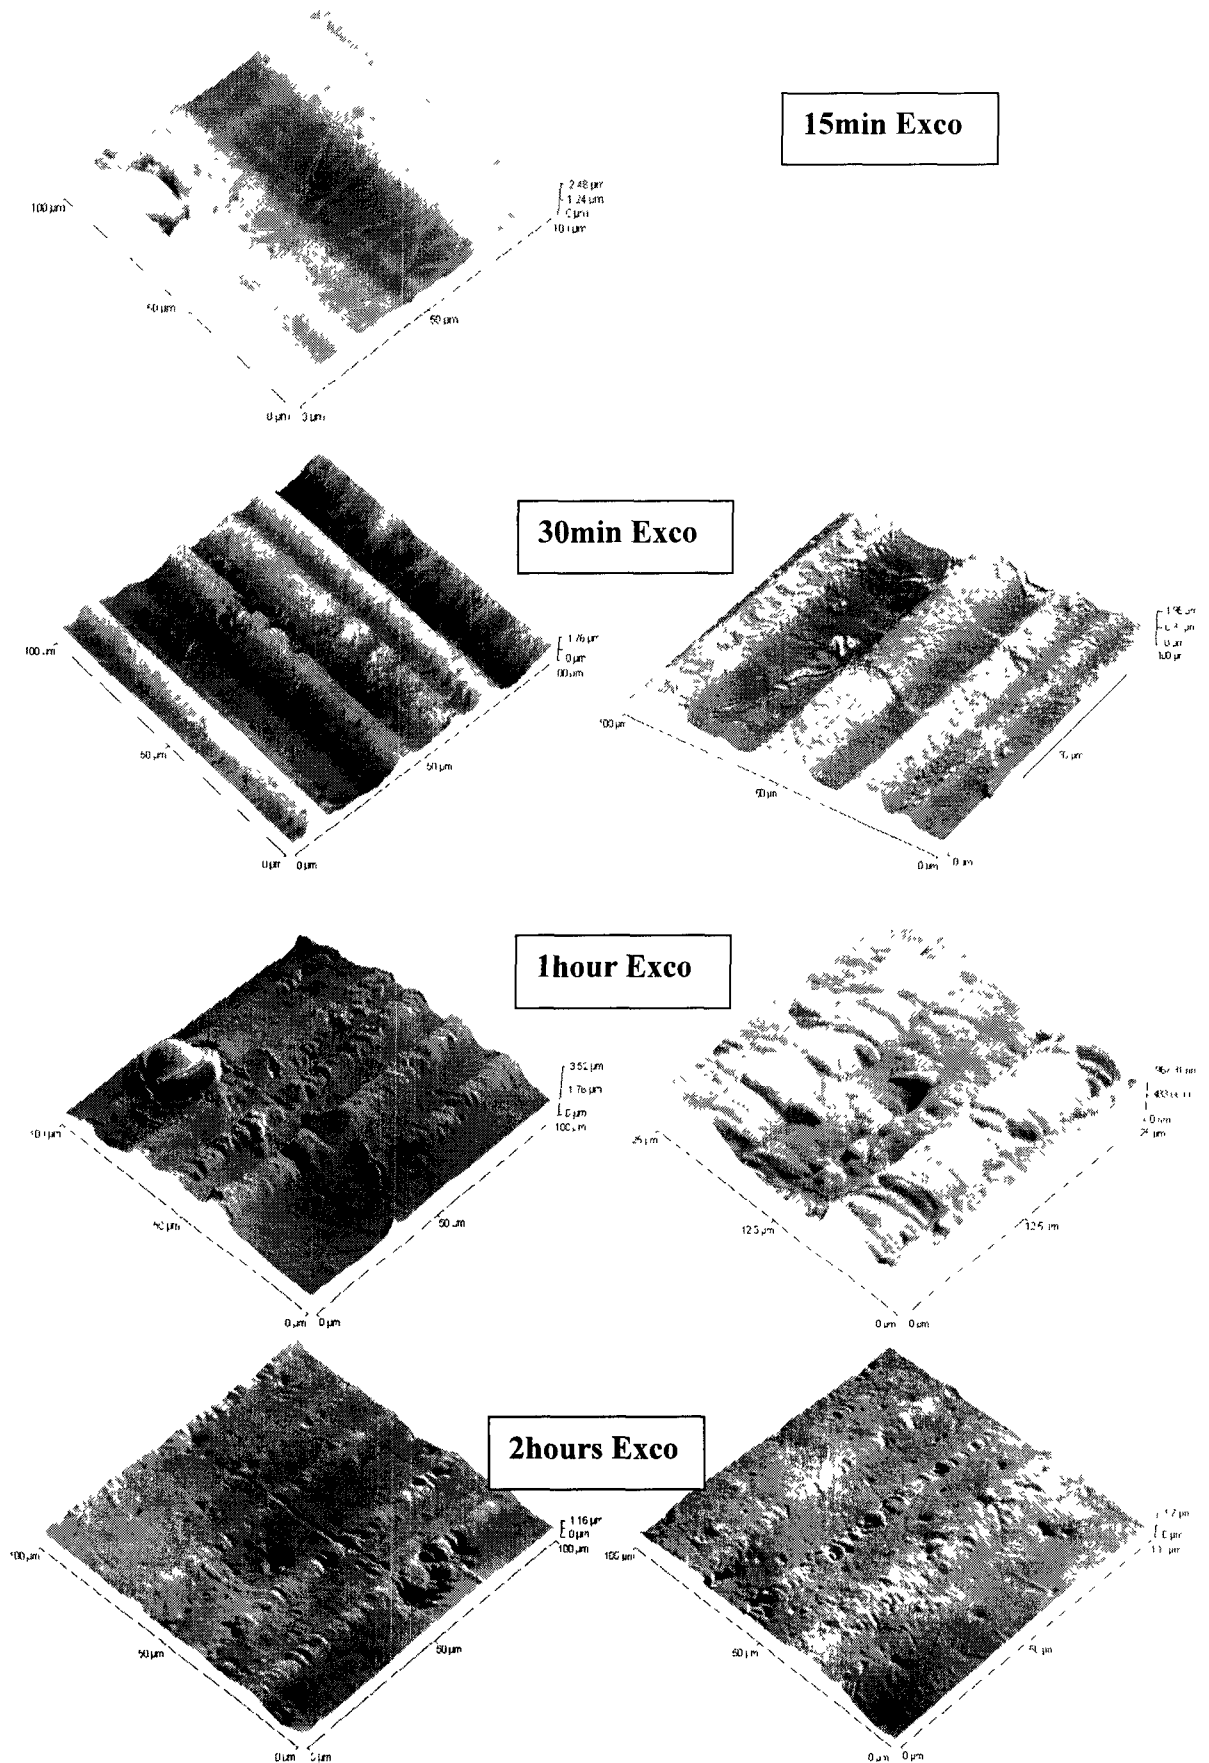
Fig. 4. 50: Alloy 6013-T6 (LT plane), for different exposure times in the corrosive solution EXCO. Characteristic rolling marks at different exposure times.
