Corrosion-induced Hydrogen Embrittlement in High-Strength Al-Alloys

THESIS

Submitted in partial fulfillment of the requirements for the degree of
Doctor of Philosophy in Mechanical Engineering
of the Department of Mechanical and Industrial Engineering
University of Thessaly

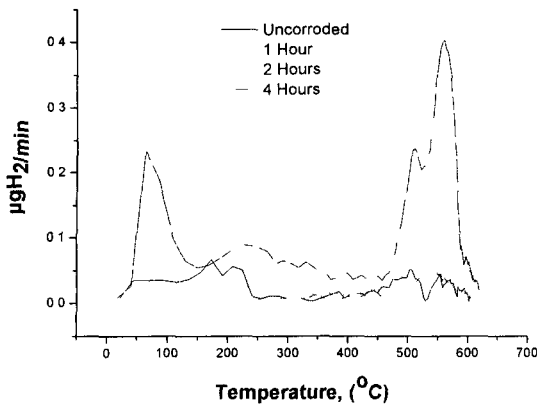
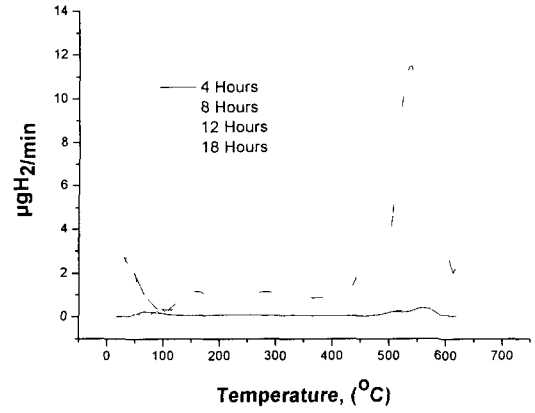
Fig. 4. 52: (a) Hydrogen desorption spectra for specimen of alloy 6013 for exposure to exco 0 to 4 hours (b) Hydrogen desorption spectra for specimen of alloy 6013 for exposure to exco 4 to 18 hours

Hydrogen evolution spectra for specimens exposed to the corrosive solution for different times are shown in Fig. 4. 52 a, b. Fig. 4. 52a contains small exposure times and indicates that the onset of hydrogen accumulation is after 4 hours in the exco solution. The behavior for longer exposure times is shown in Fig. 4. 52b and demonstrates a faster buildup of hydrogen in comparison with alloy 2024. These findings are in agreement with the increased severity of corrosion attack, as detected with AFM. They also prove that alloy 6013 permits the entrance into its structure of the hydrogen produced by surface corrosion reactions. The total amount of hydrogen as a function of exposure time is shown in Fig. 4. 52. For exposure beyond 24 hours, the amount decreases and reaches a plateau. This behavior is attributed to the extensive removal of material during corrosion (~30% weight loss) and is an indication of saturation.

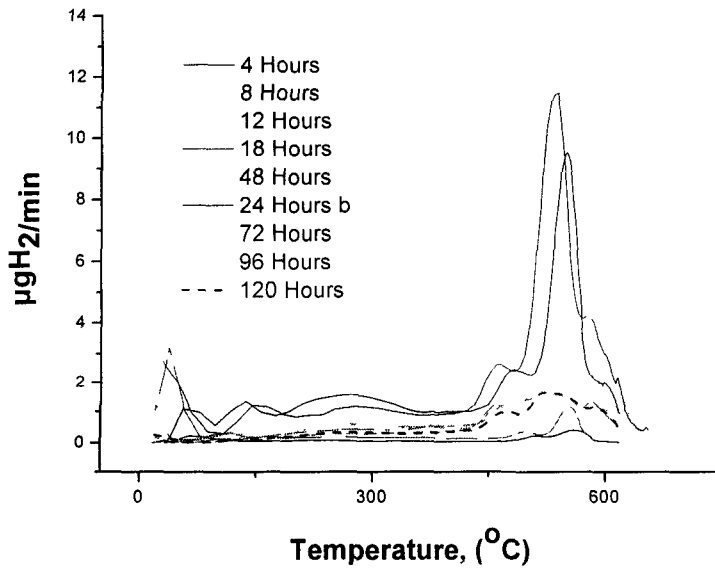
Fig. 4. 53: Hydrogen desorption spectra for specimen of alloy 6013 for exposure to exco 4 to 120 hours.

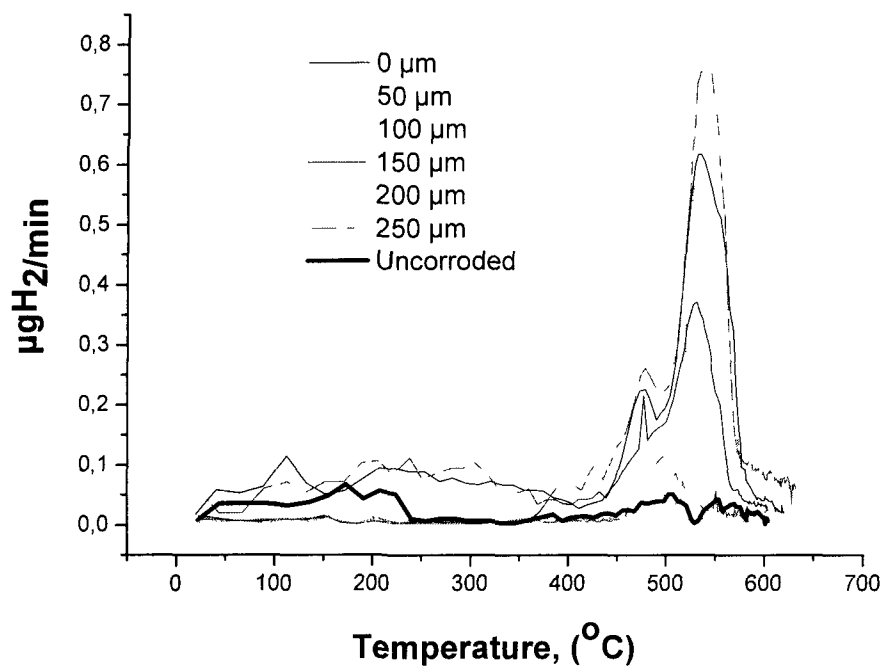
Fig. 4. 54: H_2 evolution as a function of temperature for specimens with varying removal depth

The depth of hydrogen penetration was determined as before, by exposing multiple specimens to the same corrosive conditions (4 hours in exco) and removing from each one a different depth of surface material. The respective hydrogen spectra are shown in Fig. 4. 54.

Measurement of an uncorroded specimen is included for comparison. The results demonstrate the expected decrease in hydrogen content with depth and indicate a penetration depth around 250 μm . Considering that diffusion depth is proportional to the square root of time, this number compares favorably to the estimated penetration depth in alloy 2024 ($\sim 500 \mu\text{m}$), which resulted from a 24 hour exposure.

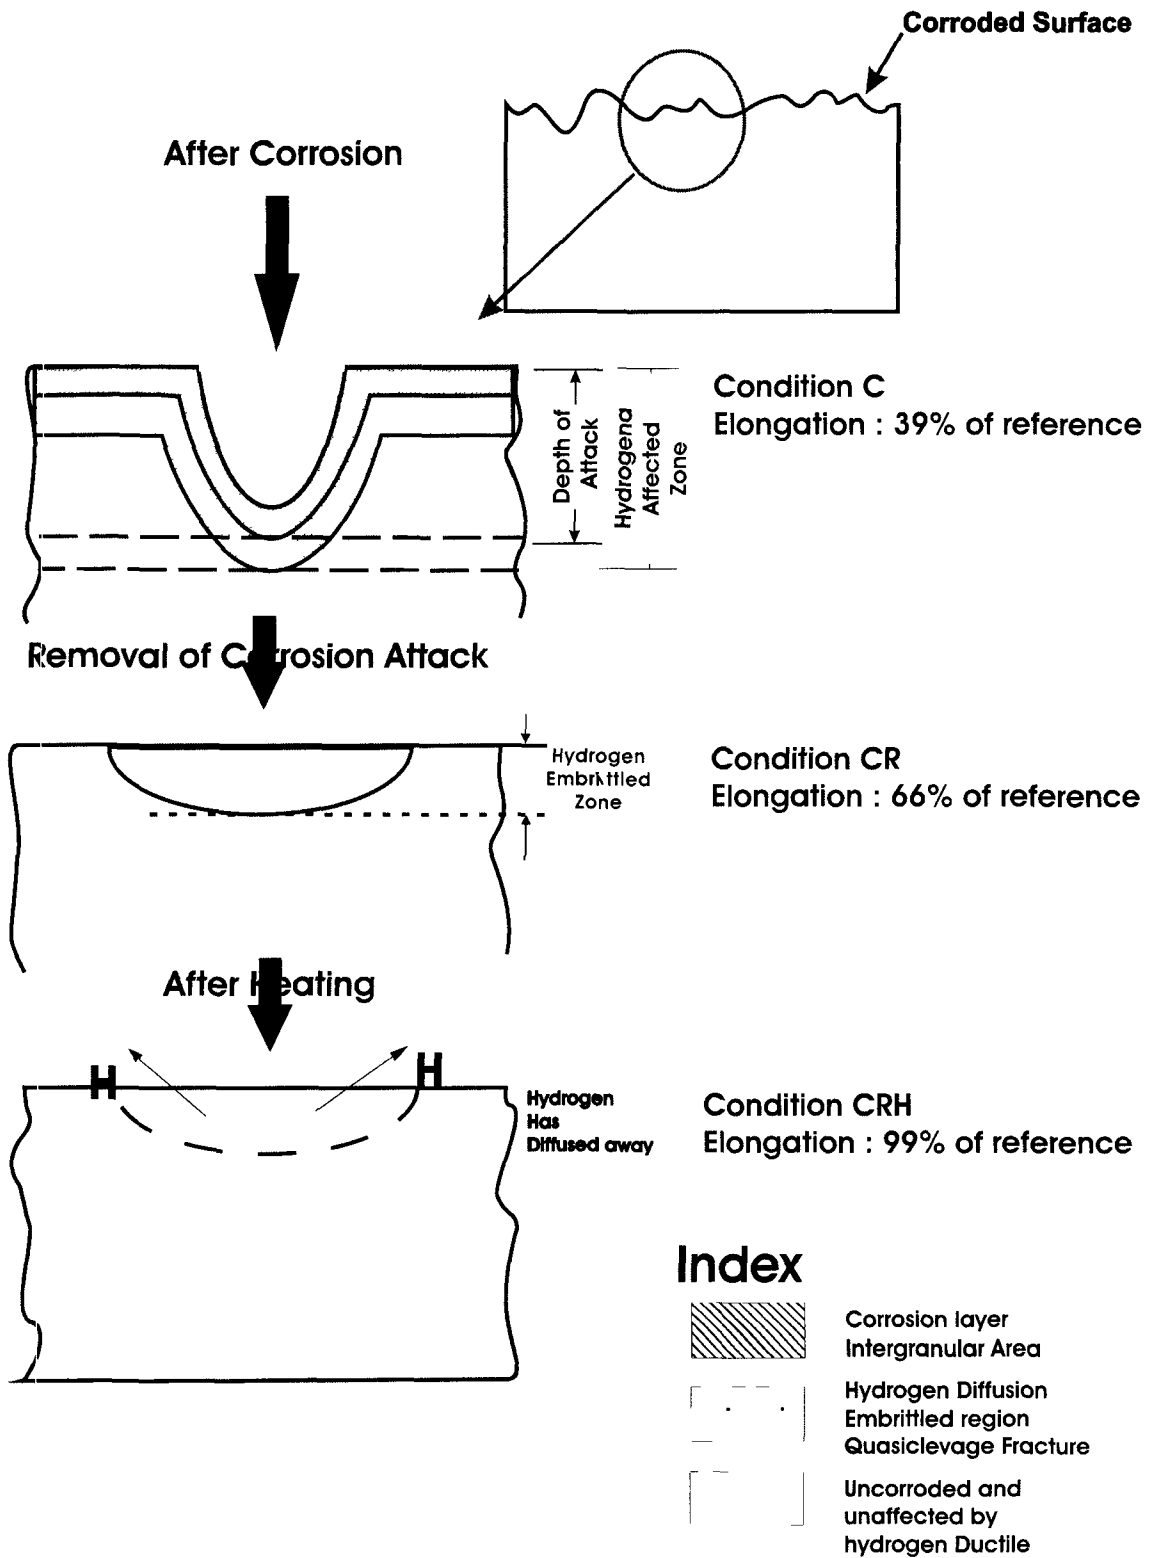
Fig. 4. 55: Schematic representation of the corrosion layer and the hydrogen affected area beneath it. After removal of the corroded layer, a hydrogen affected zone (free of corrosion) remains and affects the mechanical properties of the material (elongation 66% of reference). Heating releases trapped hydrogen and restores elongation to 99% of reference.

In order to link corrosion and hydrogen trapping to strength and ductility, results from tensile testing of corroded samples and corresponding fractographic analysis took place. Corroded material (24h EXCO) has a yield strength 92% and an elongation 39% that of the uncorroded material. Removal of the corrosion layer restores the yield strength to 100% , while ductility is only partially restored to 66% that of the reference value. This means that an embrittling mechanism still remains in the material even after all surface damage due to corrosion has been removed. Removal of the corrosion layer followed by heating at 495°C restores both the yield strength and elongation to almost 99% of the reference value. The complete restoration of ductility is attributed to hydrogen desorption by the activation of all hydrogen traps in the alloy. These conditions are shown schematically in Fig. 4. 55.

The 24 hours EXCO corrosion creates damage which penetrates in a nonuniform way from the surface to the interior of the material. The depth of attack is 350µm. Below the corrosion layer, a hydrogen zone is established due to the diffusion of hydrogen created by the corrosion process. Removal of the corrosion layer (equal to the depth of attack), removes all the corrosion damage and all hydrogen trapped in the 350µm surface layer in the alloy. The result is an elongation increase to 66% of the reference value. However, part of the hydrogen zone still remains. The heating of the alloy to 495°C (at the T4 state) removes all hydrogen from that zone by desorption and restores all ductility back to the original value. Fractography of the tensile samples showed that below the intergranular fracture zone at the surface, which is due to corrosion, there is a quasicleavage transition zone before the fracture mode turns to the ordinary dimple ductile fracture of the unaffected material. This quasicleavage zone has been embrittled by hydrogen diffusion and trapping. Removal of that hydrogen by heating restores all ductility. These results provide the first evidence of hydrogen embrittlement in 2024 alloy.

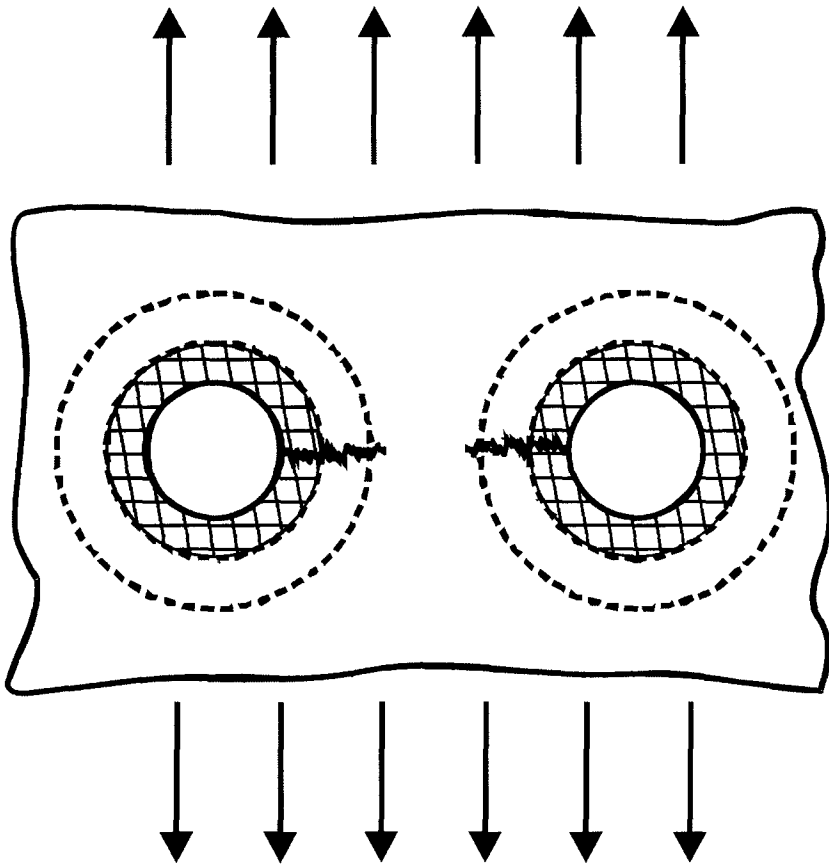
Fig. 4. 56: The situation around two adjacent rivet holes. The concentric cycles around the hole represent the corroded area around the hole and the hydrogen affected zone.

Today's aircraft design and maintenance follows the damage tolerance philosophy. According to this practice, flaws or cracks are allowed in the structure once they are tolerated by the material. Tolerance depends on the fracture toughness of the alloy. The cracks grow by fatigue. The life of the structure depends (i) on the prescribed damage tolerance and (ii) on the fatigue crack growth rate. Both of these factors are influenced by corrosion and hydrogen embrittlement. The present thesis sheds light at the degradation of ductility and hence fracture toughness, due to the corrosion-induced hydrogen embrittlement, which reduces the damage tolerance of the structure. These arguments are particularly important for the so-called "aged aircraft", which has exceeded or is near the operational lifetime, but it is still operated by the airlines. These aircrafts have accumulated damage and corrosion. The damage tolerance of the material has decreased due to hydrogen embrittlement, at least locally in critical areas such as rivet holes, in accordance with the 'local fracture toughness' concept proposed in [13]. This condition is shown in Fig. 4. 56, where the situation around rivet holes is considered to be analogous to that of Fig. 4. 55. the critical situation will appear if crack extension occurs in the hydrogen embrittled region, where, locally, damage tolerance has been reduced. These conditions call for a re-determination of lifetime, if the decision is to extend the operational lifetime of such aircrafts.
