Thesis
**Influence of stepped repair parameters on the mechanical performance
of wind turbine blade's outer shell**

DRIVAS THEMISTOKLIS
University of Thessaly, 2020

Submitted in Partial Fulfilment of
the Requirements for the Degree of Master of Science
2020

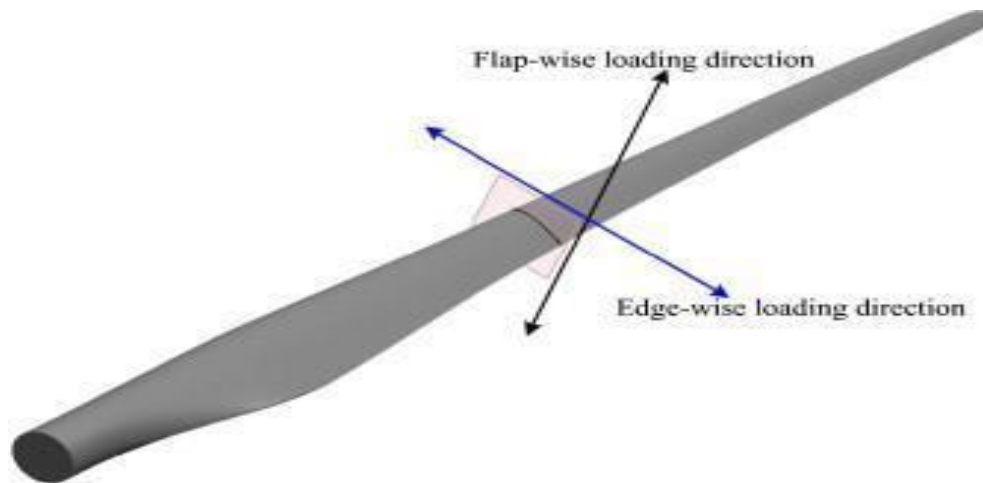
Figure 4 – Image – Basic loading directions of a wind turbine blade

Modern wind turbine blades are made of Fiber Reinforced Plastic because of the better weight-to-durability ratio of the materials compared to the wood and metals previously used. These composite materials are particularly suited for long, thin structures such as blades, because most stresses are in one direction and the fibers can be aligned to fit. It is quite obvious that most of the fibers in the Spar as well as in the aerodynamic shell have to be oriented along the length of the blade as it is the direction of the bending loads, tension on windward side and compression on the leeward side.

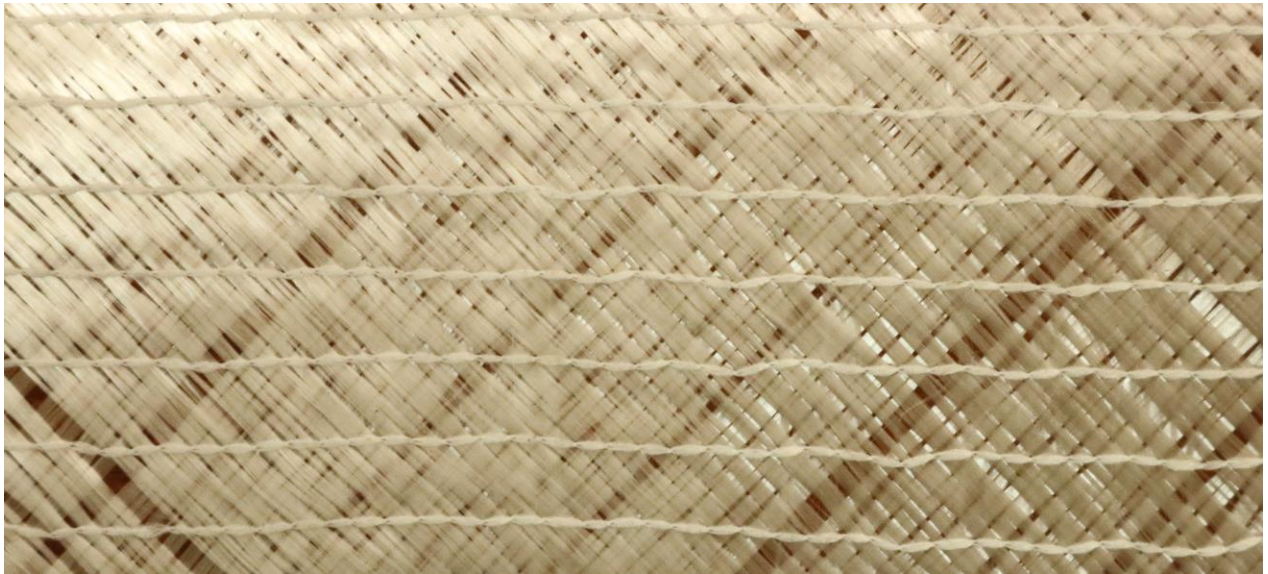
Figure 7– Image – Biaxial fiberglass fabric

1. Biaxial fiberglass: 2 fiber directions (+, - 45°), weight 310 g /m² (Figure 7)
2. Triaxial fiberglass: 3 fiber directions (+, - 45°, 0-90°), weight 1185 g /m² (Figures 8,9)
3. Epoxy resin: FIBERMAX R481 with hardener H17, weight ratio 18/100
4. Core material 80/30 (PVC foam): Thickness 30mm

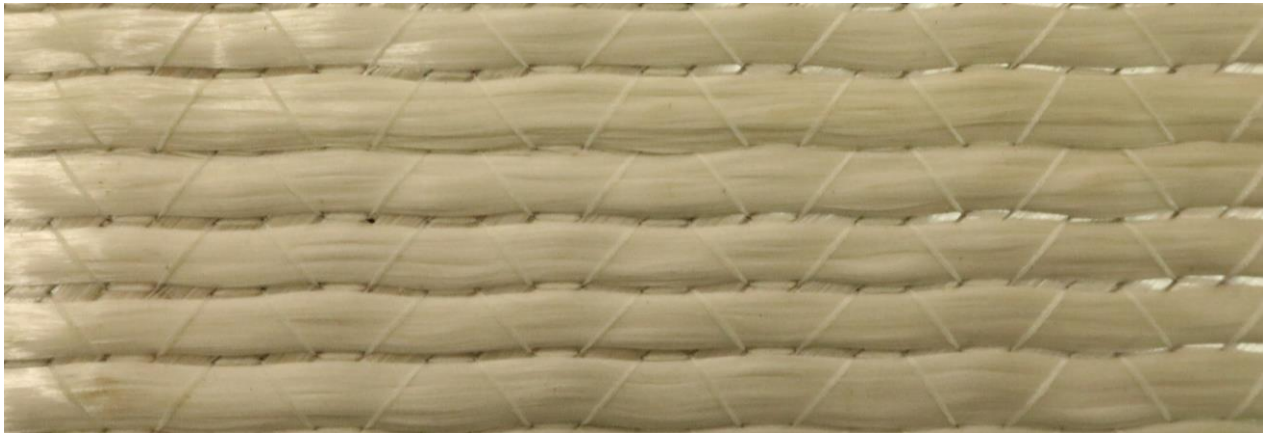
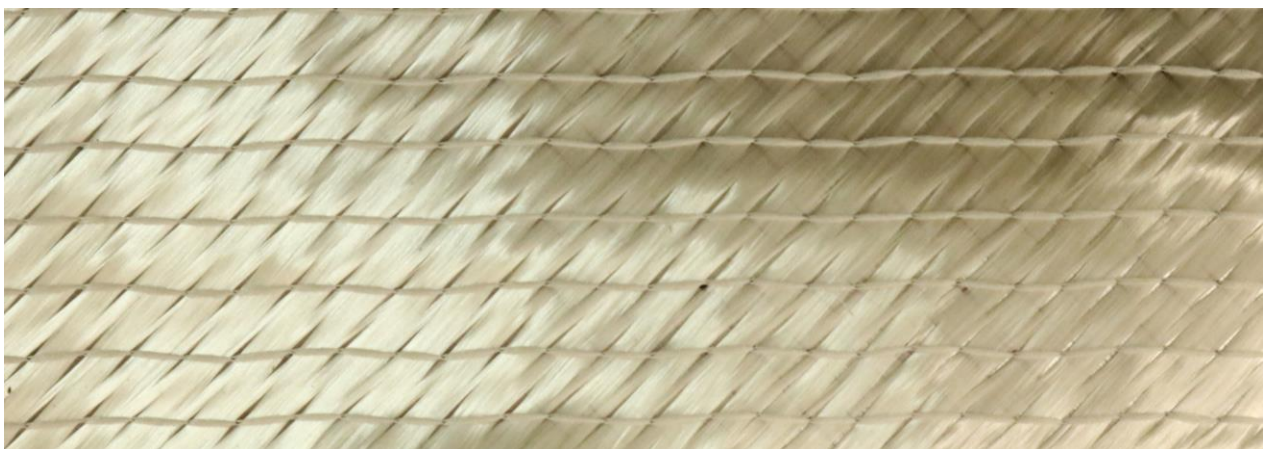
Figure 8– Image – The unidirectional side of a triaxial fiberglass fabric

Figure 9– Image – The biaxial side of a triaxial fiberglass fabric

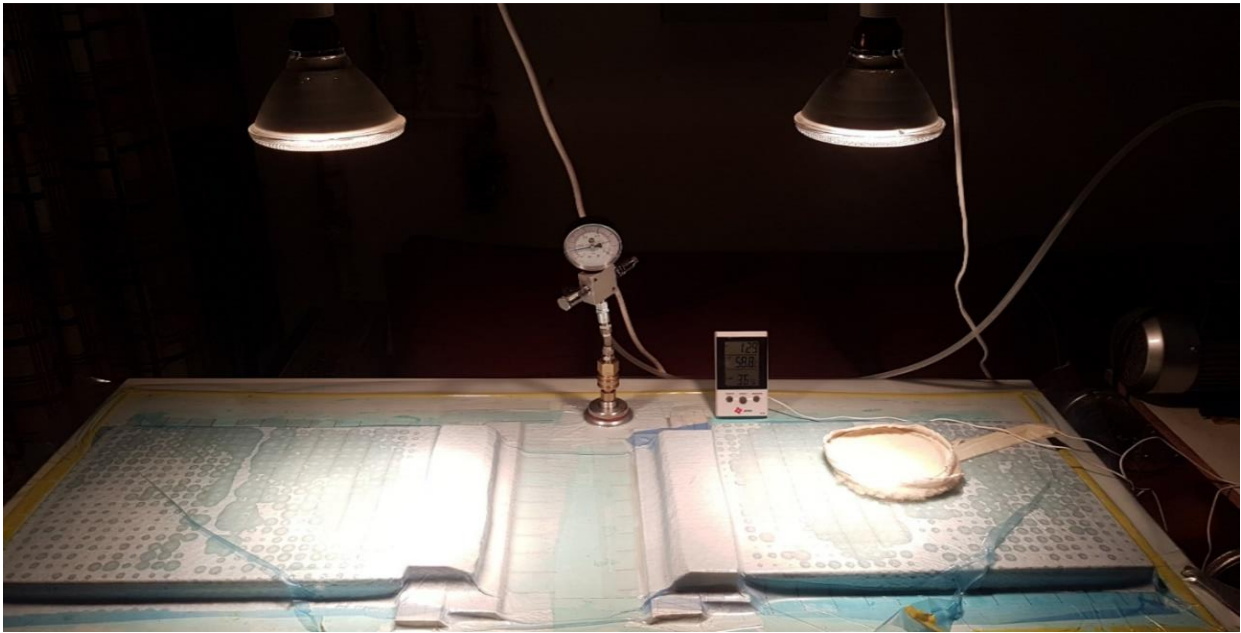
Preparing the specimens is a complicated process similar to that followed by the blade makers for the construction of the outer shell. Initially, a smooth surface is moistened with a release agent material, after which the construction of the specimen begins and the lay-up of the fiber glass fabrics takes place. The lay-up sequence of the glass fiber fabrics and core material used, were the same with the actual structure are found on the outer shell of the blades. Specifically, the lay-up sequence depends on the type of specimen produced. After the impregnation of the glass fiber fabrics and the core material with the matrix material (epoxy system) is completed, then the vacuum process is followed in order to achieve perfect adhesion between the layers and to eliminate the excess material which adds excess weight to the structure. During vacuum procedure, the thermosetting matrix material must be solidified, for this reason the vacuum membrane is sealed, heat is supplied to the specimen using special lamps and blankets (in the industry special ovens are used). The procedure followed for the manufacturing of the specimens is shown schematically in [Figures 10,11](#).

Figure 10 – Image – Vacuum Procedure

Figure 11 – Image – Ongoing vacuum-curing procedure after the impregnation of the fiberglass fabrics

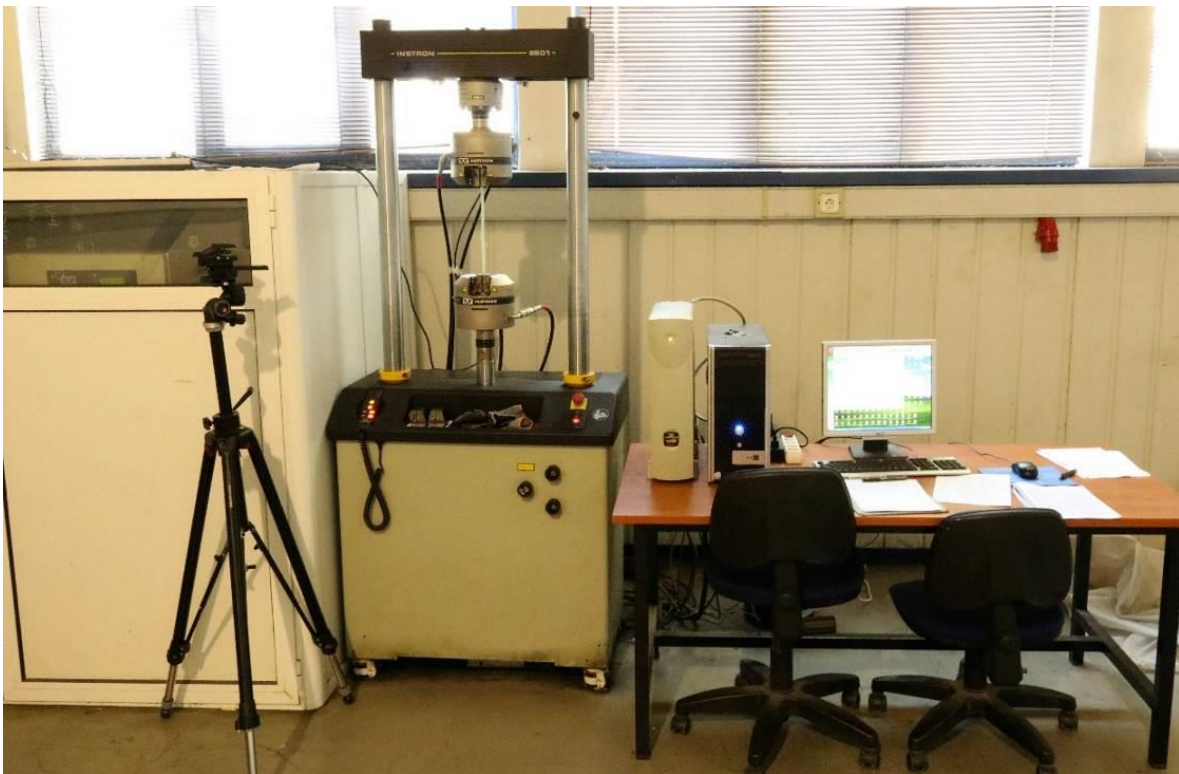
Figure 17 – Image – Tensile machine Instron 8801

All the experiments were carried out at the Laboratory of Mechanics and Strength of Materials at the Department of Mechanical Engineering of the University of Thessaly and the tensile machine used is the Instron 8801. The tensile machine consists of three main parts, the high-pressure hydraulic system, the fixed loading frame in combination with the moving piston and the central controller console. All commands in the machine are given by PCs which are converted to different pressures through the console of the machine and through the closed loop circuit, to similar piston movements. At the top of the fixed frame there is the upper grapple, which has a load cell that essentially makes measurement of the load for each time of the experiment. The hole tensile machine setup is shown in [Figure 17](#).

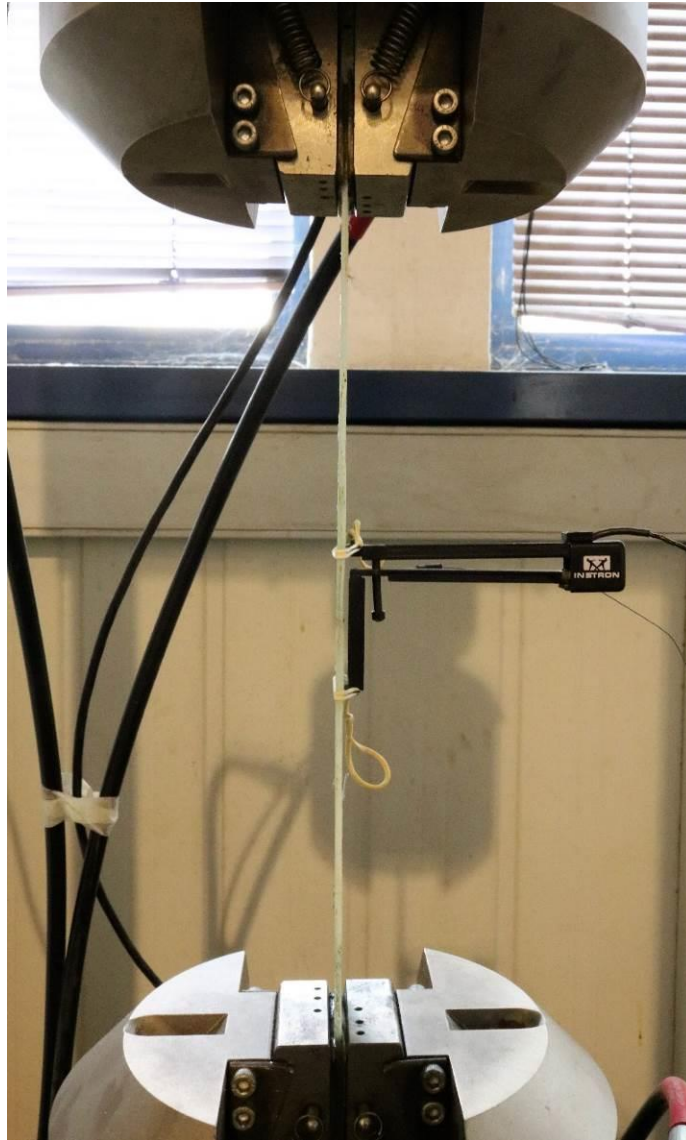
Figure 21 – Image – Tensile experimental set up

Static tensile tests were performed in accordance with ASTM D 3039 / D 3039M. The tests were carried out at a temperature of 20°C and a displacement rate of 2mm / min. During the experiment, the data collected were load and displacement, as well as strain using an axial extensometer placed on the specimen's gauge length (Figure 21).

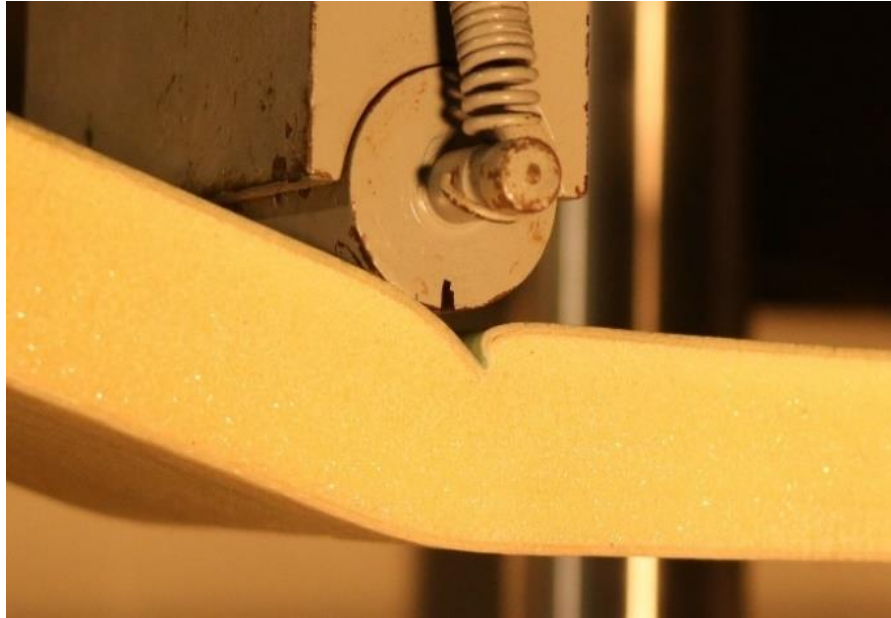
Figure 22 – Image – Failure of specimen tested without pads

The first test was carried out on a test specimen according to ASTM standard and a failure occurred at the contact points of the jig rollers (Figure 22) at relatively small load. This happened due to the sinking of the harder roller material into the relatively soft multilayer layout of the specimen supported by the stress concentration imposed at this point during bending. So, for the next tests, special protective pads were constructed and placed at the contact-load points to minimize the stress concentration effects (Figure 23).

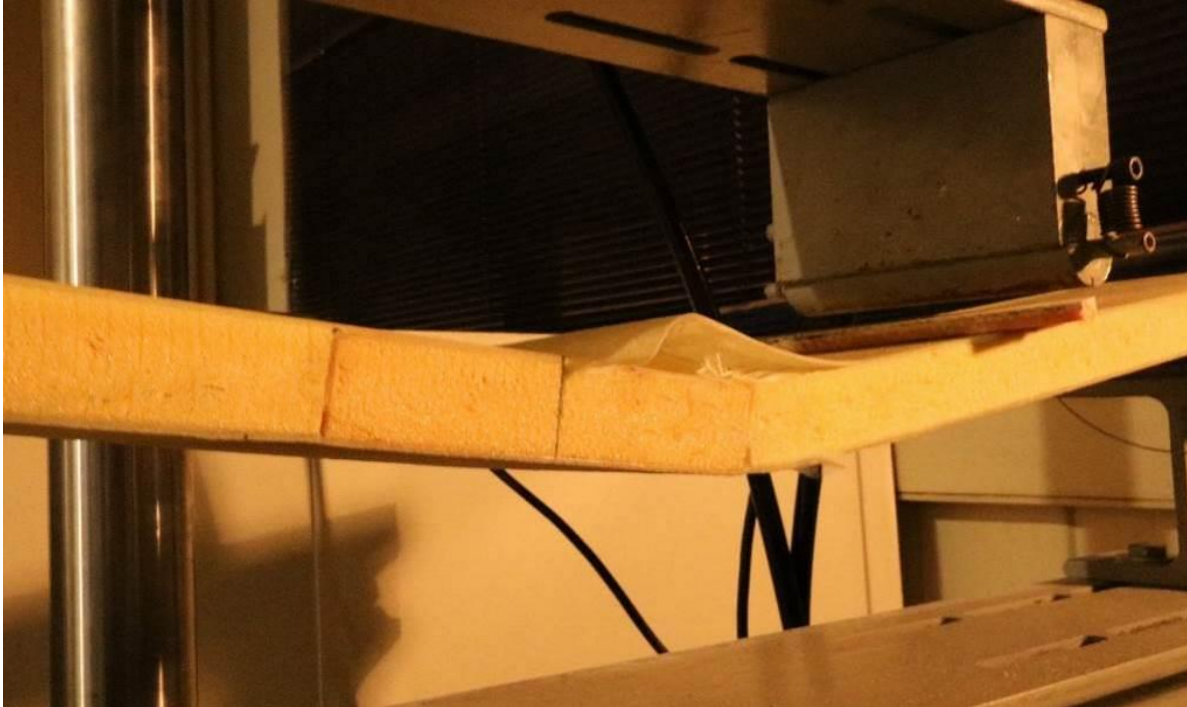
Figure 24 – Image – Failure of specimen with stepped 20mm overlap repair in the compression side

During flexural loading, failures were observed in two different regions. The specimens that had 20mm and 30mm stepped overlap repair in their structures failed at the upper region where the root of the repair is found, where compressive stresses develop (Figure 24), while the specimens with 40mm stepped repair failed at the locations of contact with the protective pads.

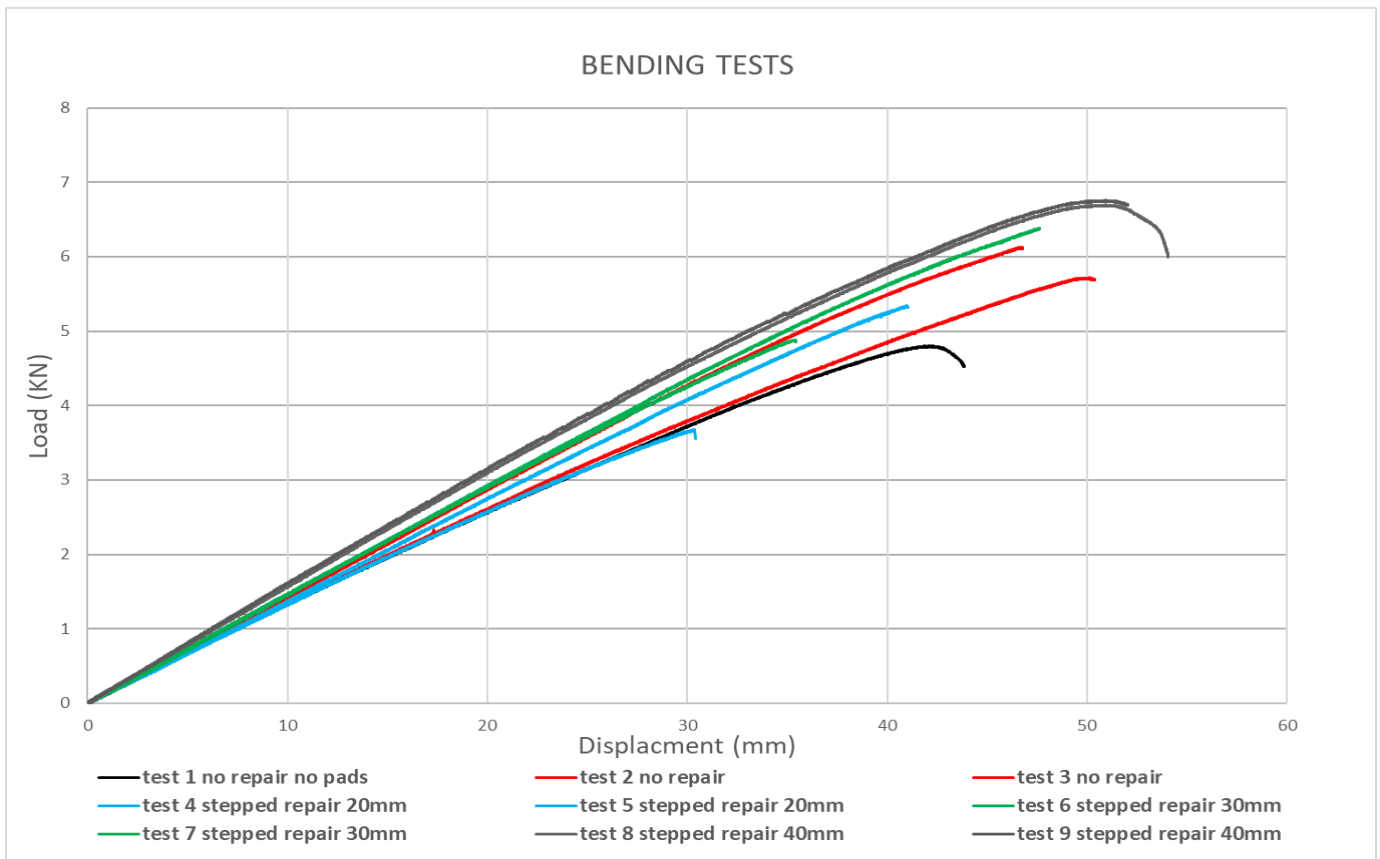
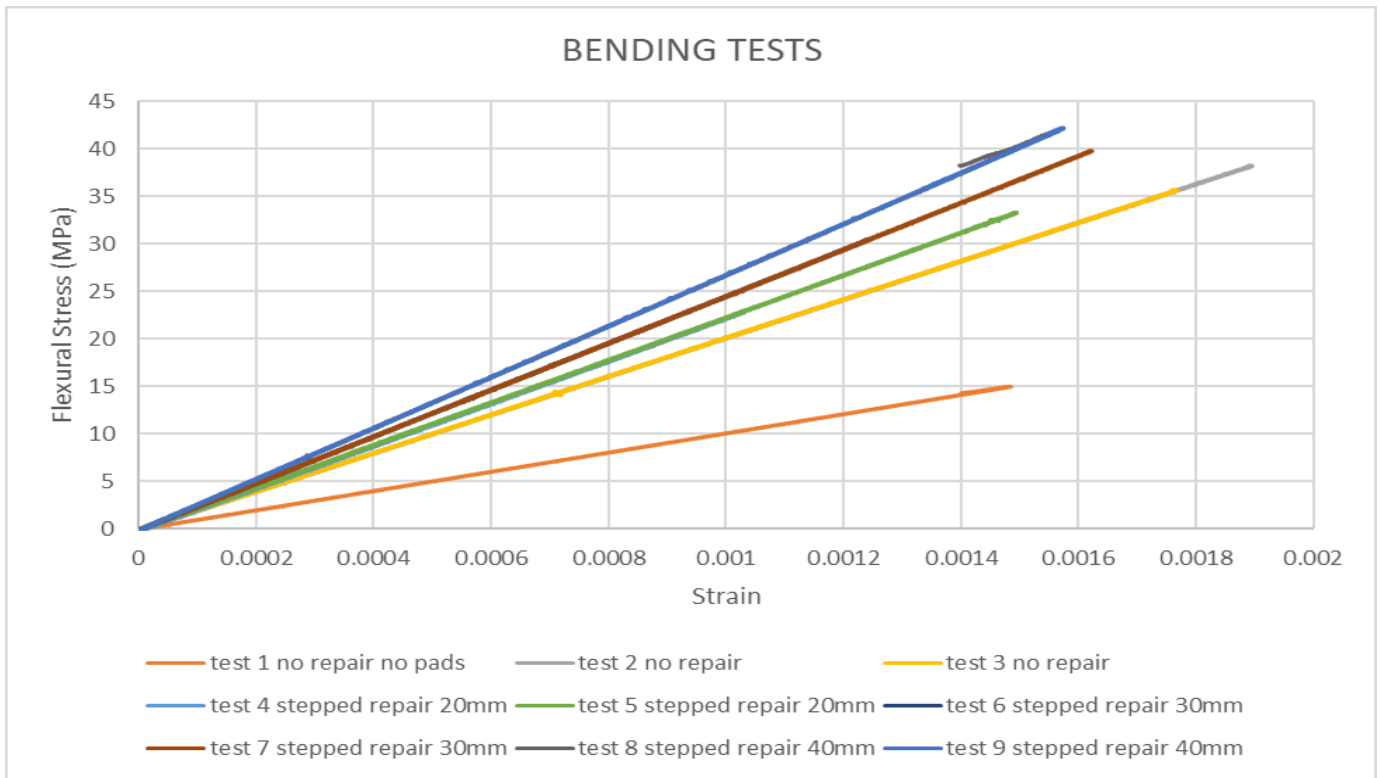
As shown in the diagrams of the performed bending tests in Figures 25,26 and taking into account the experimental scatter observed, the reference specimens exhibit lower flexural strength compared to the specimens containing the stepped repair something that is also compatible to the stiffness of the panels. Also, it is observed that with increasing the length of the step in the repair procedure, the bending strength of the specimens is increased. The increase in bending stiffness and strength of the repaired specimens is a welcome feature regarding the maintenance procedure of such structural components. The reason for this increase lies in the nature of the repair technique, which in order to fill the gap created by the removal of the composite damaged material, finally by the stepped overlap method higher density of glass-fiber plies (double fiber-fabrics in the overlap regions) is found in the repair area ,than the original undamaged configuration. This, contributes to an increased bending stiffness at the area of the repair and hence requires a higher load for failure.

Figure 25 – Diagram – Load-Displacement

Figure 26 – Diagram – Stress - Strain

In order to explain the above variation of bending stiffness, the fiber density increased in the repaired specimens was estimated according to the following formula and the results are shown in Table 5. It has to be commented that, the fiber density increases due to the overlaps, shown in the following table, is distributed only close to the repair region (inside the loading span), which results in an important increase of flexural stiffness.

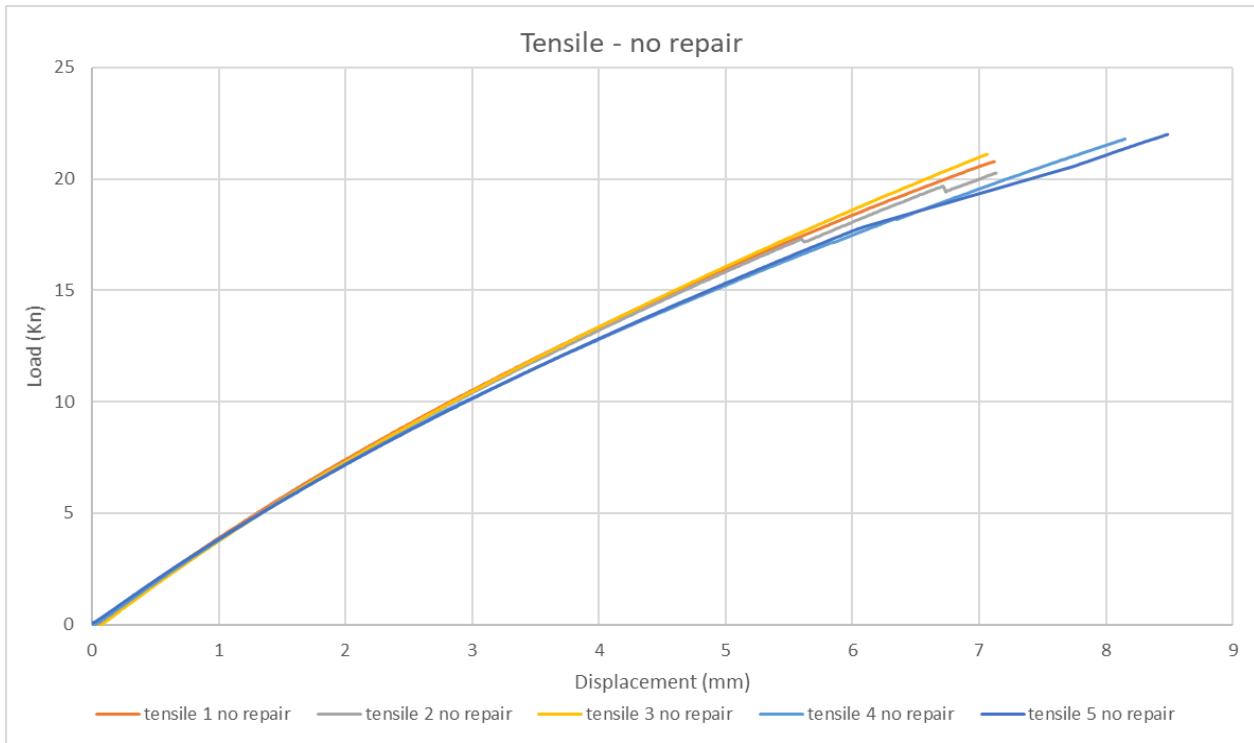
Figure 30 – Diagram – Load-displacement curve of tensile specimen without repair

In [Figures 30](#) through [37](#) the stress-strain and load-displacement diagrams, such as concentrated [Tables](#) are shown for every tensile experiment separately. Finally, comparative [Figures 38,39,40,41,42](#) were created, in order to give us the ability to easily compare the mechanical behavior between the reference specimens (no repair) and the other three types of repaired specimens.

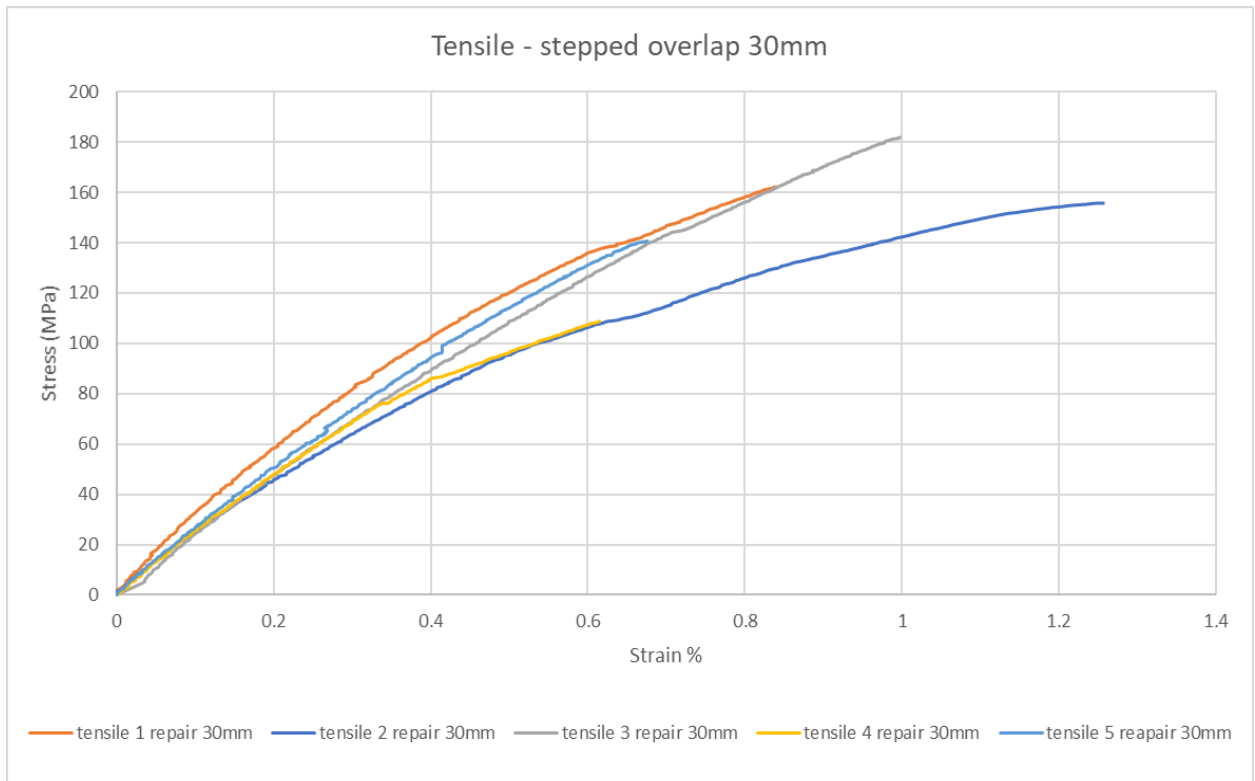
Figure 35 – Diagram – Stress-strain curve of test specimen with 30mm overlap repair to its structure

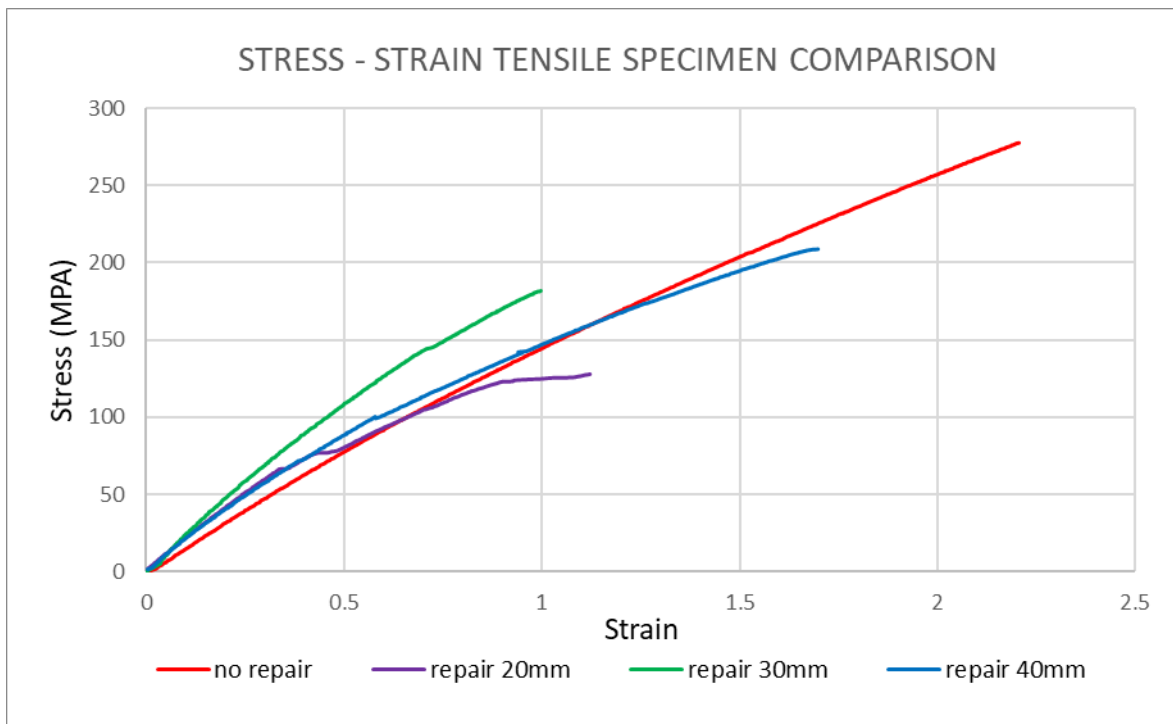
Figure 39 – Diagram – Stress - Strain curve comparison of all specimen categories

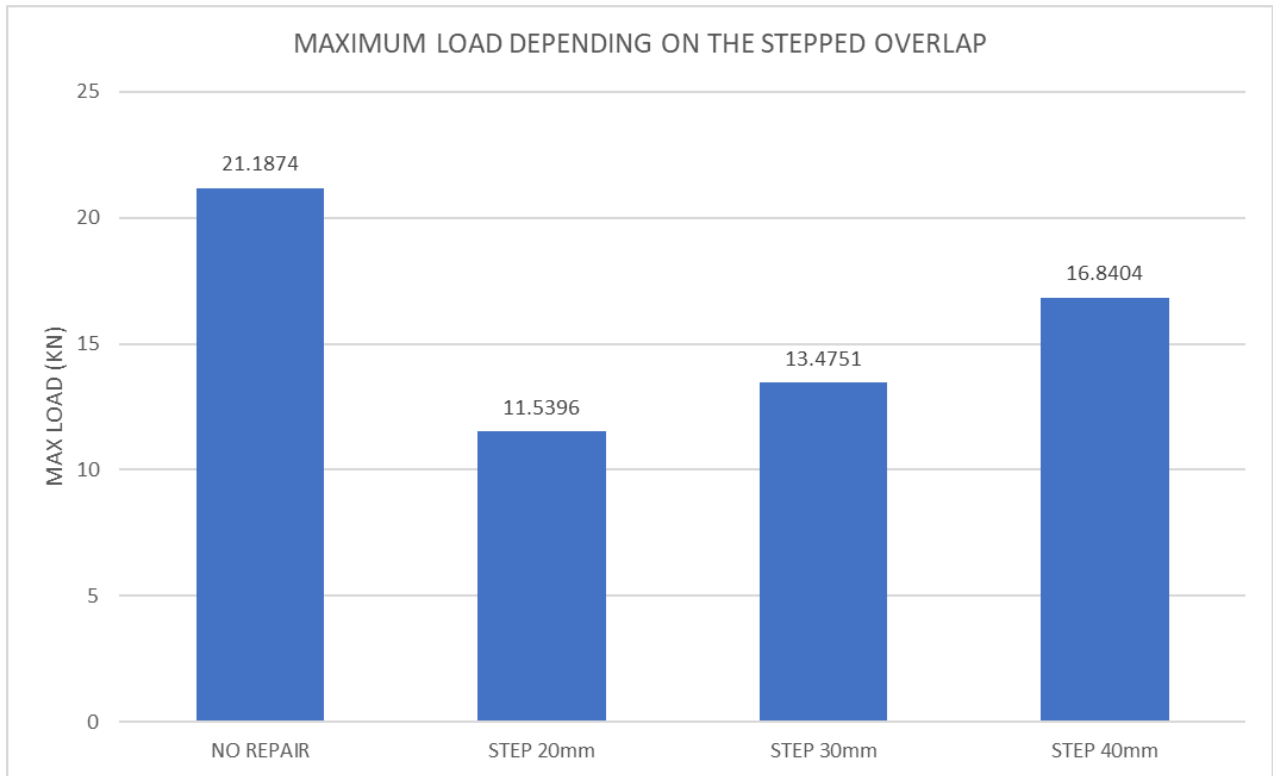
Figure 40 – Diagram – Comparison of the maximum load between every category of tensile specimens

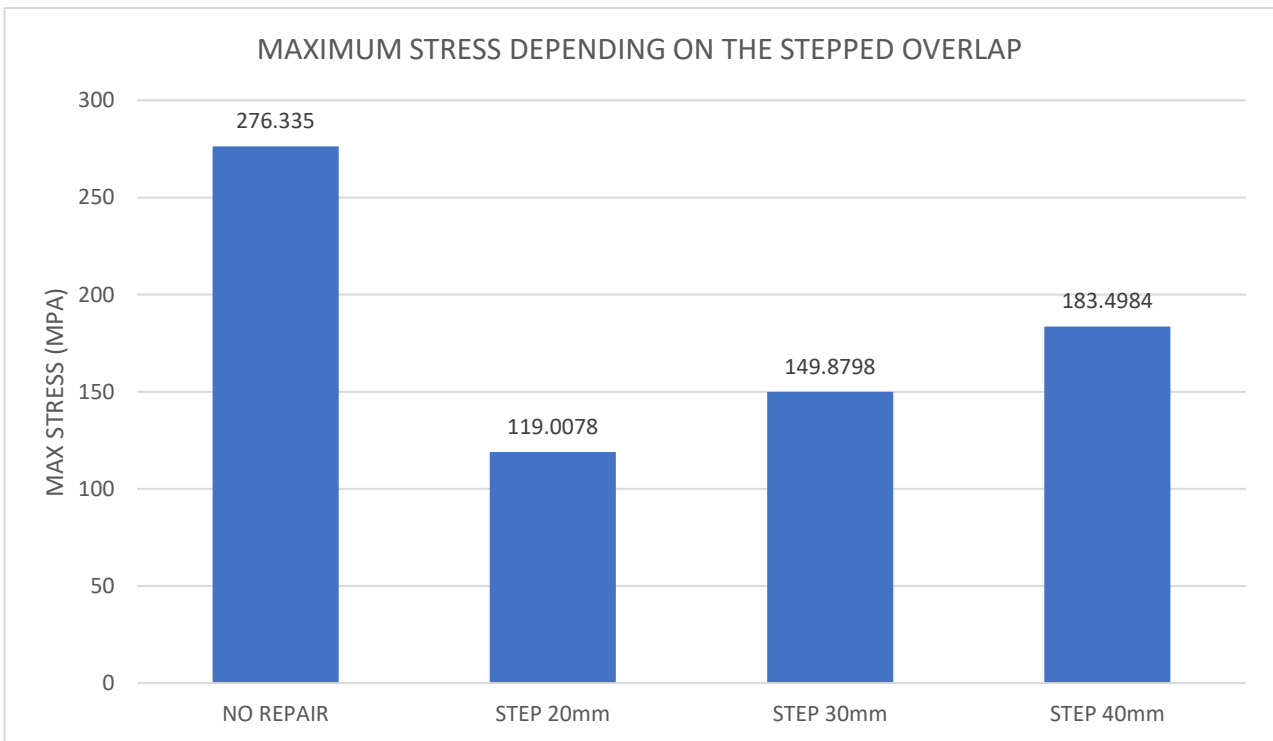
Figure 41 – Diagram – Comparison of the maximum stress between every category of tensile specimens

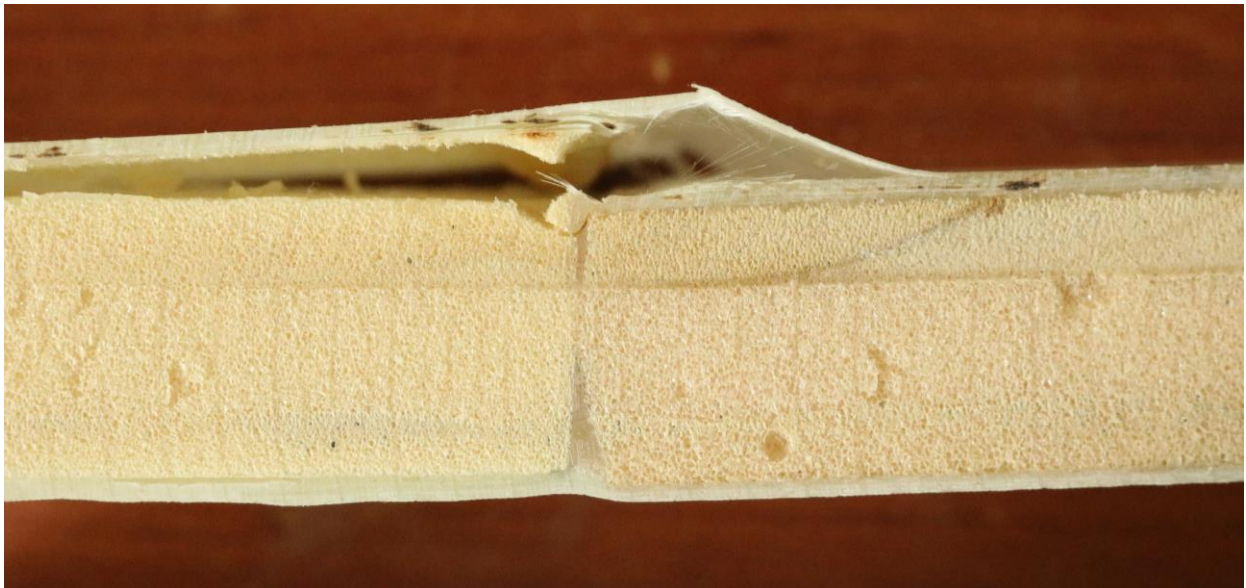
Figure 43 – Image – Four-point bending specimen with stepped repair in its structure – Delamination failure mechanism and fiber breakage

In repaired composite specimens, fracture during bending, in the most cases occurred at the upper side of the beam (specimen), where compression takes place, at the locations close to the edge of the repair steps, which due to the discontinuity imposed in the laminate structure by the repair and following the adhesion of new glass fiber layers, impose certain stress concentration at the specific point, as well as a non-uniform stiffness and hence stress distribution at the specific area. This leads to the fracture initiation at this area of the compressive side, which is followed by delamination failure. Damage evolution in the final stage is cracking at the upper part of the laminate, this sequence is shown in [Figure 43](#).

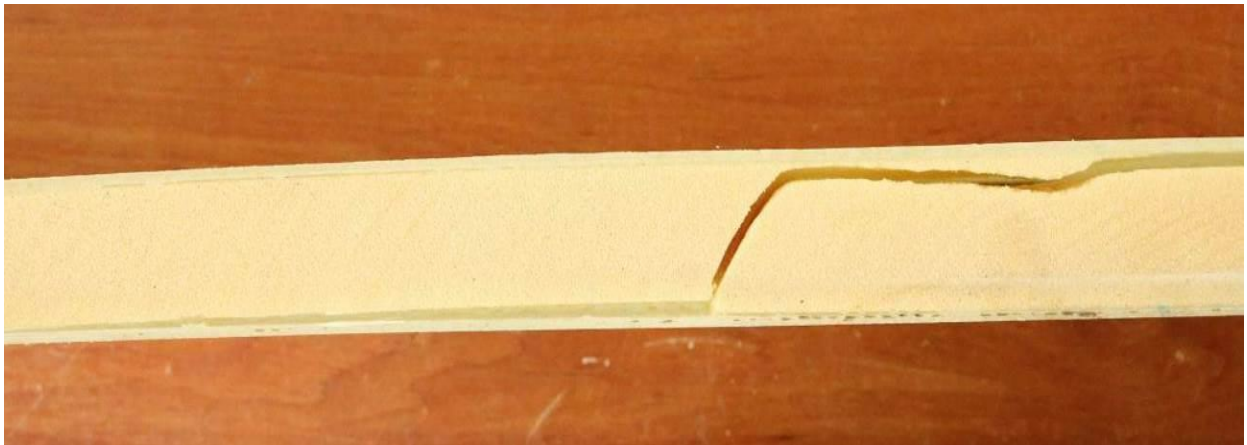
Figure 44 – Image – Four-point bending specimen without repair in its structure- Delamination failure mechanism

Specimens without a repair in their structure have continuous fibrous phase which means that the stresses are evenly distributed without high stress concentration in any certain areas. The failure mechanism is characterized as delamination of the outer lamination on the compressive side, which is followed by cracking of the core material as shown in [Figure 44](#). The delamination is result of the differentiation of stresses between the two sides, compression in the upper side tension in the lower side.

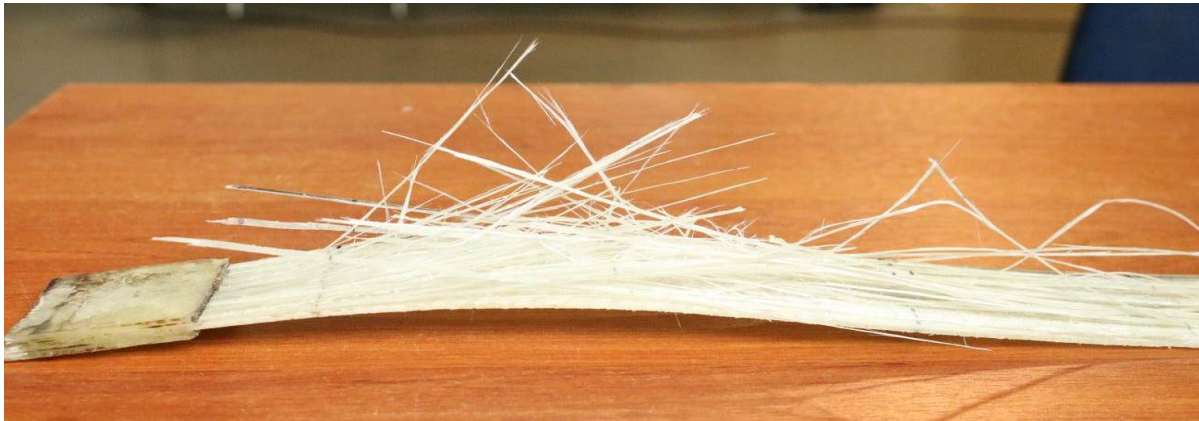
Figure 46 – Image –Tensile specimen with no repair in its structure – Matrix and fiber failure

The tensile specimens without repair in their structure exhibited higher durability under tension in comparison to the specimens with repair in their structure. The elongation and the forces that these specimens can handle is much higher than the specimens with repair. By having continuous fiber phase, and evenly distributed stresses the failure-delamination mechanism has no place to start. The glass fibers can withstand high elongation something that happens in this series of experiments, but the matrix material which has high stiffness cannot elongate as much and eventually of the above lead to the cracking of the matrix material. During the matrix failure, many small and sharp pieces are formed which are found between the stressed fibers, these small pieces and the higher stress distribution only in the fibrous phase eventually lead to fiber breakage as it is shown in [Figure 46](#).

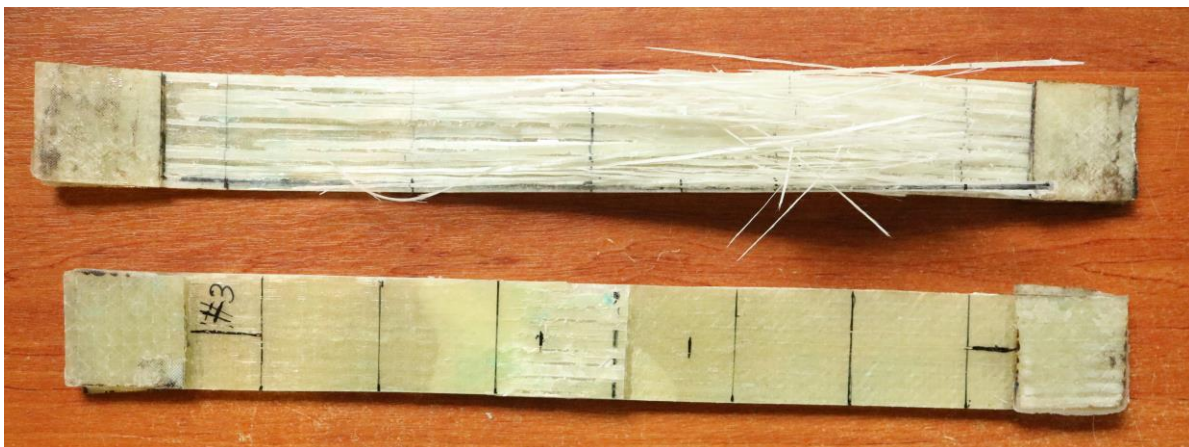
Figure 47– Image – Repaired and non-repaired Tensile specimens after failure

In [Figure 47](#) a comparison between the failure modes in different categories of specimens is made. It is obvious that the repaired specimen's failure is attributed to delamination and the failure in non-repaired specimens is attributed to the failure of the matrix materials.
