# Corrosion-induced Hydrogen Embrittlement in High-Strength Al-Alloys

THESIS

Submitted in partial fulfillment of the requirements for the degree of  
Doctor of Philosophy in Mechanical Engineering  
of the Department of Mechanical and Industrial Engineering  
University of Thessaly

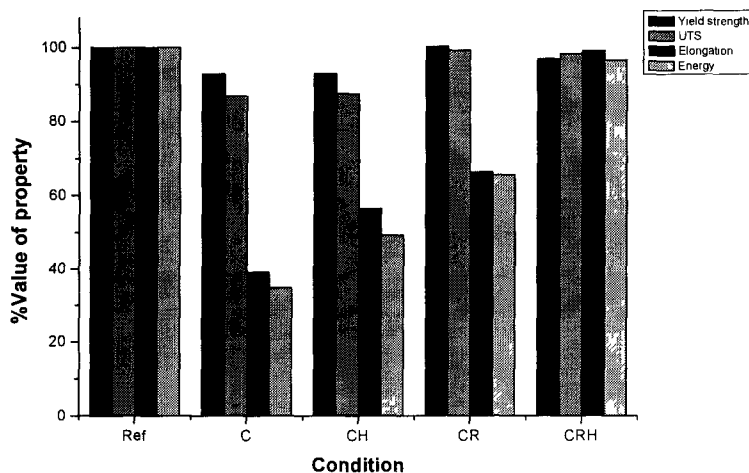
Fig. 4. 32: The results of Table 8 represented as percentages of the respective reference values [97].

The results presented in Table 9 and Fig. 4. 32 depict the following:

Corrosion degrades yield strength and ultimate tensile strength as expected, however the degradation of tensile ductility (elongation and energy density) is more pronounced (Condition C). Examining conditions CH and CR independently we see that the removal of the corrosion layer restores entirely the strength values and enhances the tensile ductility. Heating of the corroded material does not affect the strength values; however it enhances the tensile ductility. Removal of the corrosion layer and then heating the material not only restores the strength values but it also restores ductility as well (condition CRH).

The fractographic analysis for conditions C and CR presented above correlate with the hydrogen profile in the material (Fig. 4. 27) and the tensile data of Fig. 4. 32. The hydrogen affected zone extends below the corrosion layer. This is the embrittled (quasicleavage) zone between the intergranular corrosion and the ductile uncorroded matrix seen in the above fractographs. Removal of the corrosion layer (CR) removes the effects of corrosion but leaves the hydrogen embrittled zone in place. This is the reason for the incomplete restoration in ductility for condition CR. Only in condition CRH, where all hydrogen has also been removed, there is a complete restoration of ductility.
