UNIVERSITY OF THESSALY
SCHOOL OF ENGINEERING
DEPARTMENT OF MECHANICAL ENGINEERING

Failure mechanisms in heat exchangers

Submitted in partial fulfillment of the requirements for the degree of Diploma in
Mechanical Engineering at the University of Thessaly

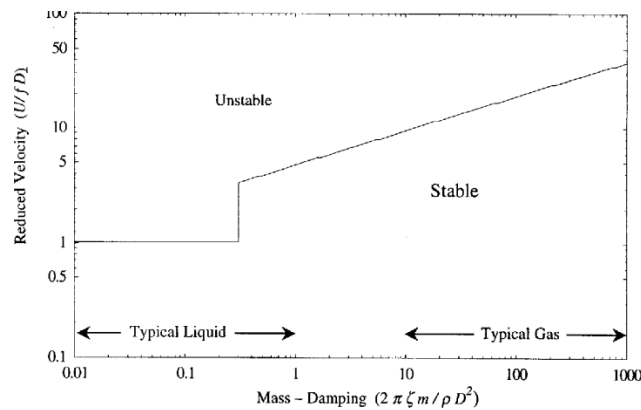
Figure 2-4: Fluidelastic stability chart for a rotated triangular geometry [13].

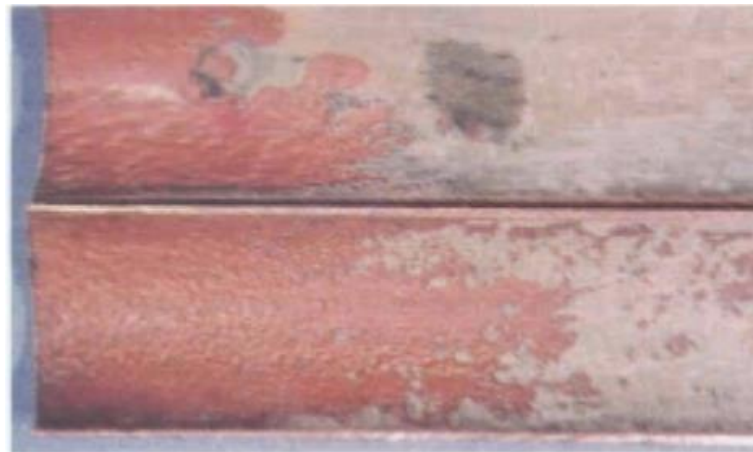
Figure 2-11: Erosion-corrosion attack [39].

We detect this failure mechanism usually below the shell inlet nozzle, inside the U-bend area of tubes, particularly the tighter bends, in the entrance area of tubes, or at the point of contact with baffles and tubes [3]. When tubes contain fluids like inferior crude oil special attention must be given because of the nitrogen and sulfur compounds that crude oil contains. These compounds impose a high risk of failure [40].

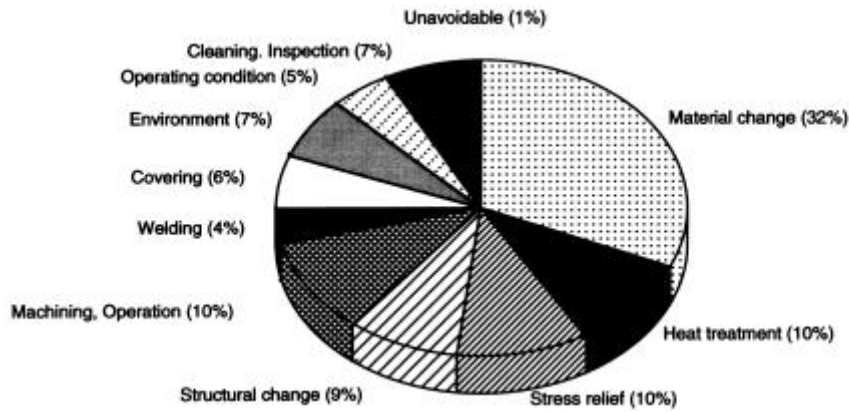
Figure 4-2: percentage of correcting measures in SCC cases [41].

Based on the above figure it is obvious that most cases demand material change (32%) and a few heat treatment (10%) and stress relief (10%) [41].

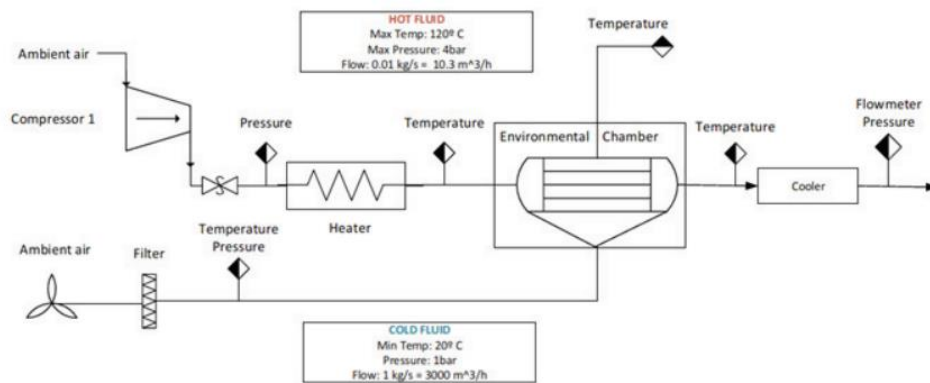
Figure 4-4: Air-to-air rig design [12].

As can be seen in the above figure air-to-air consists of a cold and a hot open circuit. The hot end of the rig begins with compressed air from the compressor. Following that, a heater boosts the temperature of the air, which can be monitored by the temperature sensor before passing through the heat exchanger. Temperature is measured again at the heat exchanger's outlet to monitor its performance. A cooler will chill the exhaust before it is exhausted, reducing it to tolerable levels. A blower pushes ambient air through the filter to the heat exchanger, which is subsequently exhausted.

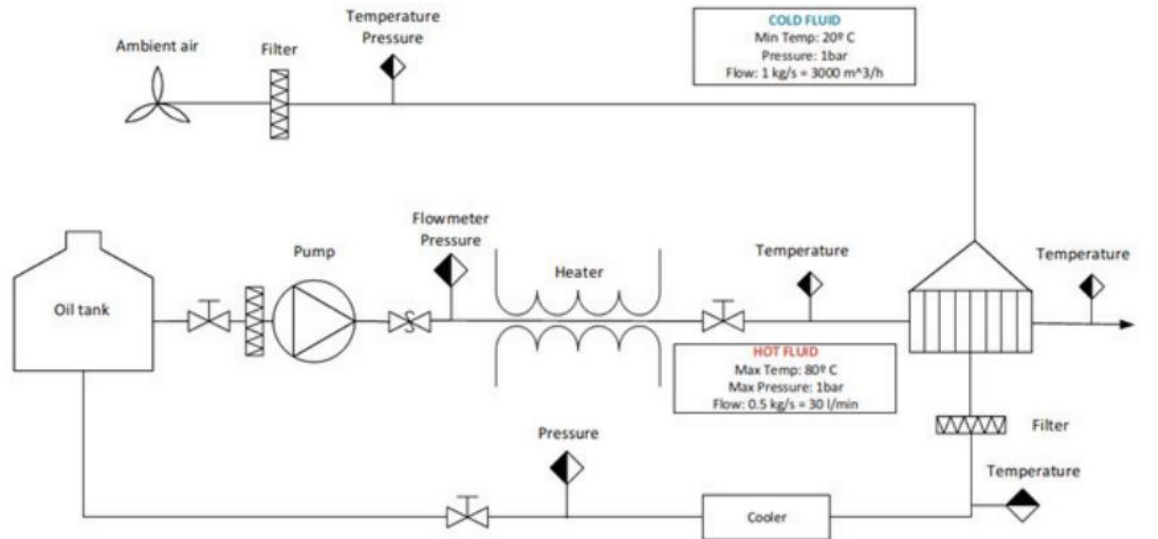
Figure 4-5: Oil-to-air rig design [12].

The oil-to-air heat exchanger rig is made up of a hot circuit (closed loop system) and a cold circuit (open system). The hot one starts with an oil tank to store the fluid, followed by a pump that pulls it from the container and pushes it through a filter into the system. The oil is then passed through the heater and its temperature is recorded before entering the heat exchanger. The temperature of the oil as it exits the heat exchanger is also measured before it is cooled and returned to the oil tank. The cold air circuit stays unchanged from the air-to-air rig design [12].
